APPENDIX A

**Photographs taken by Samuel Gowan on 8/15/2022 of the Scribner Road Area
and the Akron Quarry**

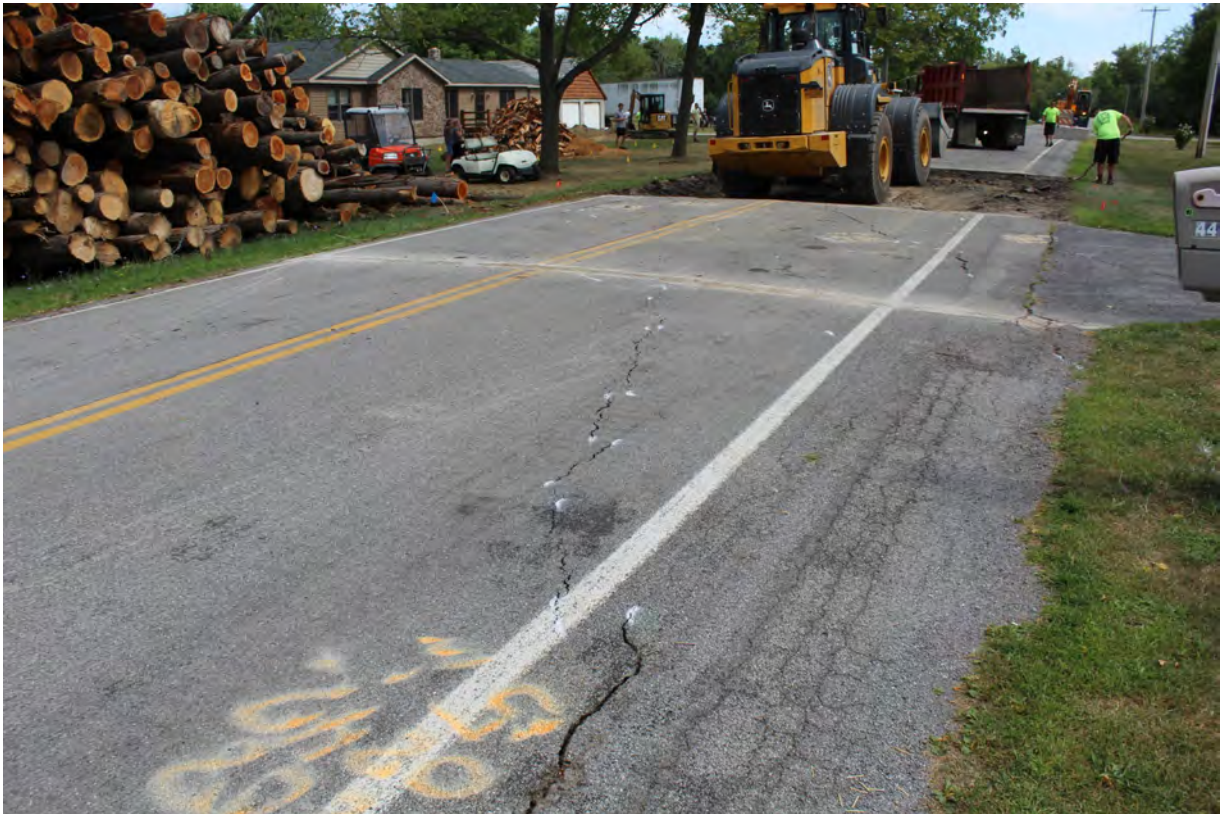
3009, 8/15/2022, by Sam Gowan: View to the north-northeast. 445 Scribner Road (Corfu, NY) on left side of road. Large woodpile recently placed at 445 Scribner Road. Fractures from recent event extending diagonally across the road.

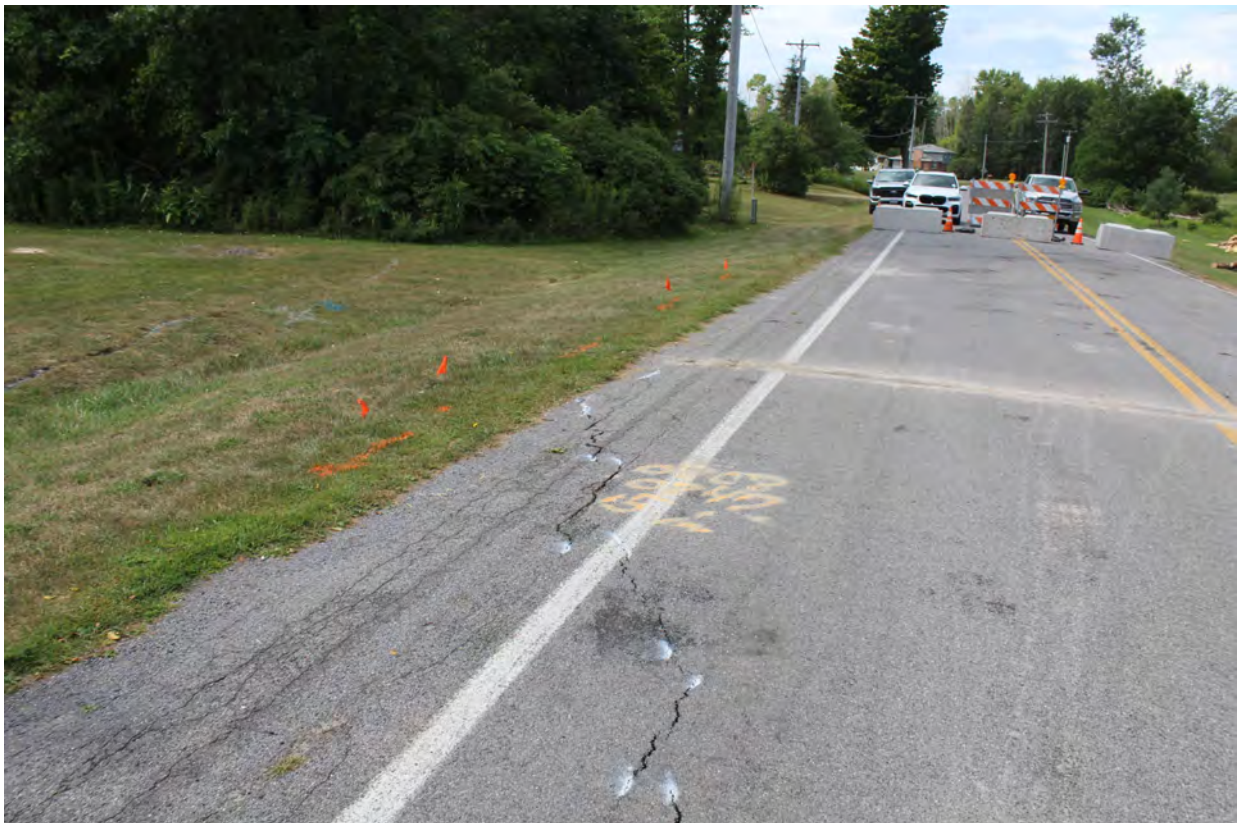
3010, 8/15/2022, by Sam Gowan: View to south-southwest across the corner of the yard at 440 Scribner Road. Fractures visible on both sides of the roadside ditch.

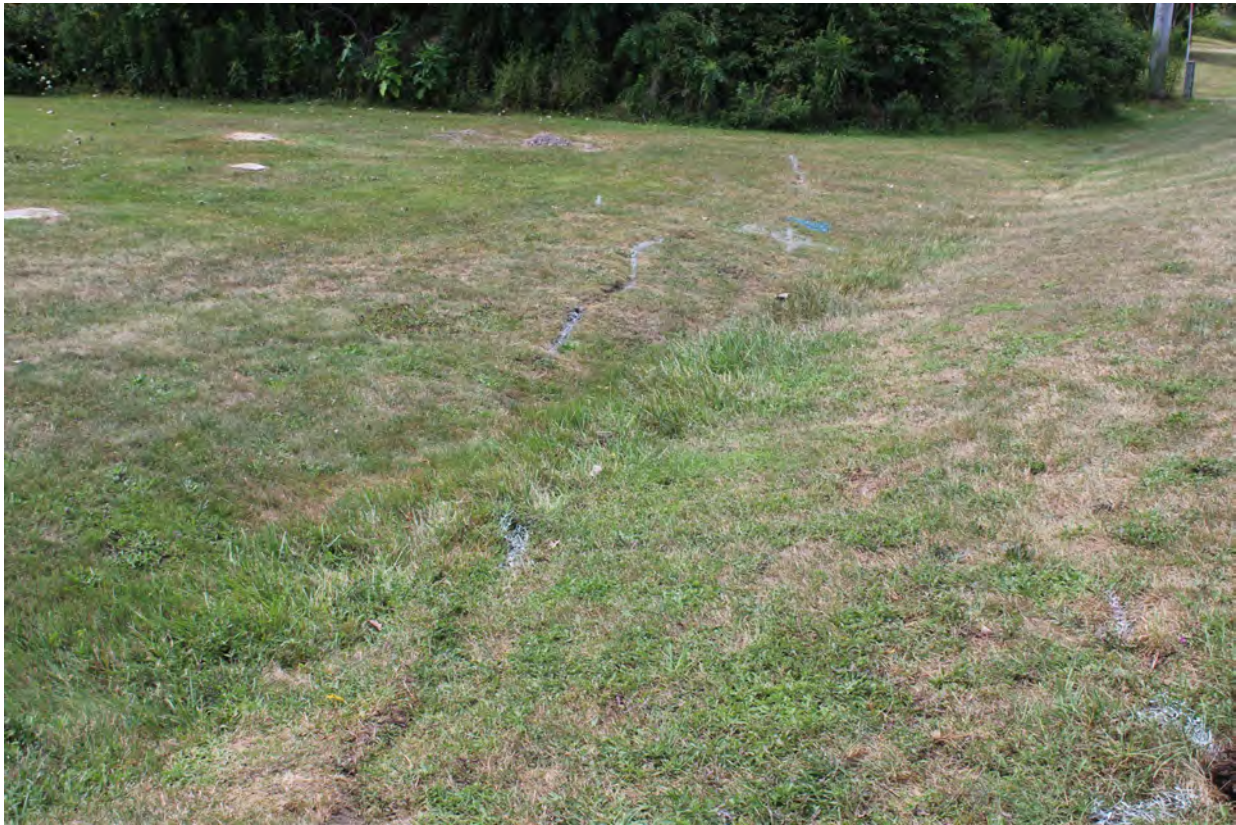
3011, 8/15/2022, by Sam Gowan: View to south-southwest across the corner of the yard at 440 Scribner Road. Fractures visible on both sides of the roadside ditch.

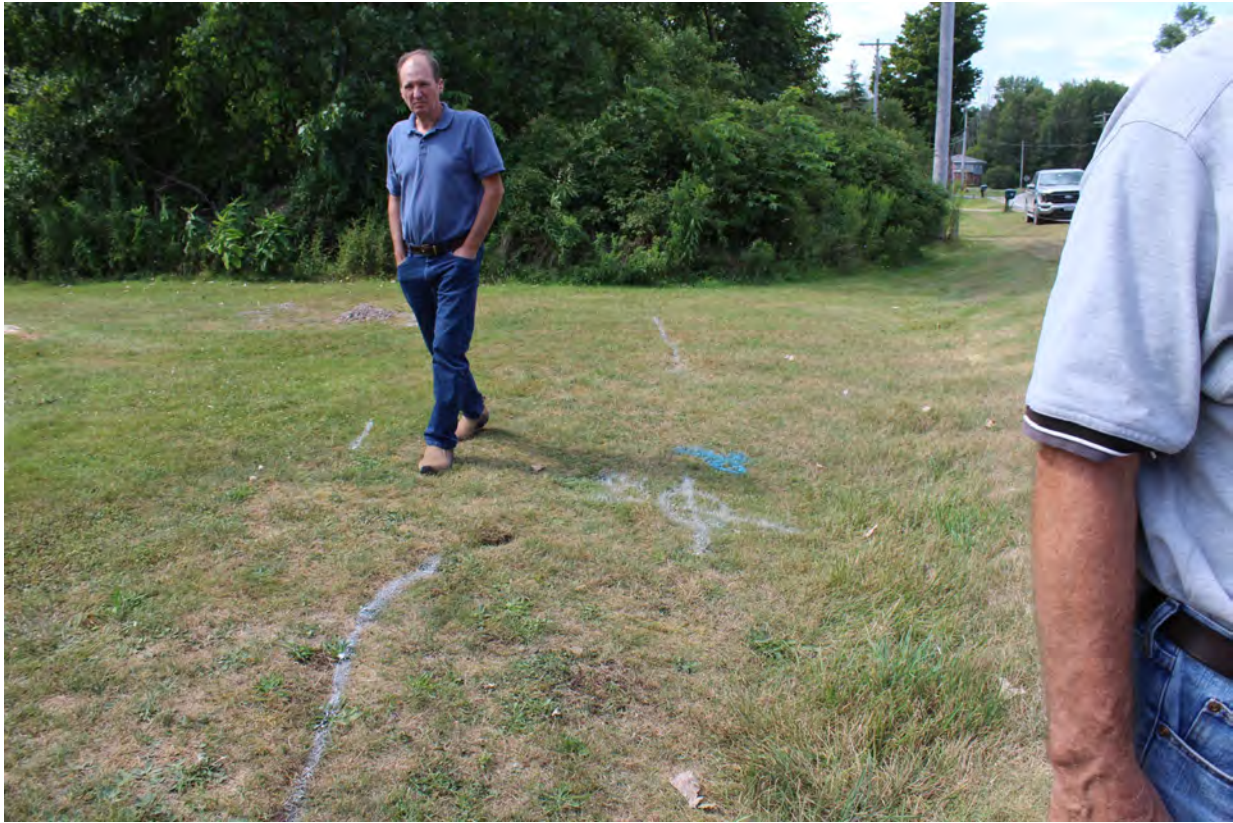
3013, 8/15/2022, by Sam Gowan: View to south-southwest in the yard at 440 Scribner Road, with Jeff Slade of AGS in the picture.

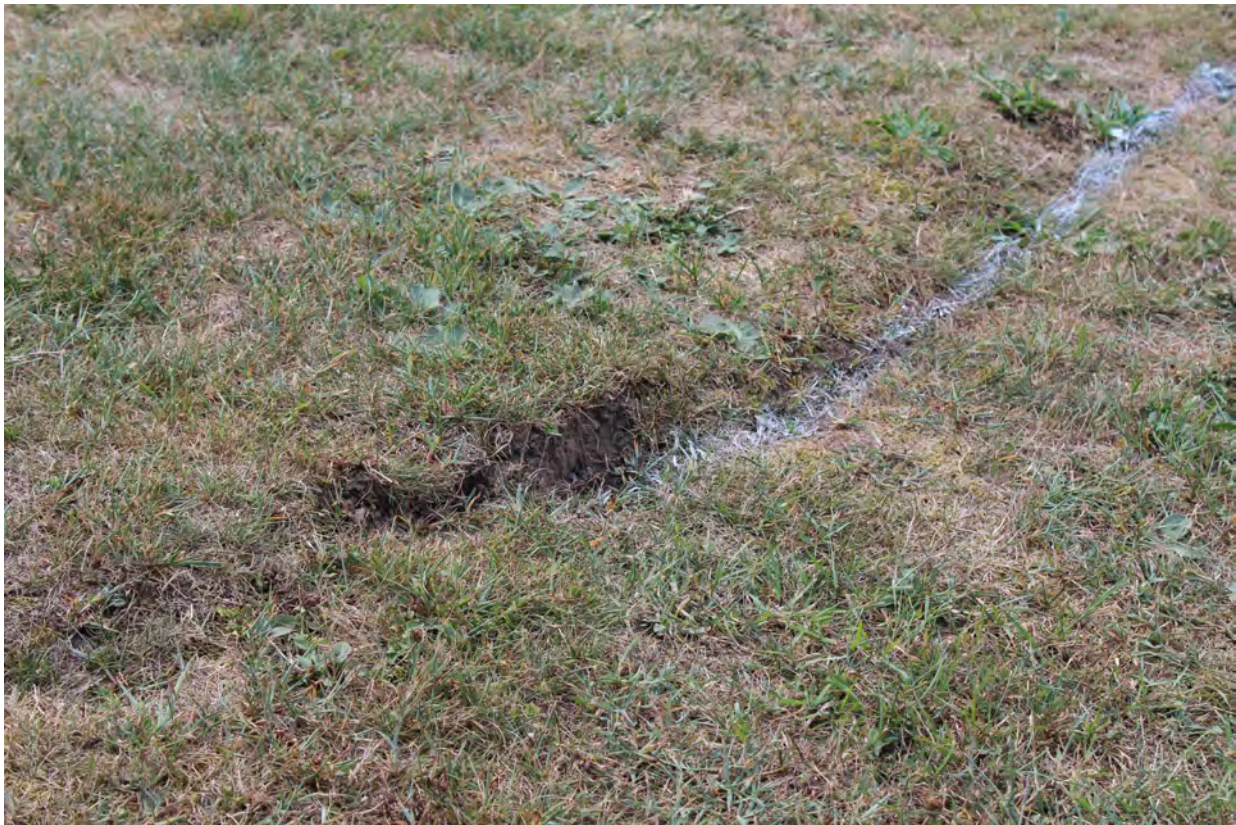
3014, 8/15/2022, by Sam Gowan: Closeup of the fracture with view toward the south, at 440 Scribner Road and at the approximate location of Gowan location 134.

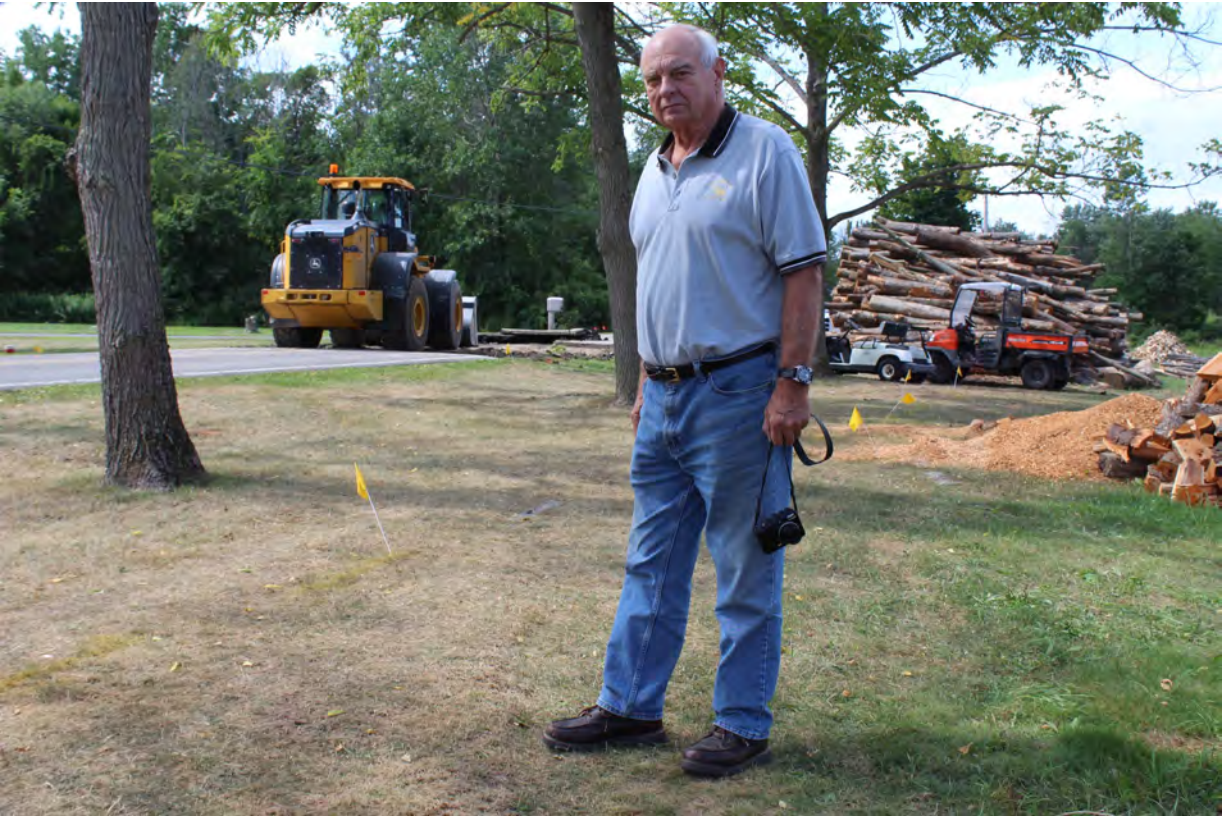
3015, 8/15/2022, by Sam Gowan: View to south-southwest from the front yard at 445 Scribner Road toward the corner of the yard at 440 Scribner Road. This view shows John Hellert of AGS with the toe of his boot at the edge of a linear feature that was not an open fracture and was indicated to be the result of vehicle traffic in the yard.

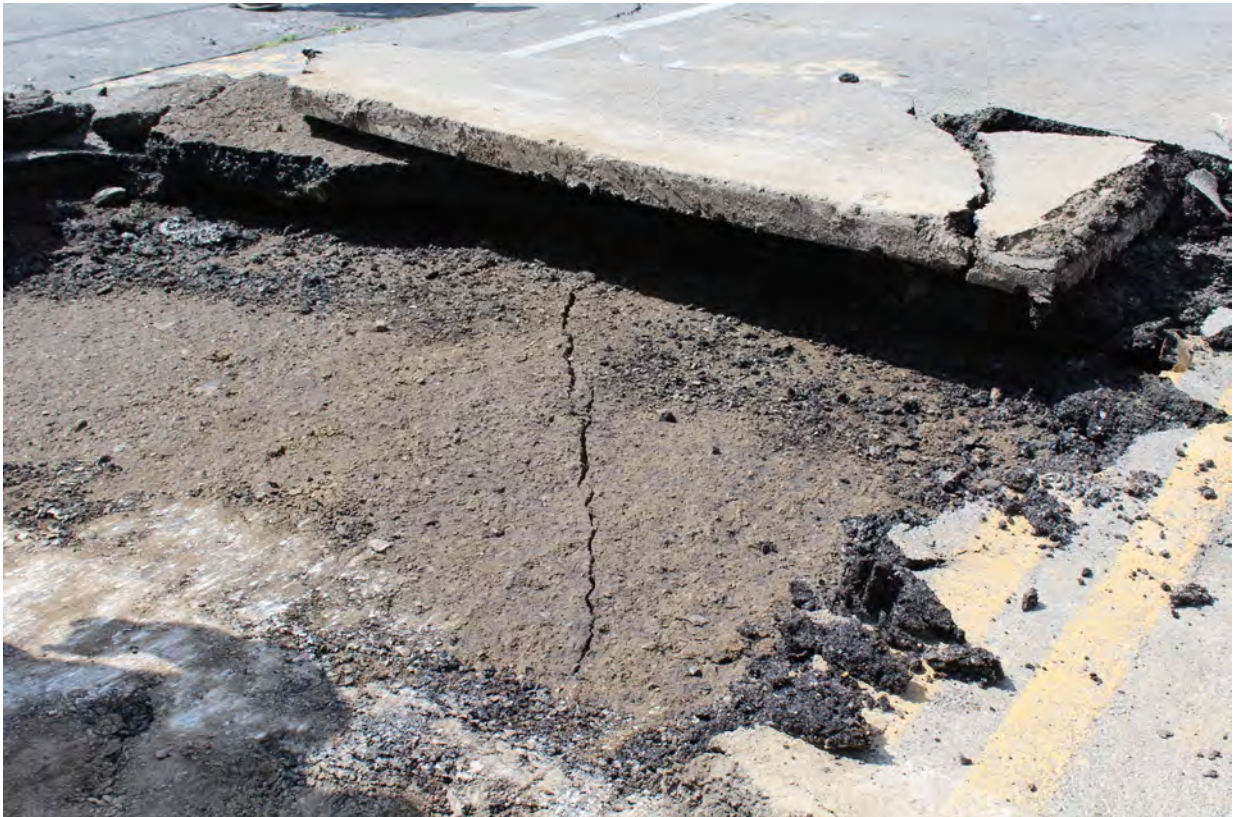
3016, 8/15/2022, by Sam Gowan: View to the south-southwest of a fracture in the recently exhumed subbase of Scribner Road

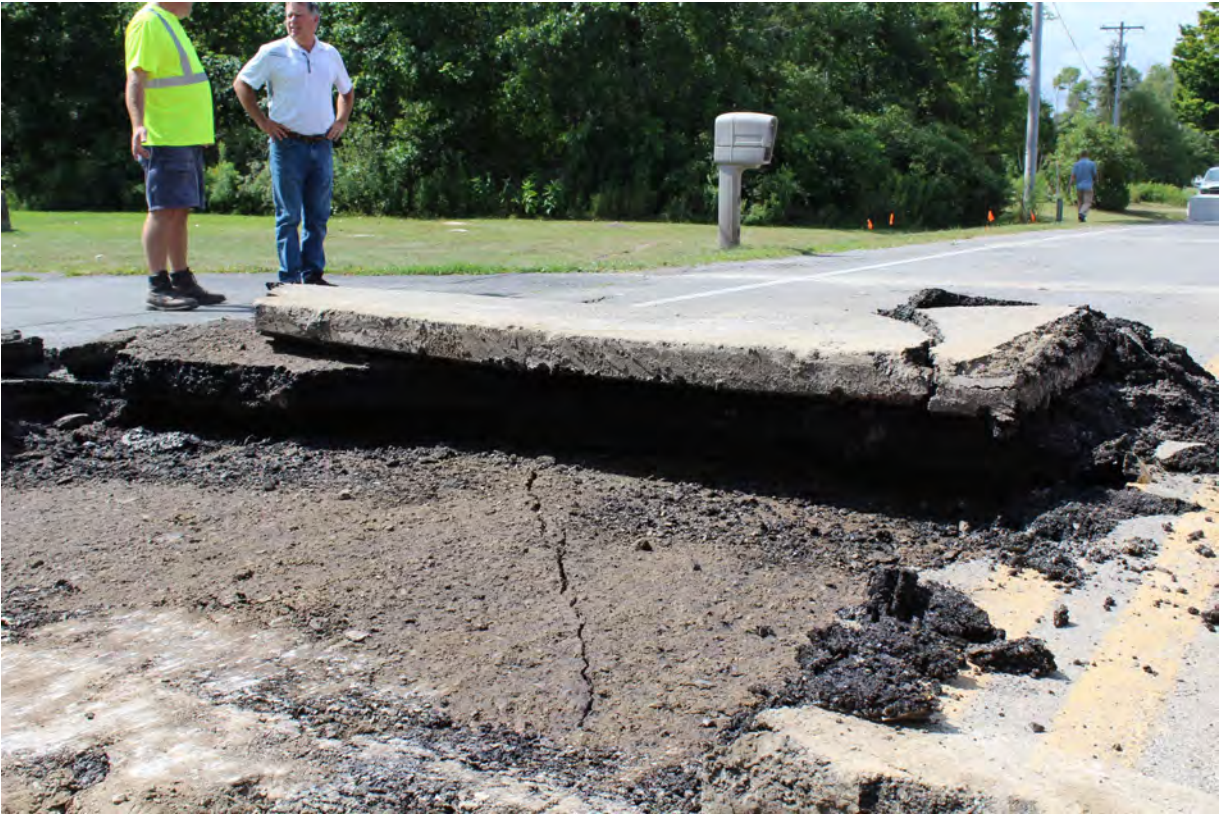
3017, 8/15/2022, by Sam Gowan: View to south-southwest of a fracture in the subbase of Scribner Road with Norm Gardner (white shirt) of CPL and the mailbox at 440 Scribner Road in the background.

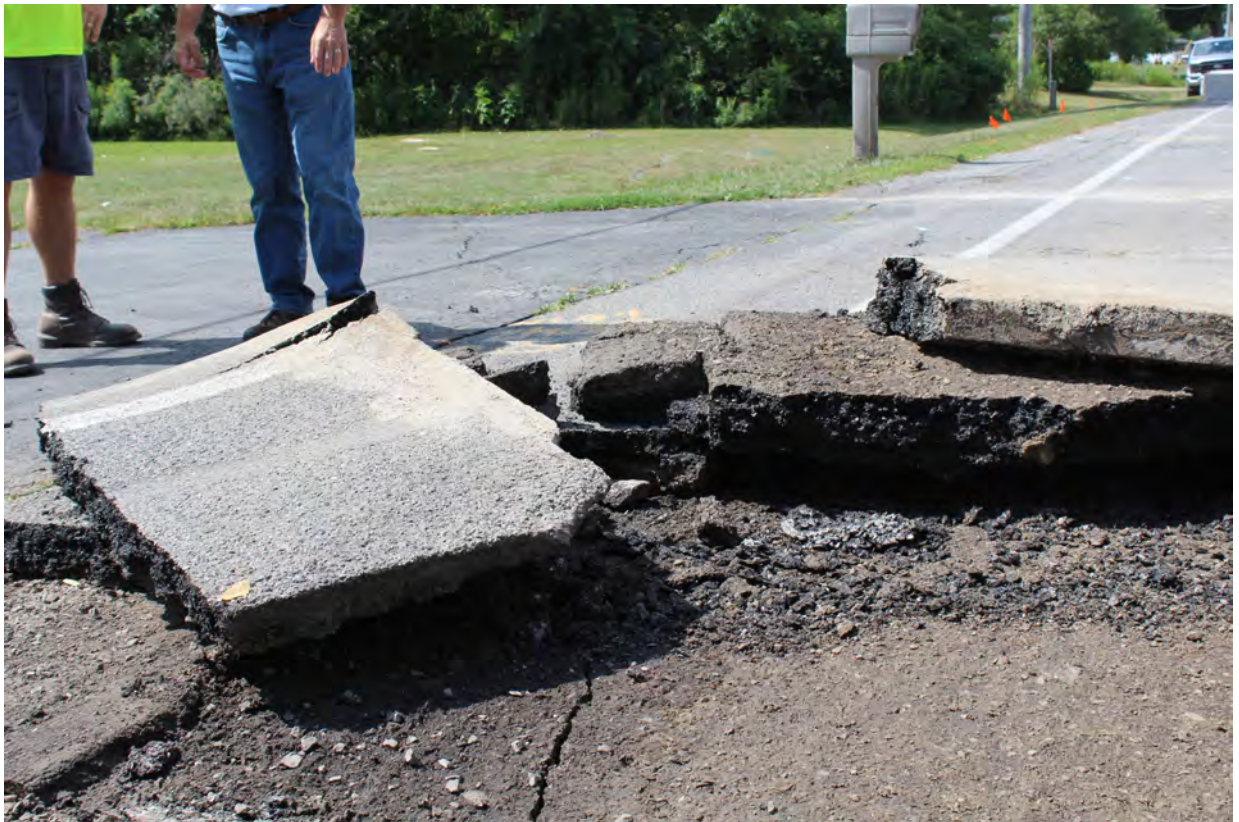
3018, 8/15/2022, by Sam Gowan: View to the south-southwest of a fracture in the road subbase.

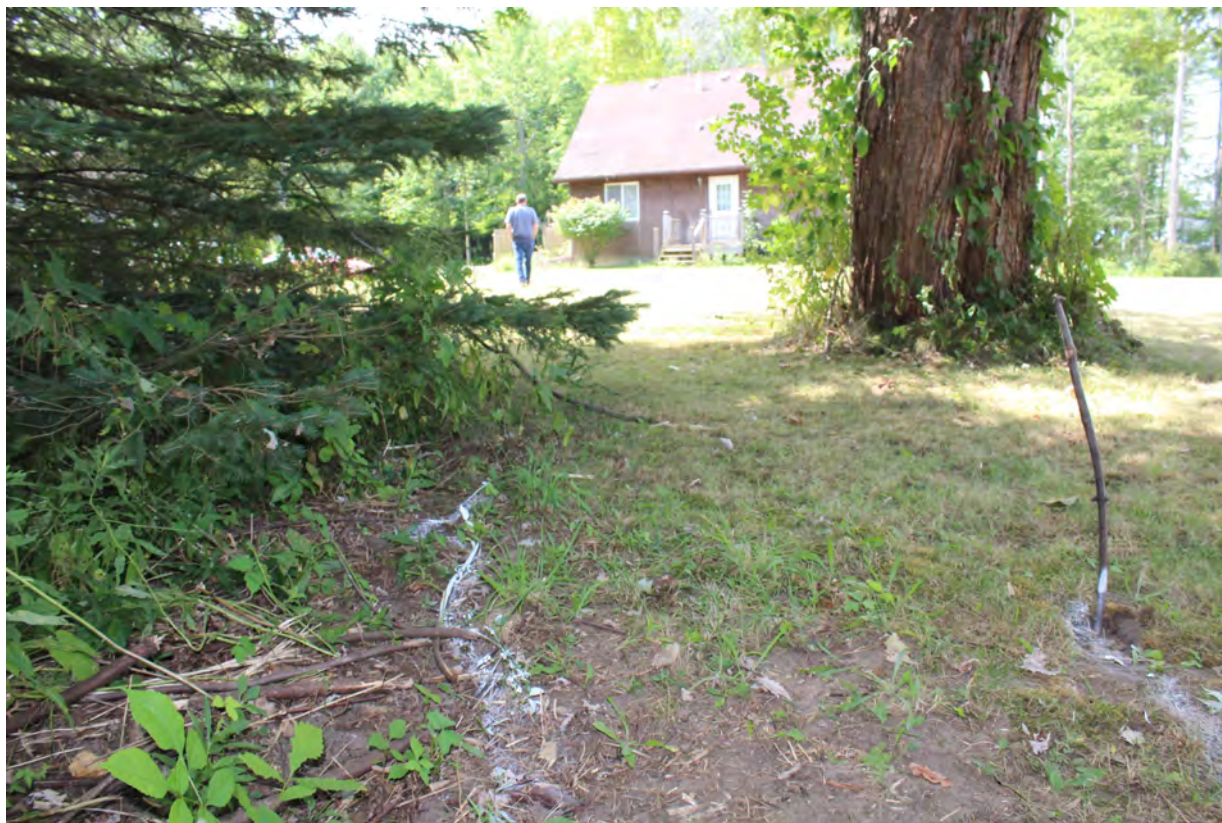
3019, 8/15/2022, by Sam Gowan: View to south-southwest at 430 Scribner Road with Jeff Slade (AGS) in the background. The white paint in the foreground was used to mark possible fractures, but no fracture was visible at this location upon inspection.

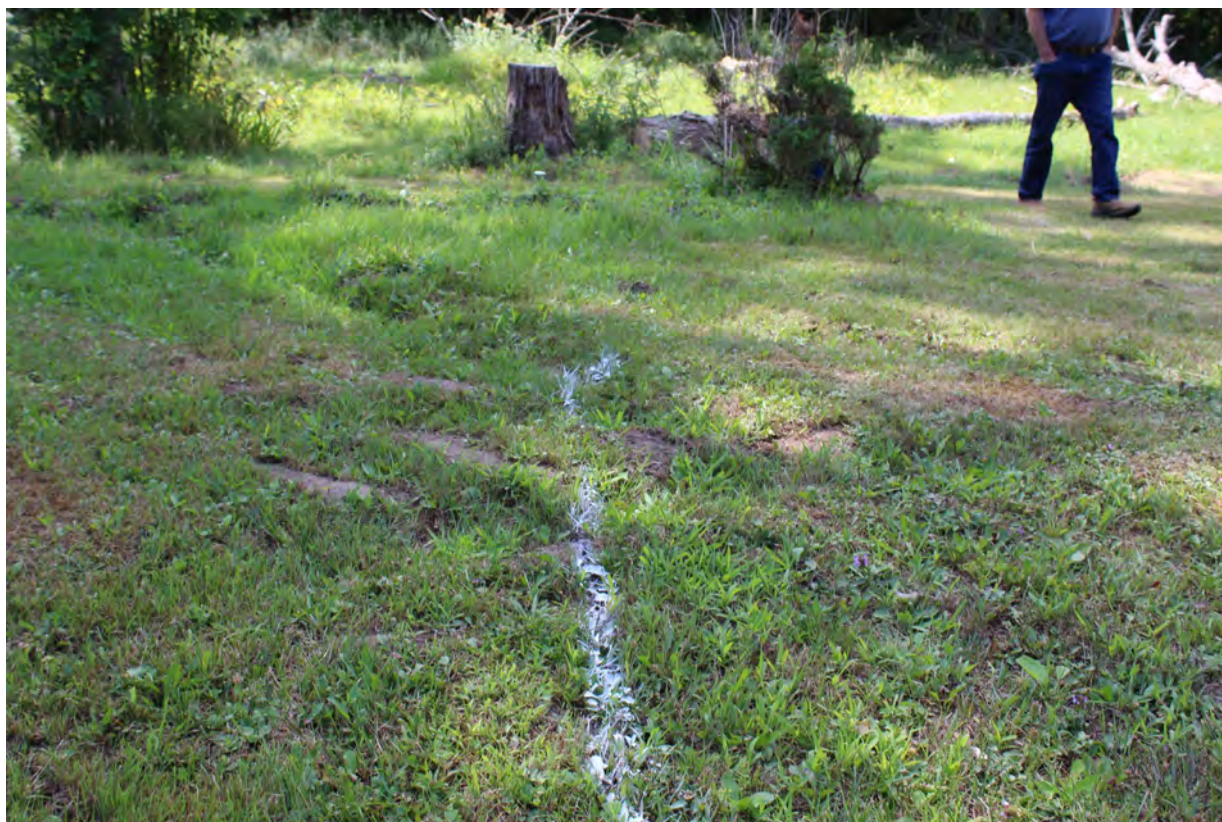
3020, 8/15/2022, by Sam Gowan: View to south-southwest at 430 Scribner Road. A residential well is located in the vegetation between Jeff Slade (AGS) and the tree stump. The fracture in the foreground is at Gowan location 133.

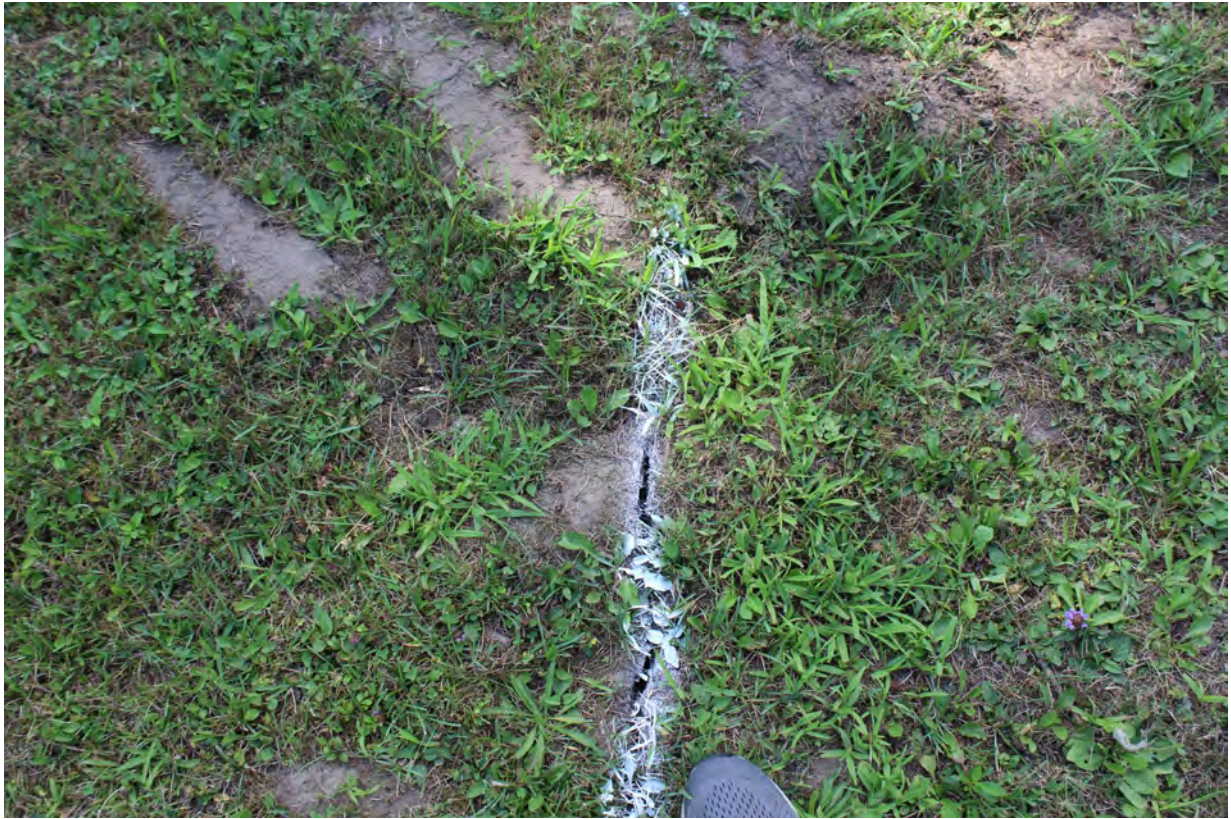
3021, 8/15/2022, by Sam Gowan: Visible aperture in fracture at Gowan location 133 (430 Scribner Road).

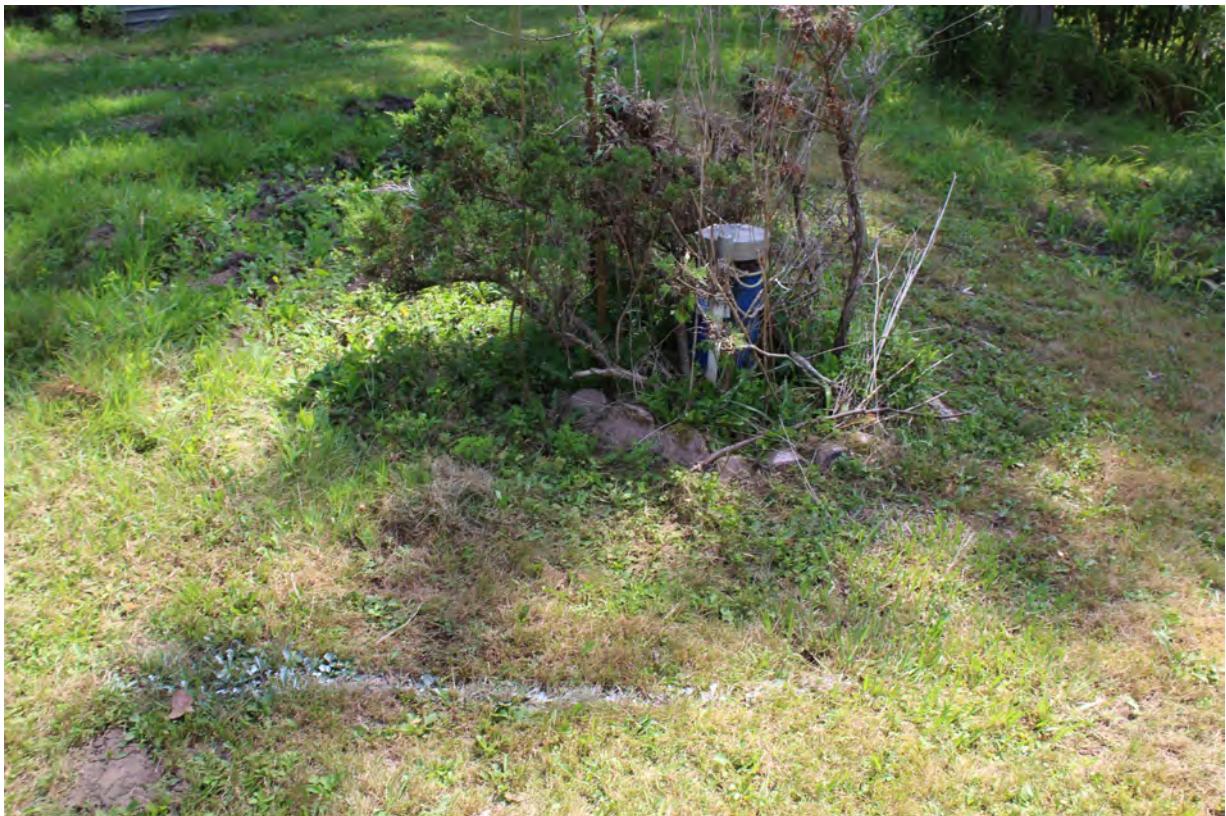
3022, 8/15/2022, by Sam Gowan: View of the water supply well in the vegetation at 430 Scribner Road. No fracture was observable along the painted line in the foreground. Location is at Gowan 132.

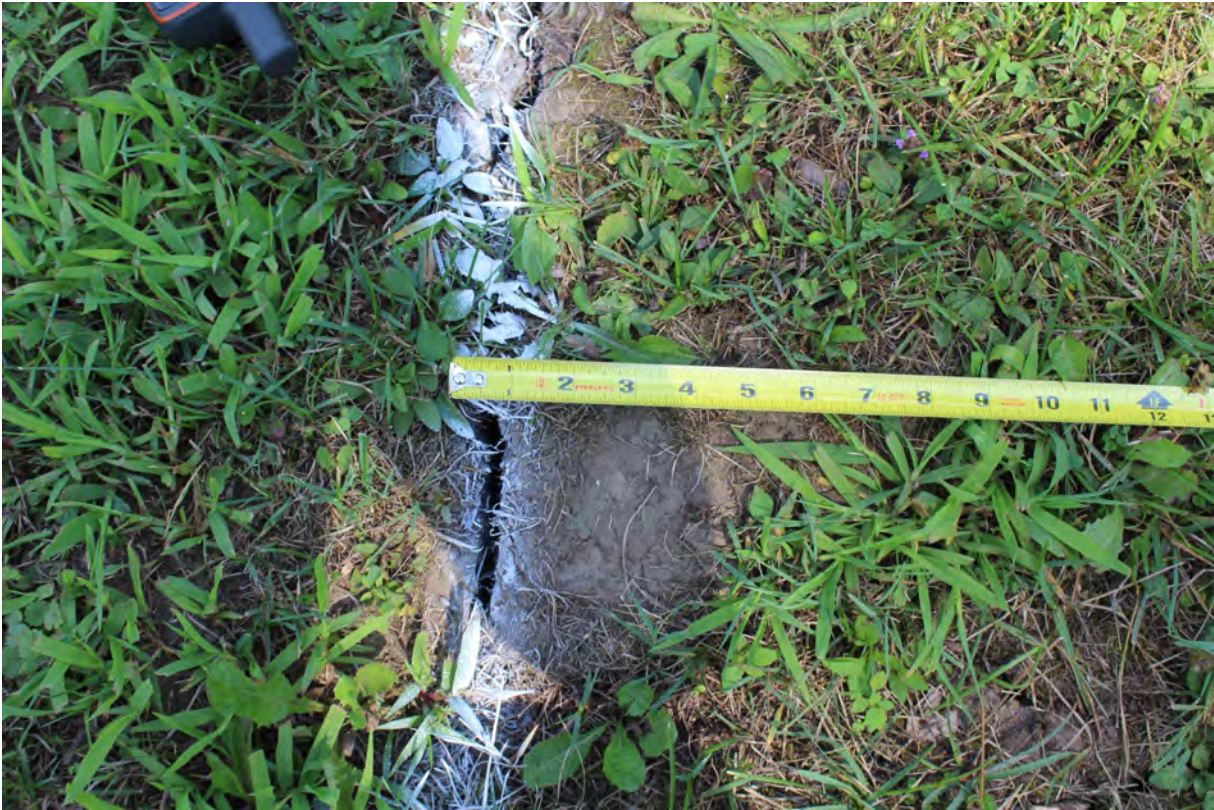
3023, 8/15/2022, by Sam Gowan: Measured aperture in fracture at Gowan location 133 (430 Scribner Road). No fractures were observed further to the south-southwest.

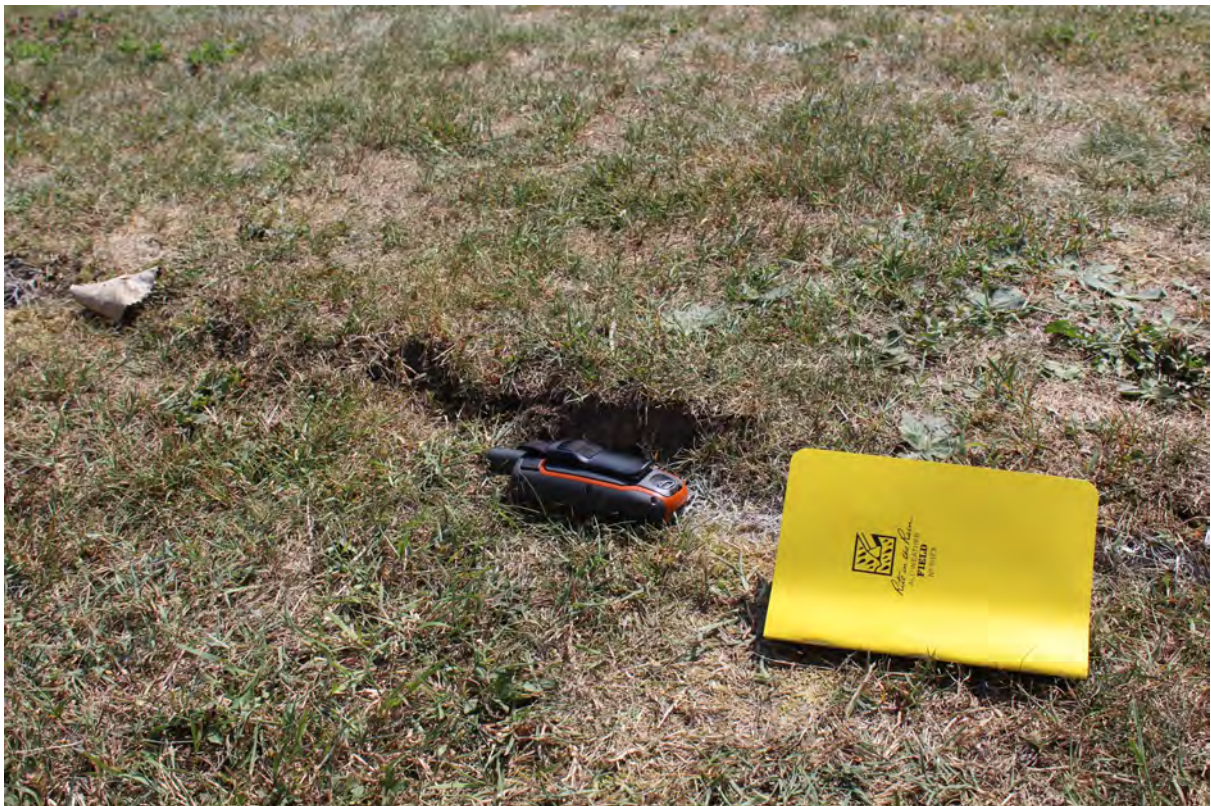
3024, 8/15/2022, by Sam Gowan: View toward the east of an apparent offset in a fracture at 440 Scribner Road (Gowan location 134). The field book is 7 inches long.

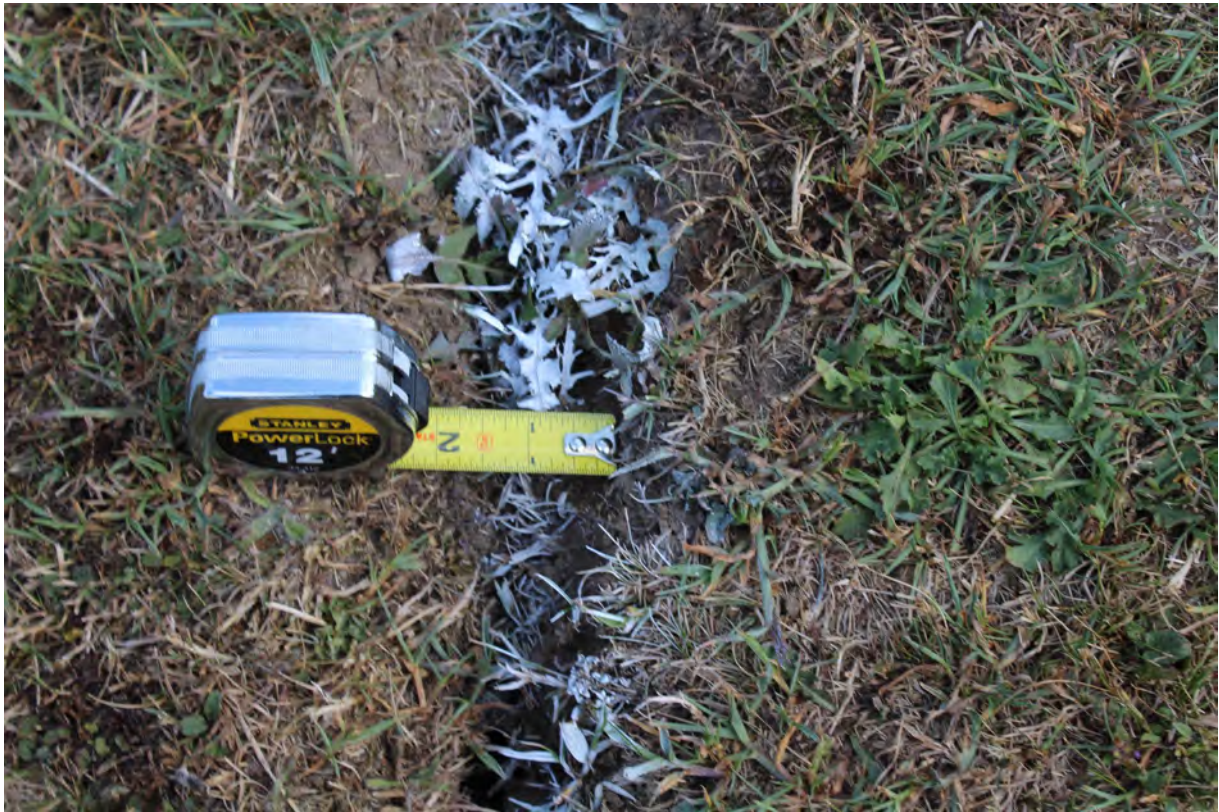
3025, 8/15/2022, by Sam Gowan: Near the mailbox at 440 Scribner Road. Offset in fracture at Gowan location 135.

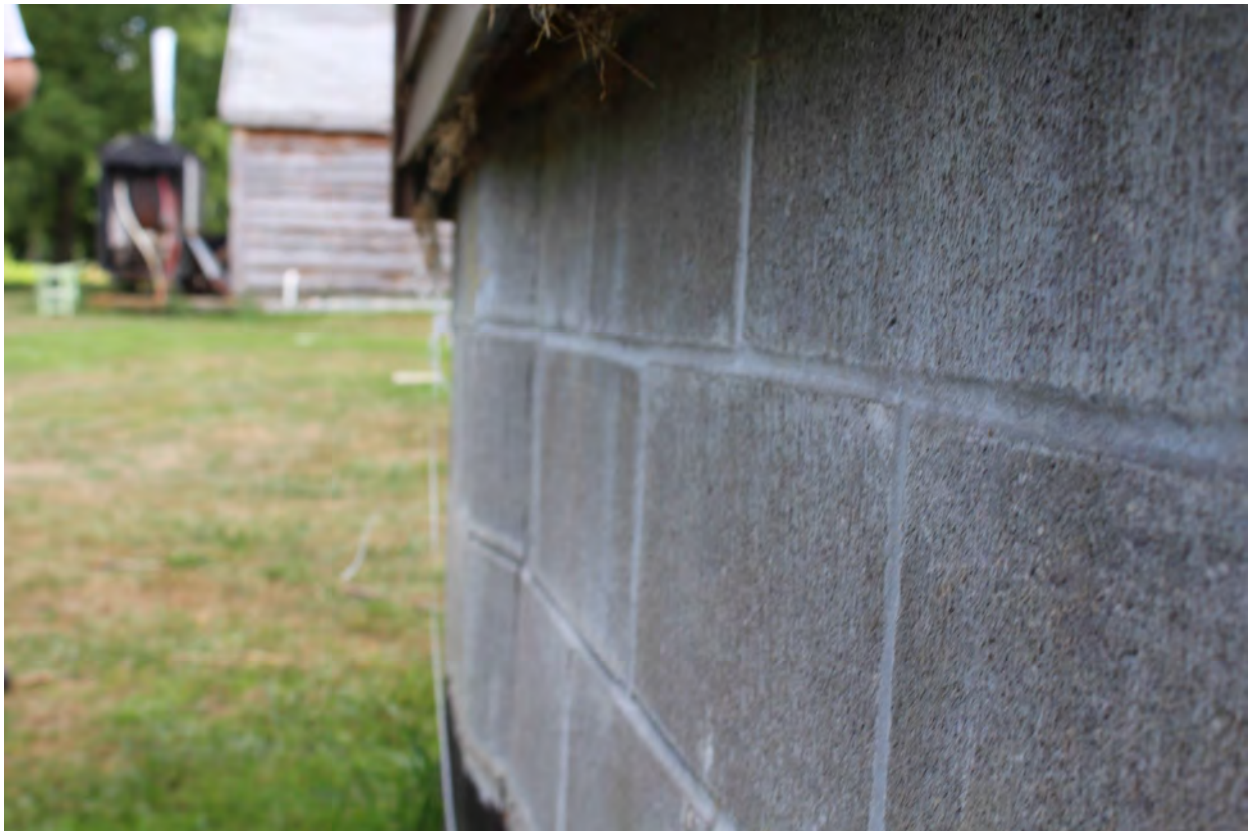
3027, 8/15/2022, by Sam Gowan: View of caved in basement wall at the northeast end of the northwest wall of the addition at 445 Scribner Road.

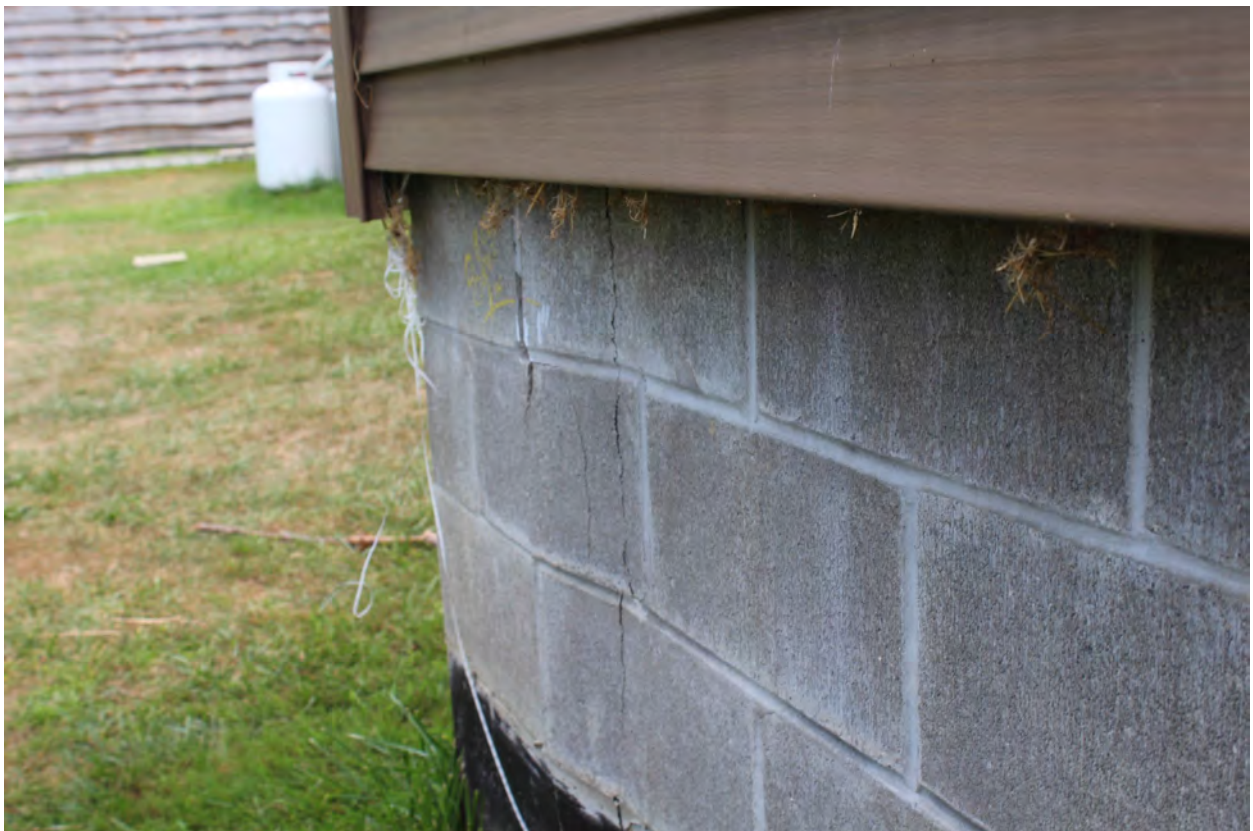
3028, 8/15/2022, by Sam Gowan: View of the caved in basement wall at the northeast corner of the southwest wall of the addition at 445 Scribner Road.

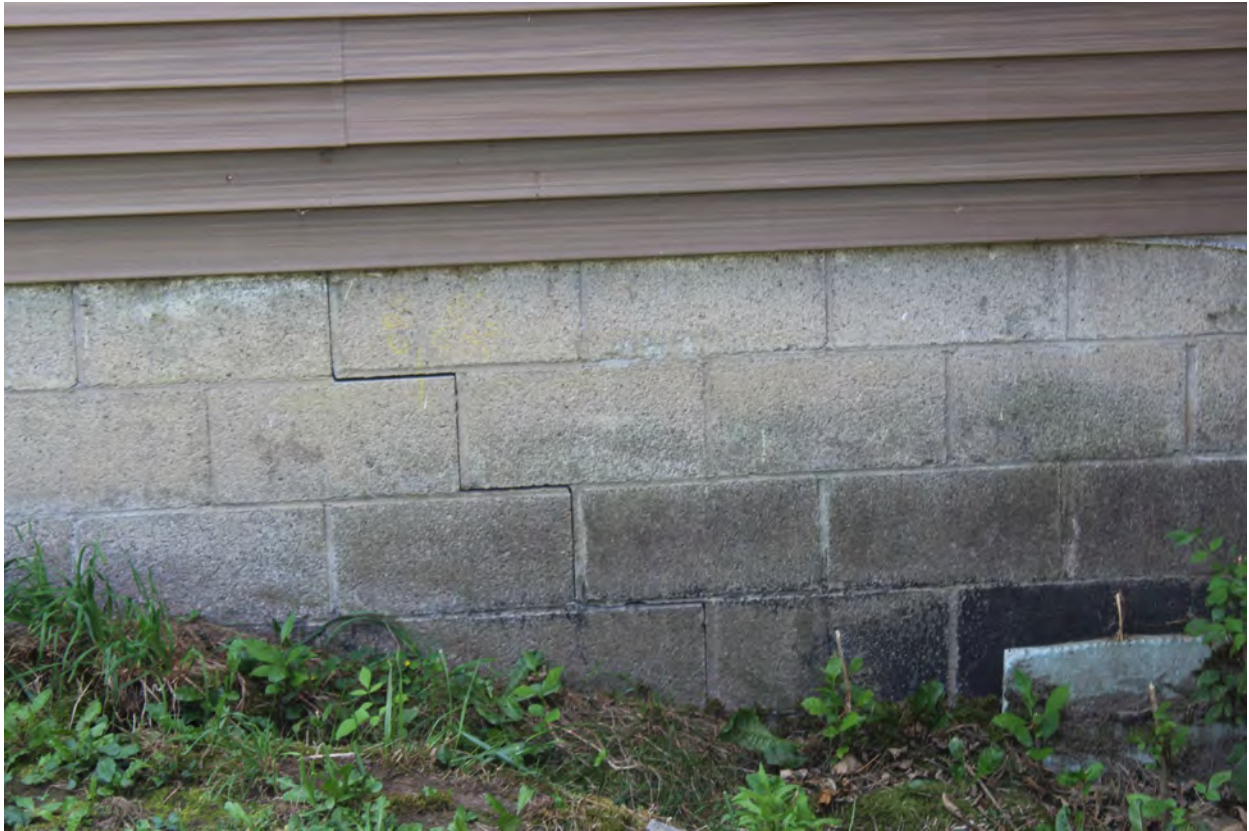
3031, 8/15/2022, by Sam Gowan: View to the east of the northwest foundation wall of 445 Scribner Road. Fracture is in the northwest basement wall to the northeast of the addition.

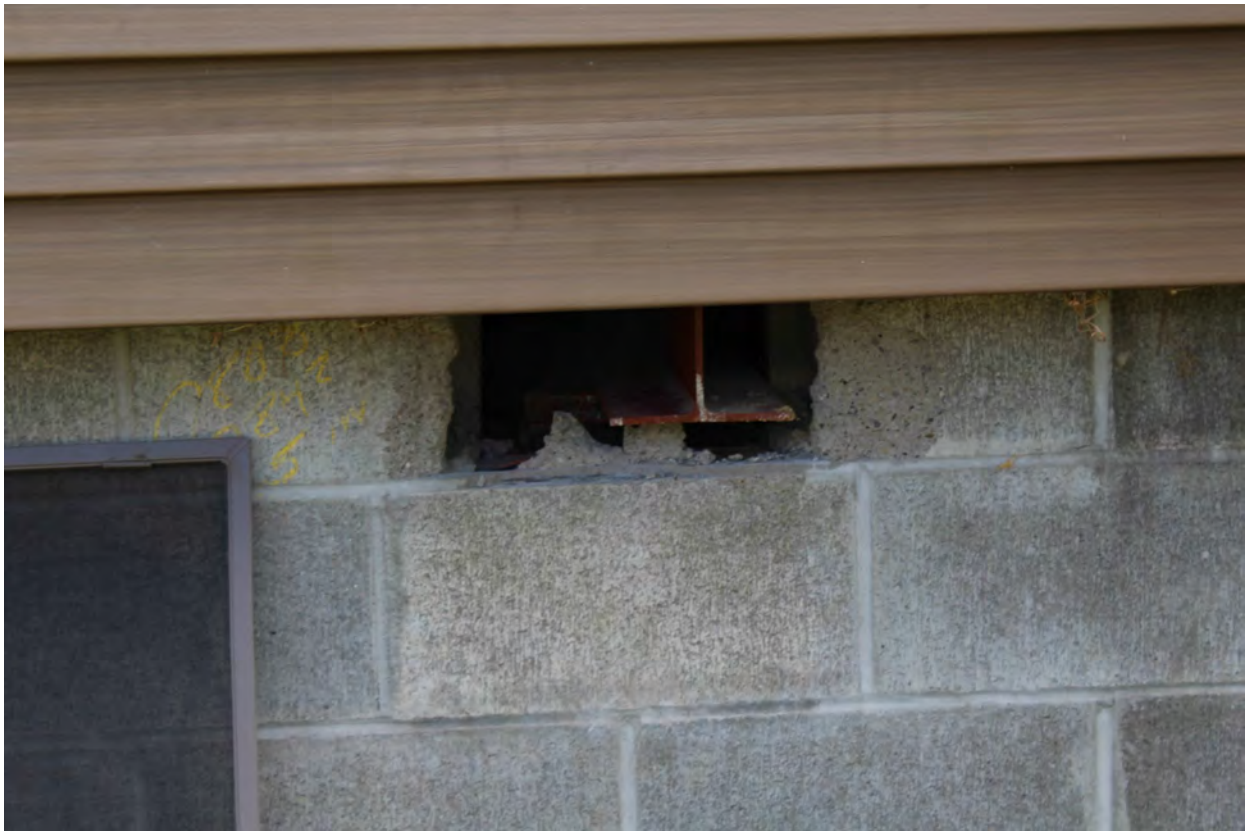
3033, 8/15/2022, by Sam Gowan: Steel beam visible pushing through the northwest wall of the addition at 445 Scribner Road. View to the east.

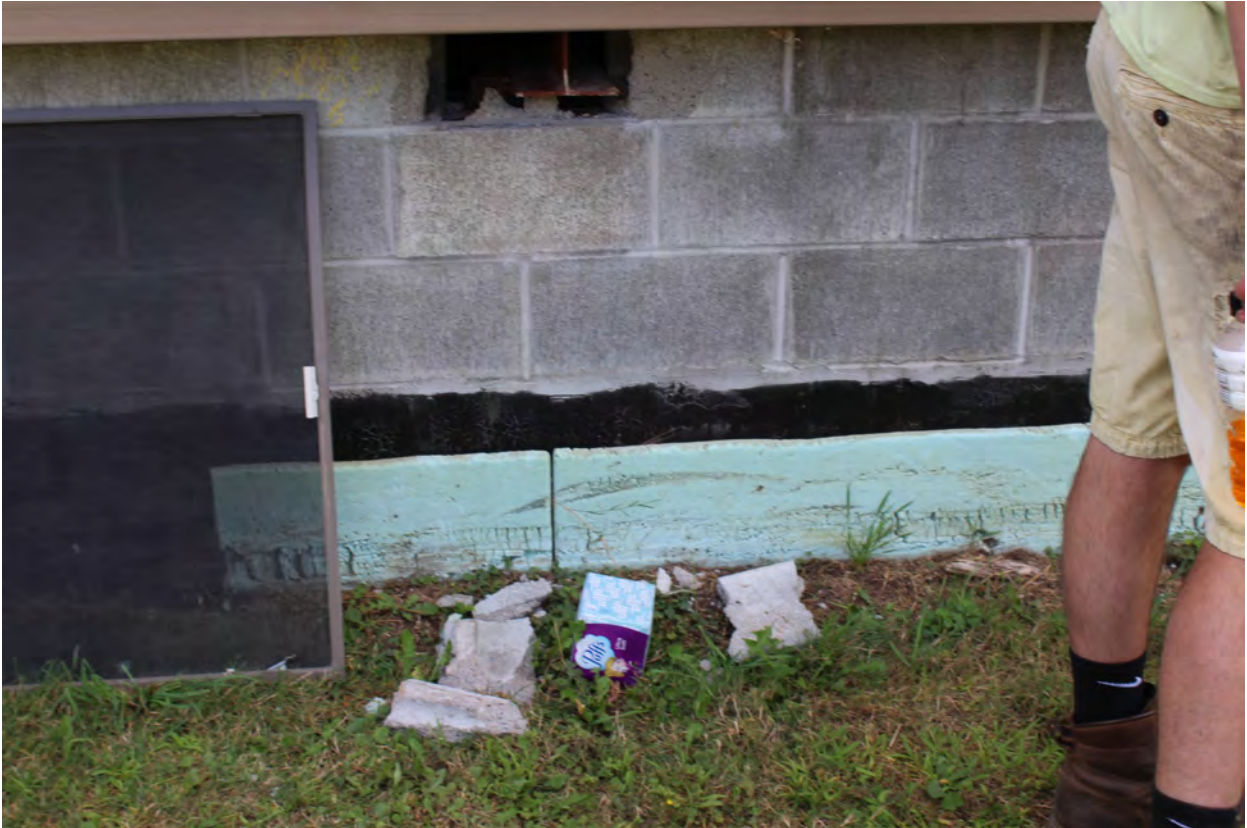
3034, 8/15/2022, by Sam Gowan: View to the east of the beam that punched through the northwest wall of the addition at 445 Scribner Road.

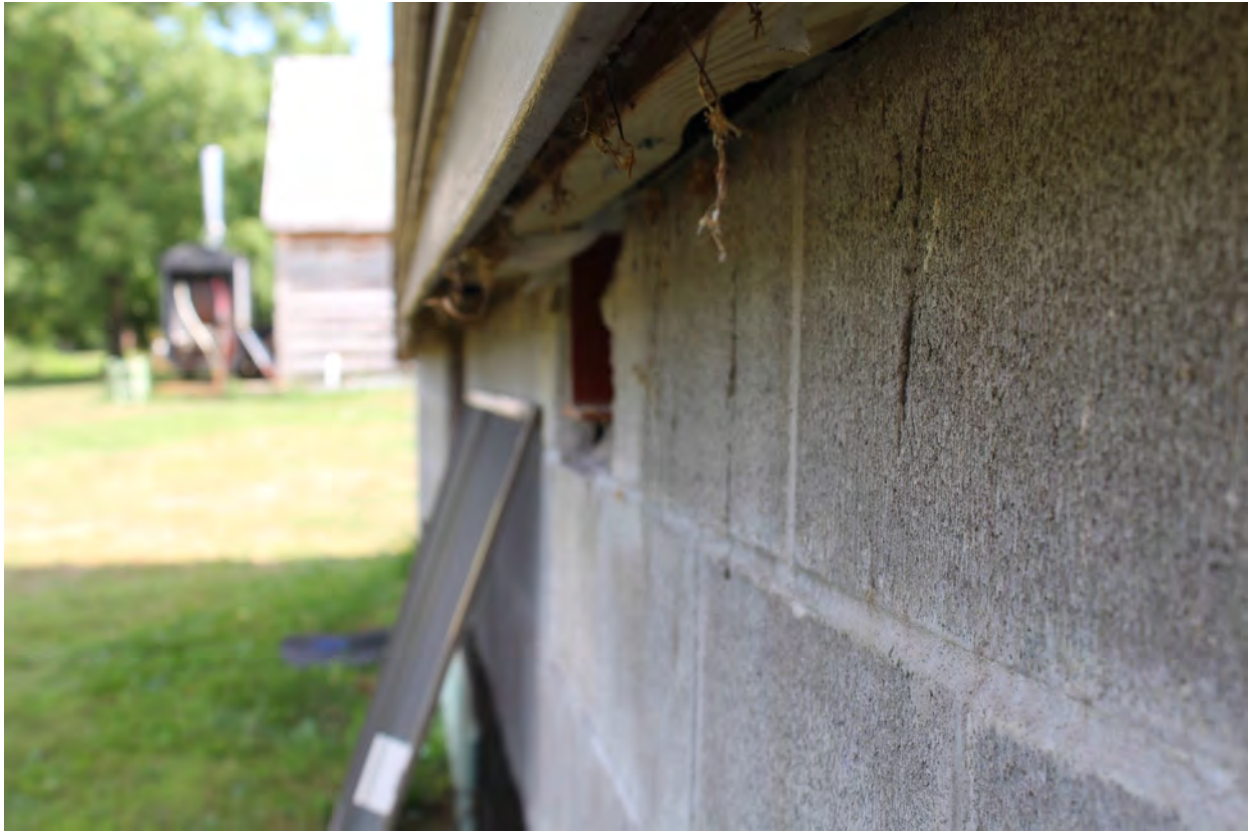
3036, 8/15/2022, by Sam Gowan: View to the northeast along the northwest wall of the addition showing the tip of the steel beam.
