APPENDIX A

**Photographs taken by Samuel Gowan on 8/15/2022 of the Scribner Road Area
and the Akron Quarry**

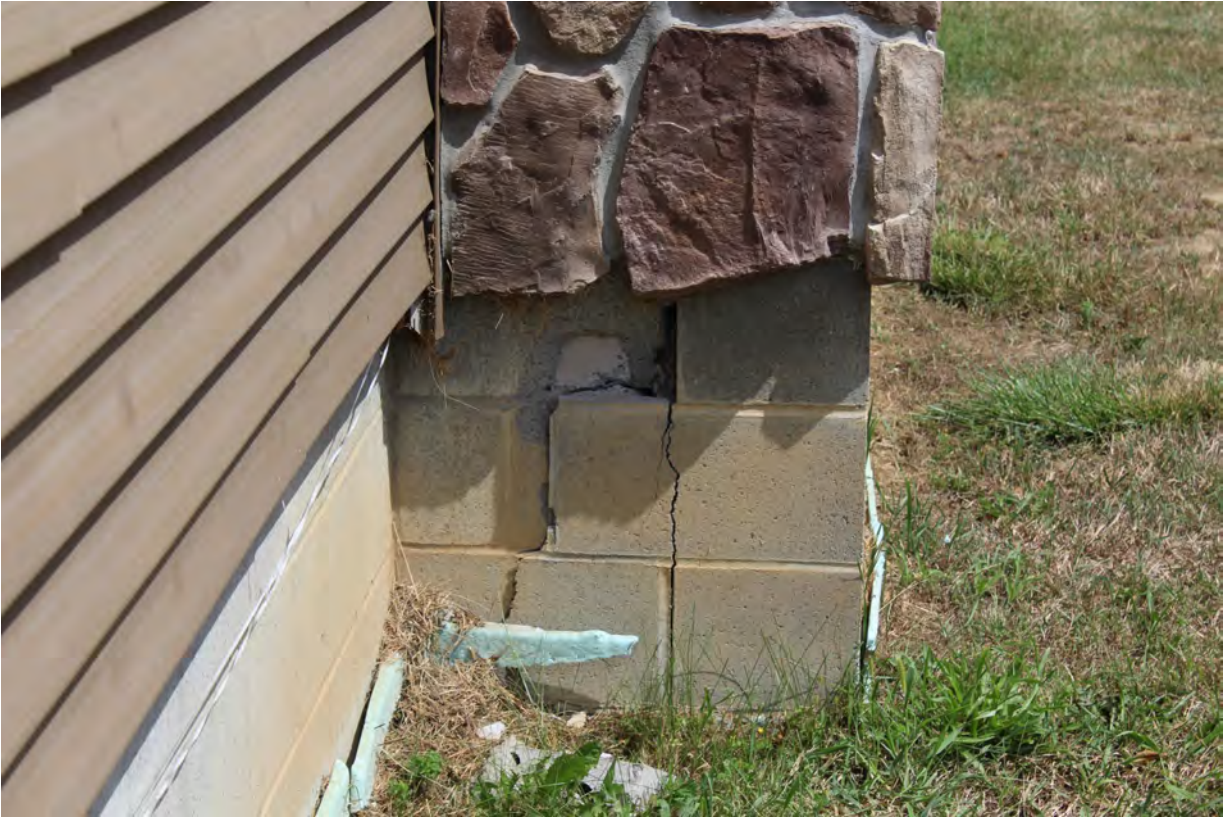
3038, 8/15/2022, by Sam Gowan: View to the northeast of broken and fractured cinder blocks on the southeast side of the addition at 445 Scribner Road.

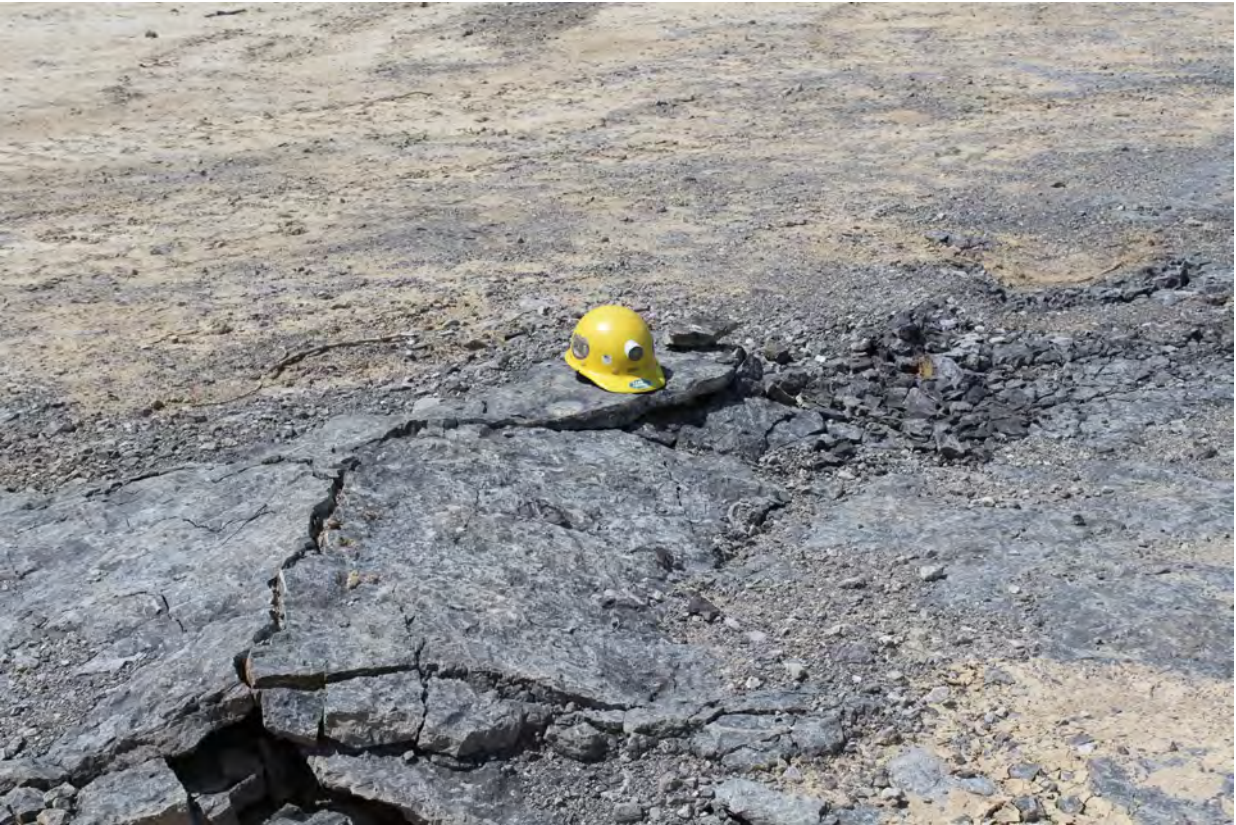
3042, 8/15/2022, by Sam Gowan: Localized rock pop-up in the County Line Stone Akron Quarry.

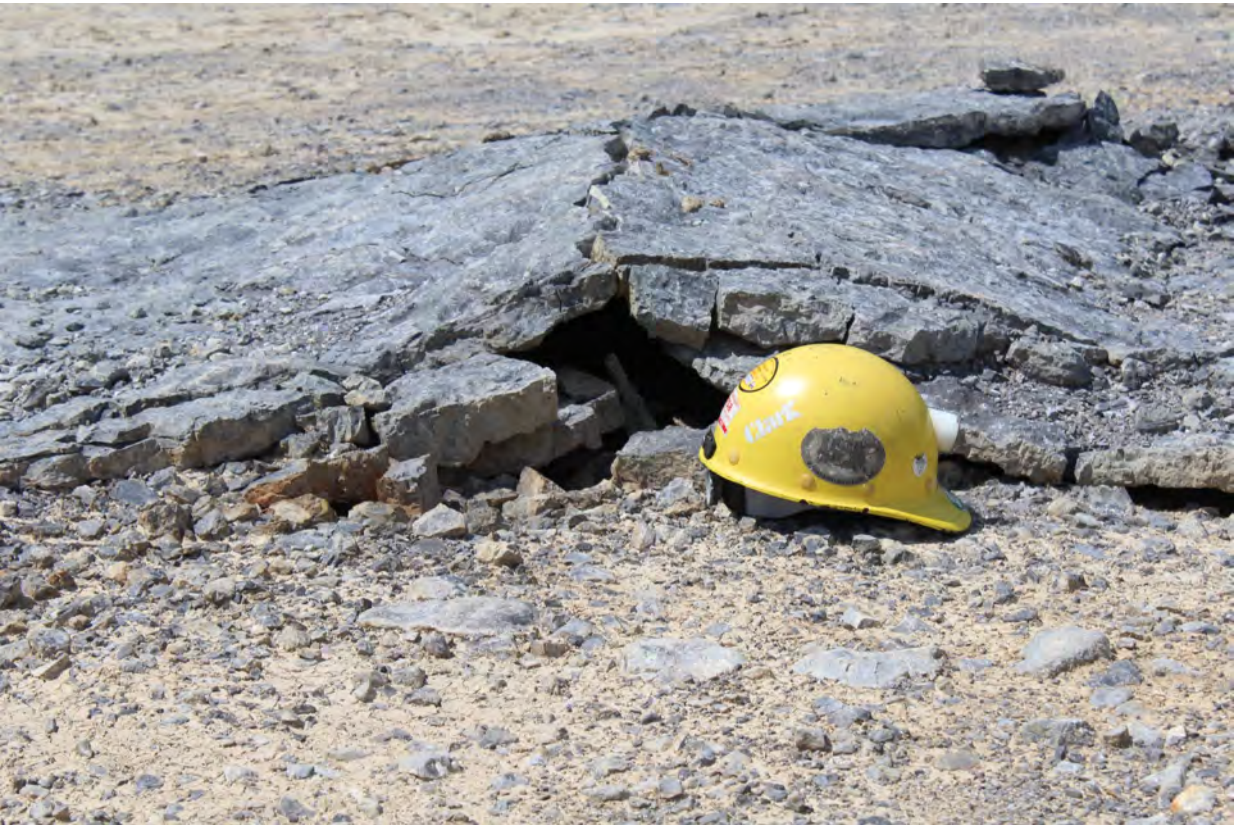
3043, 8/15/2022, by Sam Gowan: Localized rock pop-up in the County Line Stone Akron Quarry.

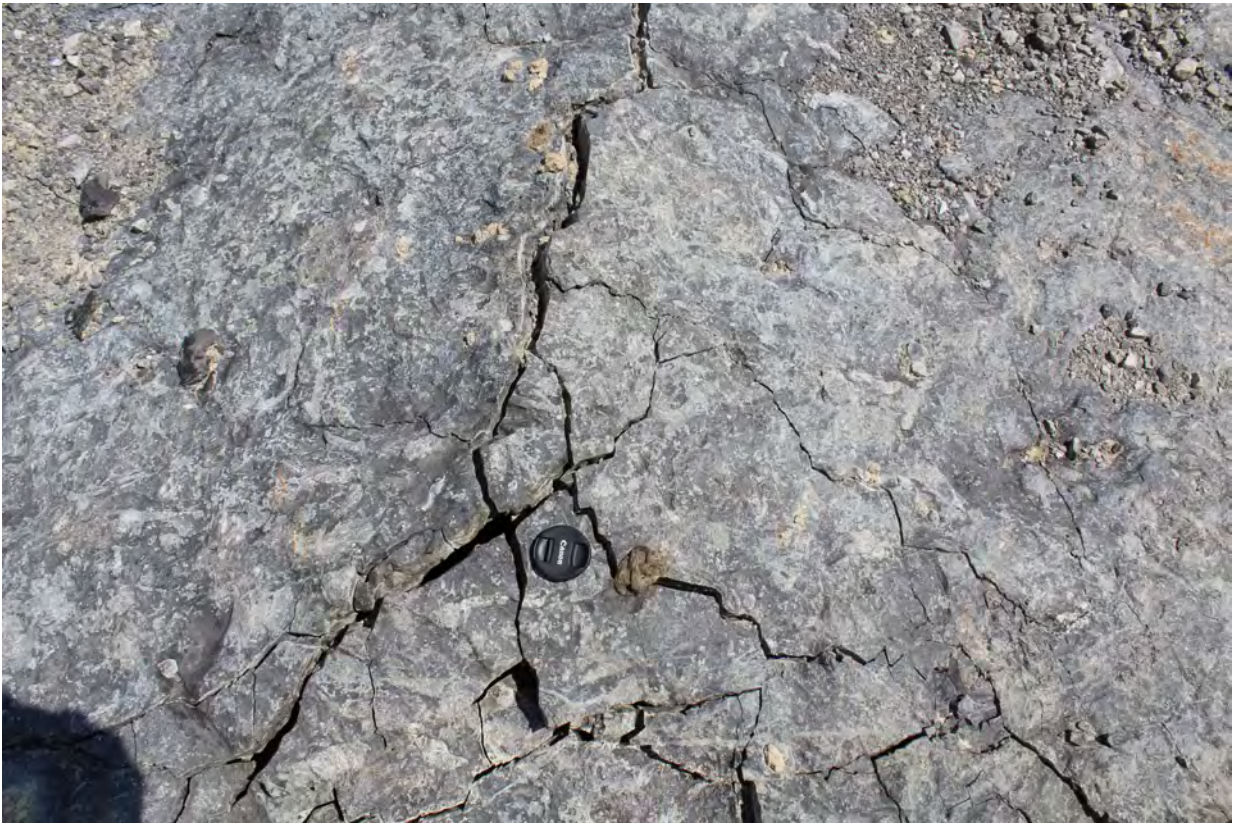
3044, 8/15/2022, by Sam Gowan: Top view of the localized rock pop-up in the County Line Stone Akron Quarry (see 3042).

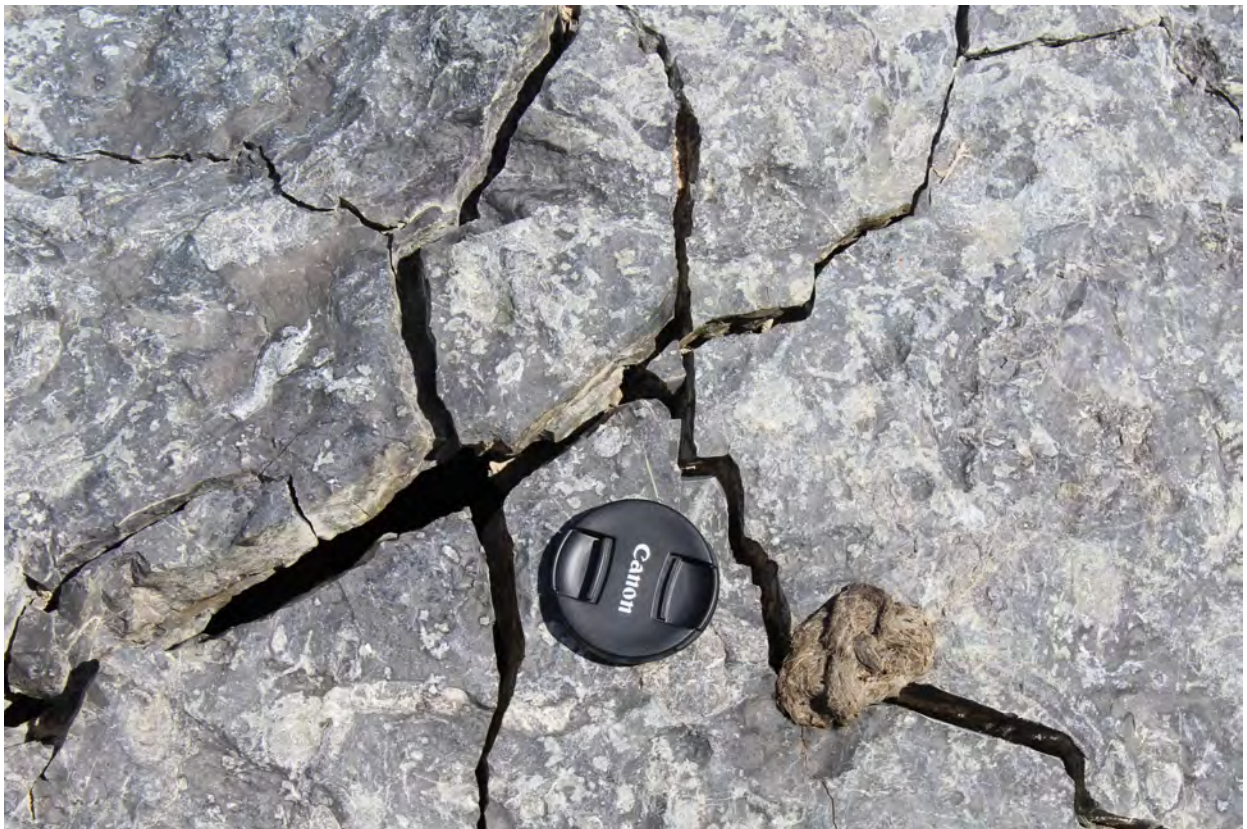
3045, 8/15/2022, by Sam Gowan: Closeup top view of the localized rock pop-up in the County Line Stone Akron Quarry (see 3042).

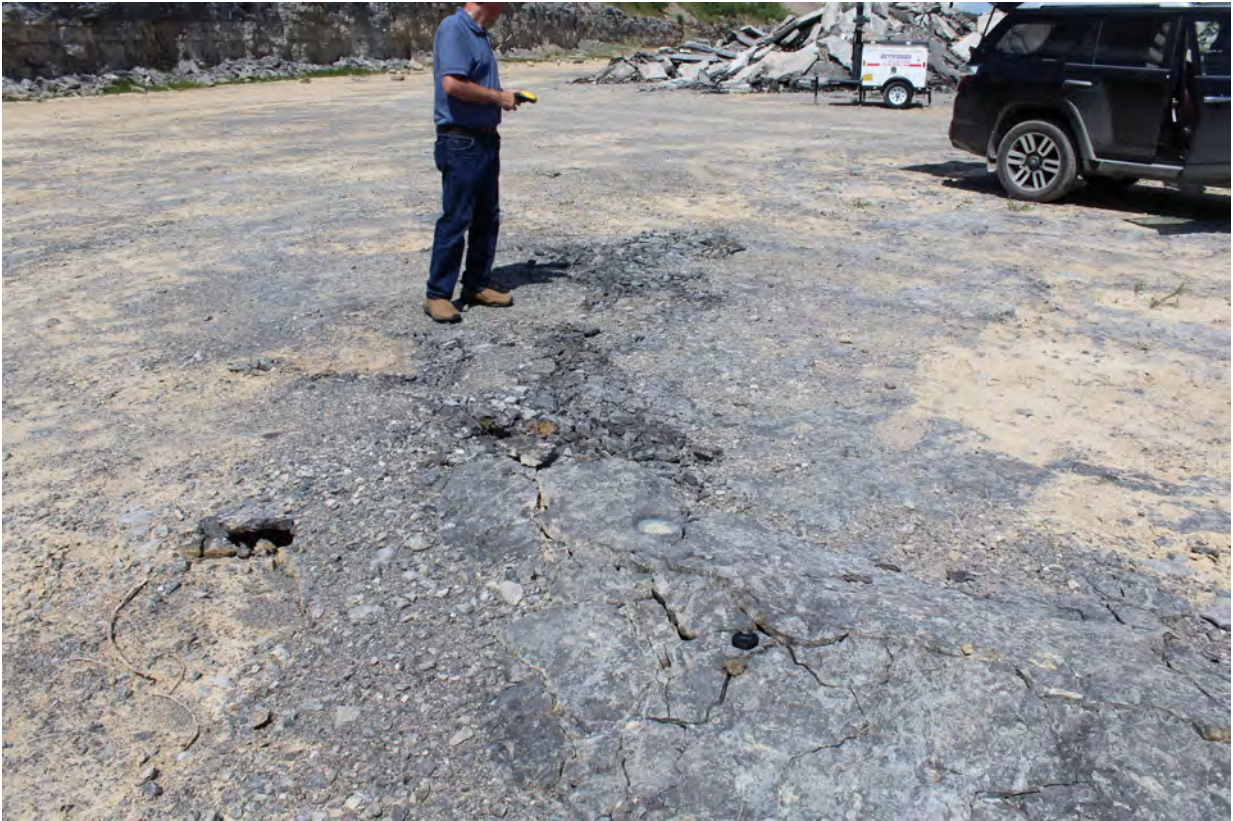
3046, 8/15/2022, by Sam Gowan: Broken rock associated with the localized rock pop-up in the County Line Stone Akron Quarry.

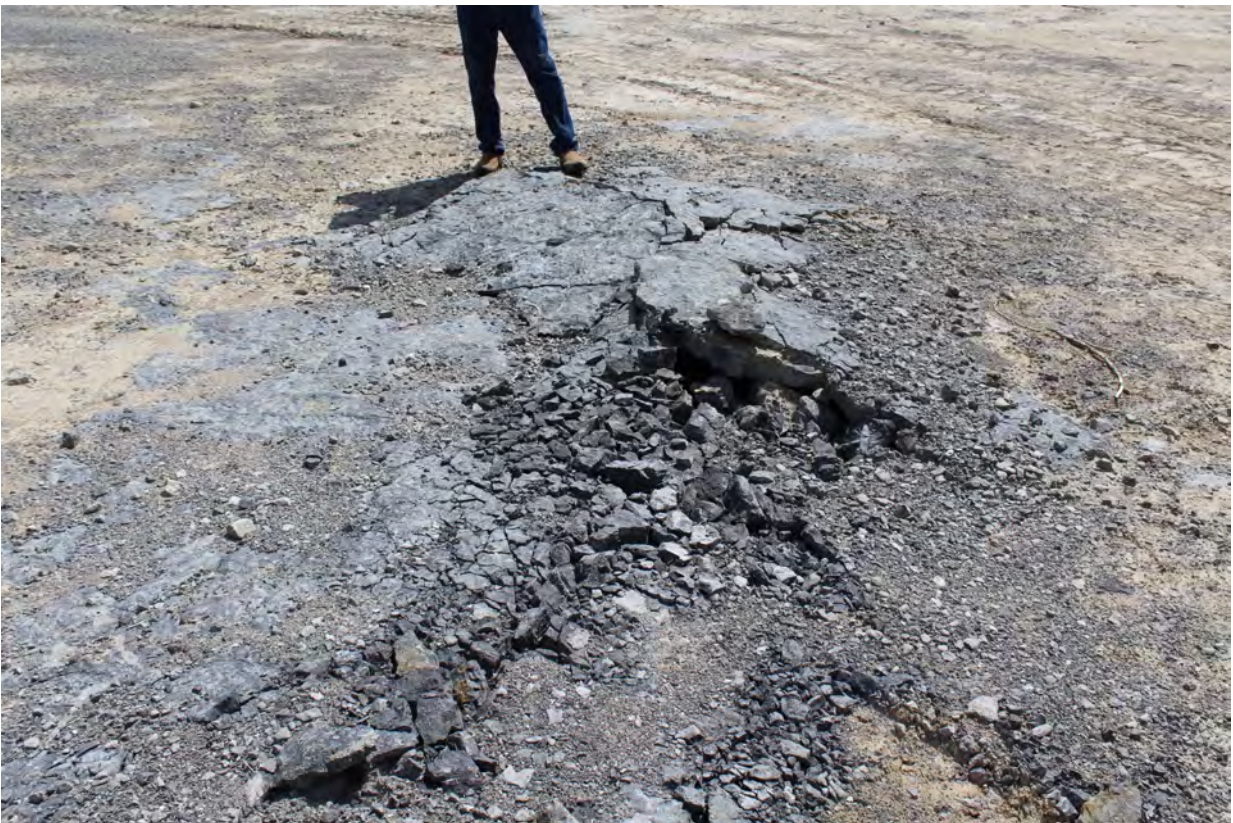
3047, 8/15/2022, by Sam Gowan: Localized rock pop-up in the County Line Stone Akron Quarry.

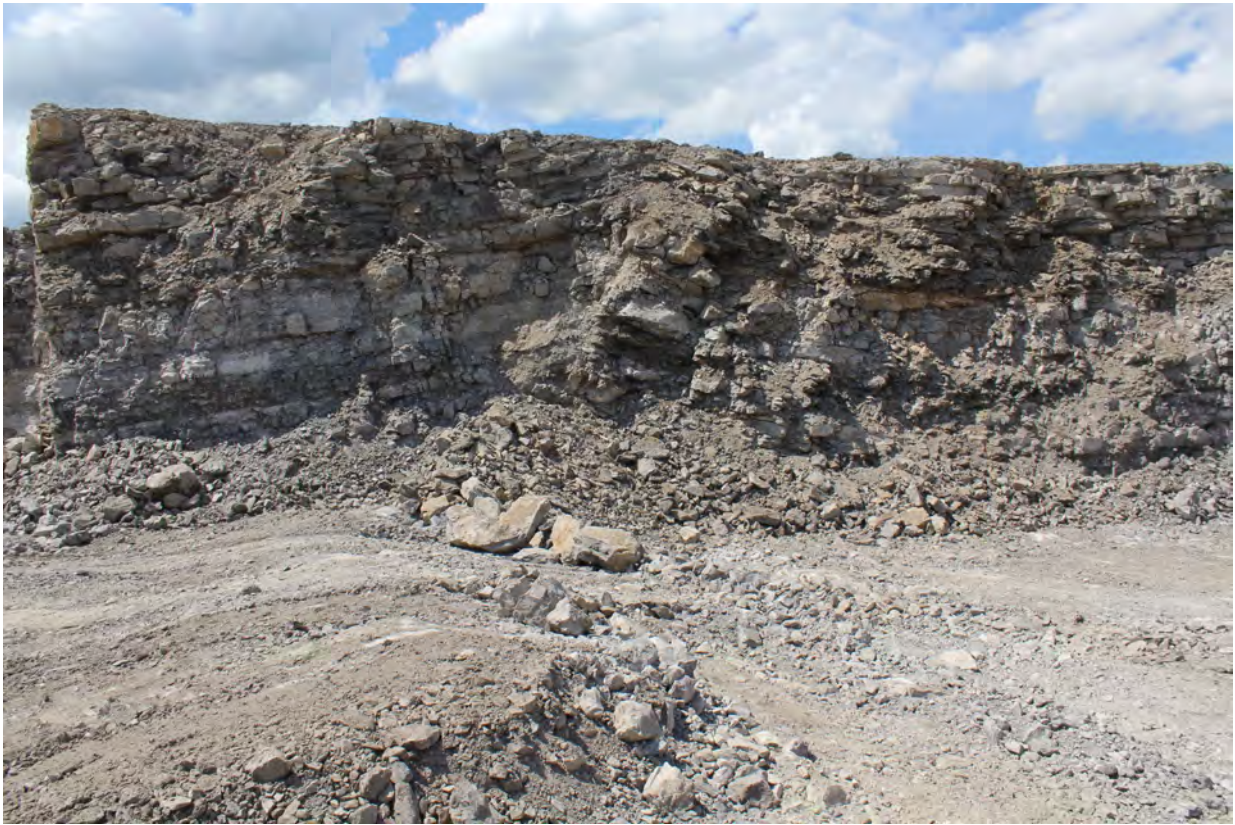
3048, 8/15/2022, by Sam Gowan: West end of a rock pop-up that trends N75°W across the County Line Stone Akron Quarry.

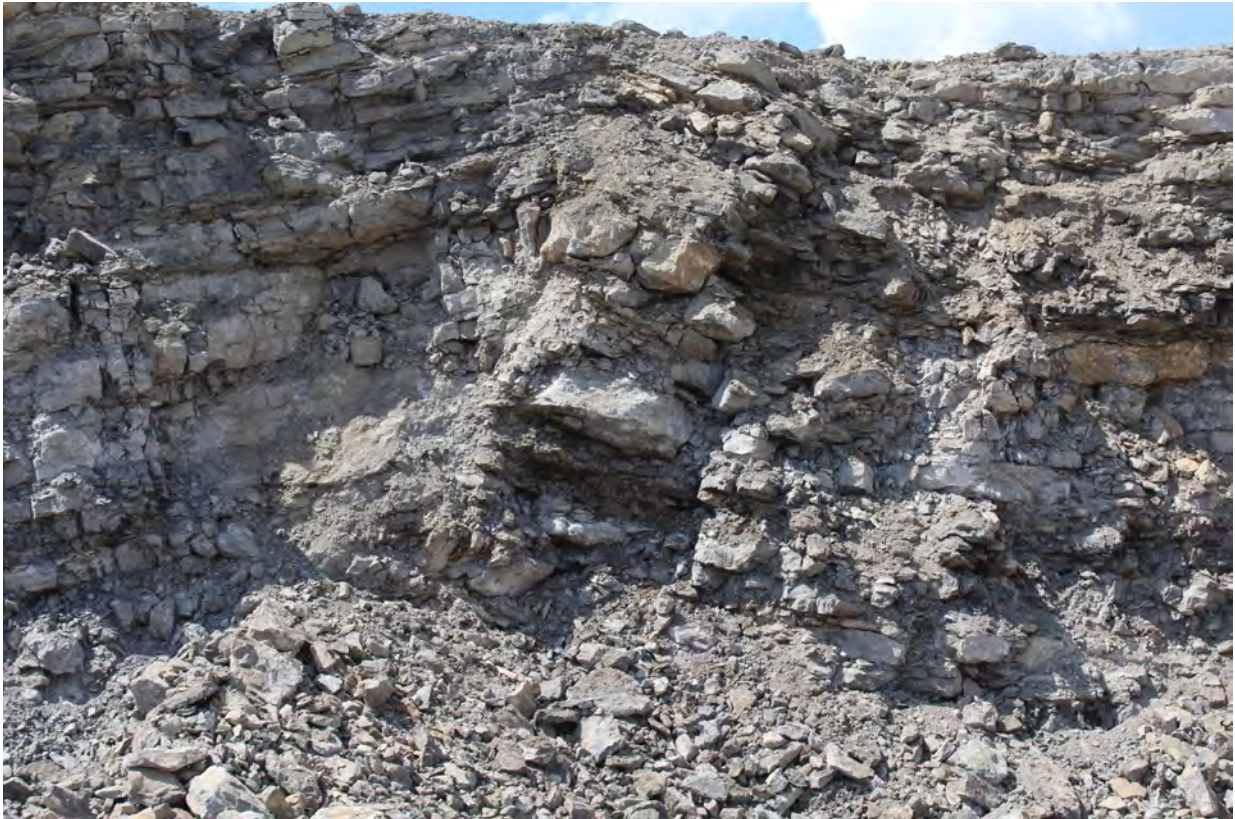
3049, 8/15/2022, by Sam Gowan: View to the west of the N75°W oriented pop-up in the County Line Stone Akron Quarry.

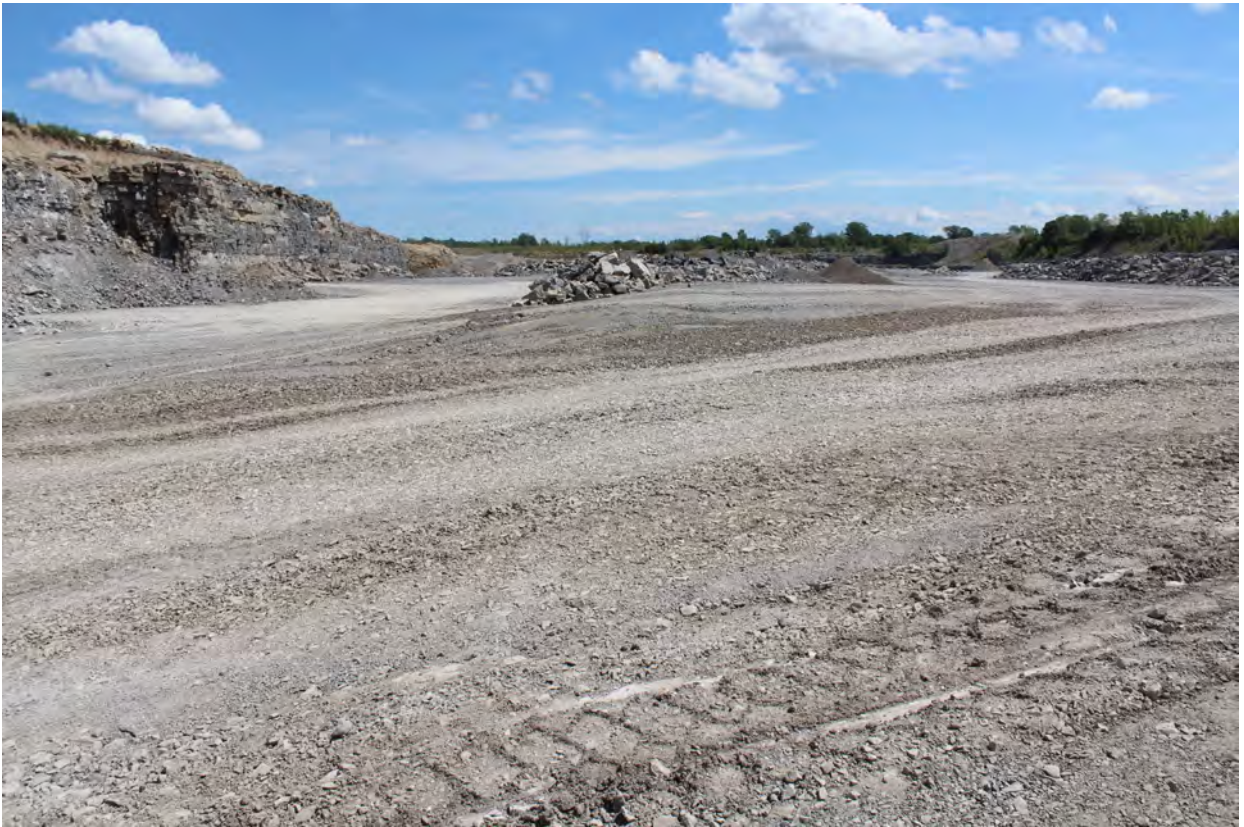
3050, 8/15/2022, by Sam Gowan: View to the east of the N75°W trending rock pop-up. The rock pop-up has been covered with mined rock at the County Line Stone Akron Quarry.

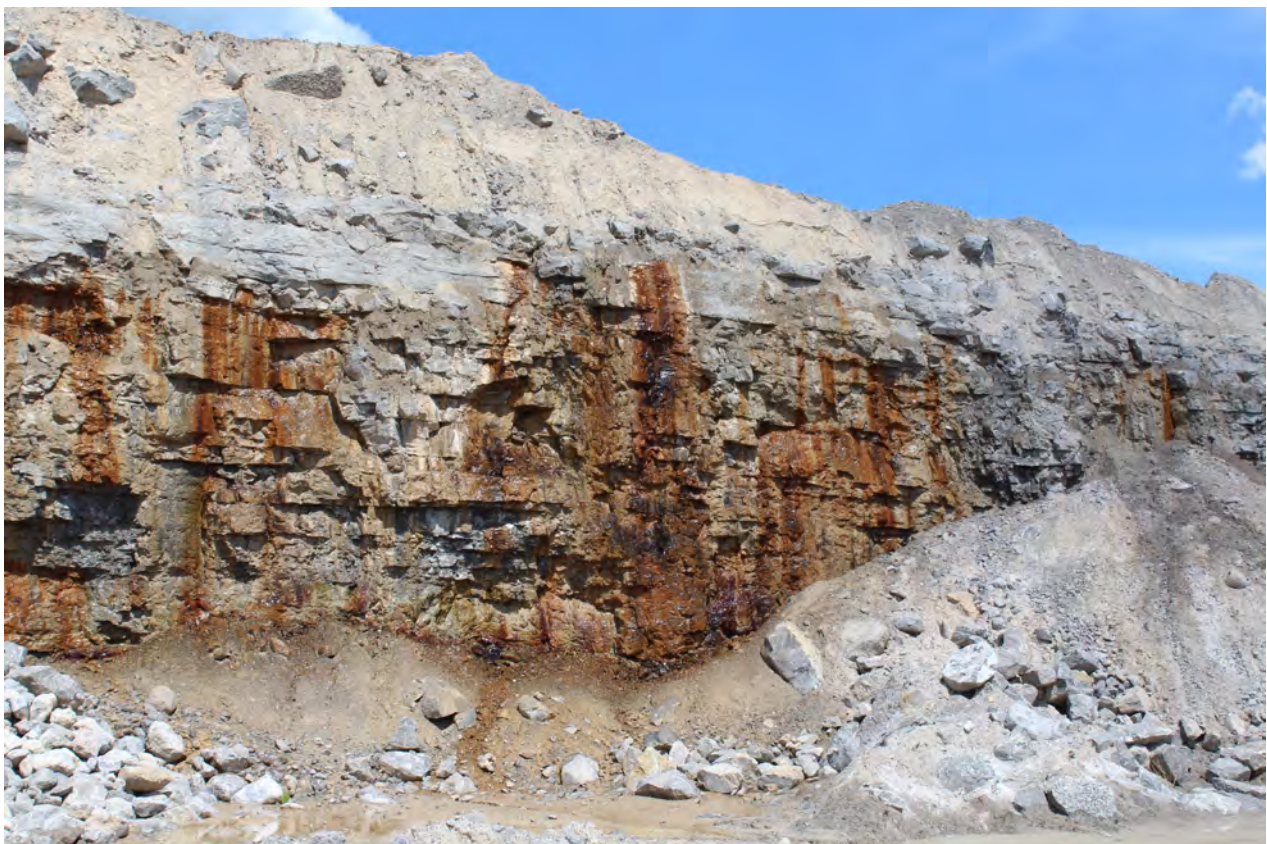
3055, 8/15/2022, by Sam Gowan: Ground water and iron staining emanating from near the base of the overburden on the north highwall of the County Line Stone Akron Quarry. The discharged ground water is pooled on the quarry floor at the base of the highwall.

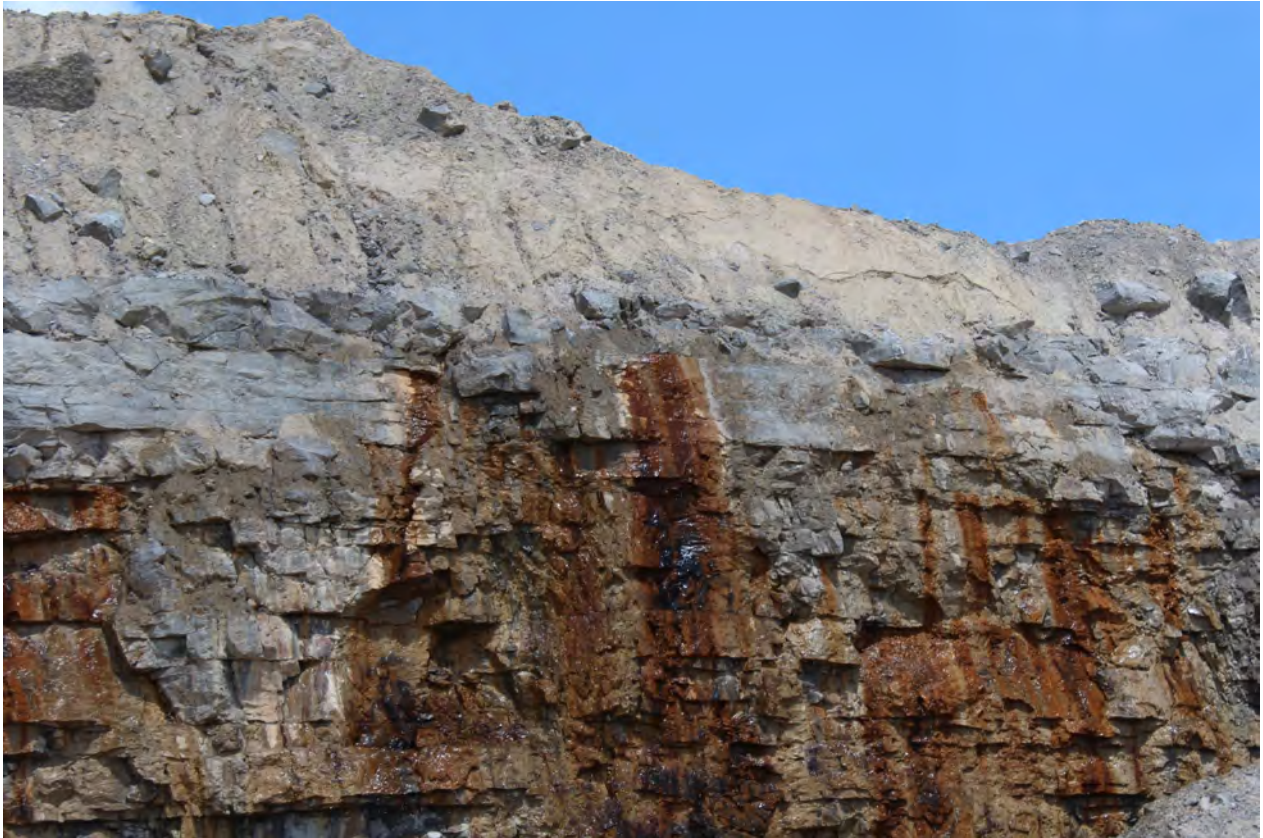
3056, 8/15/2022, by Sam Gowan: Ground water seepage from near the base of the overburden on the north face of the County Line Stone Akron Quarry.

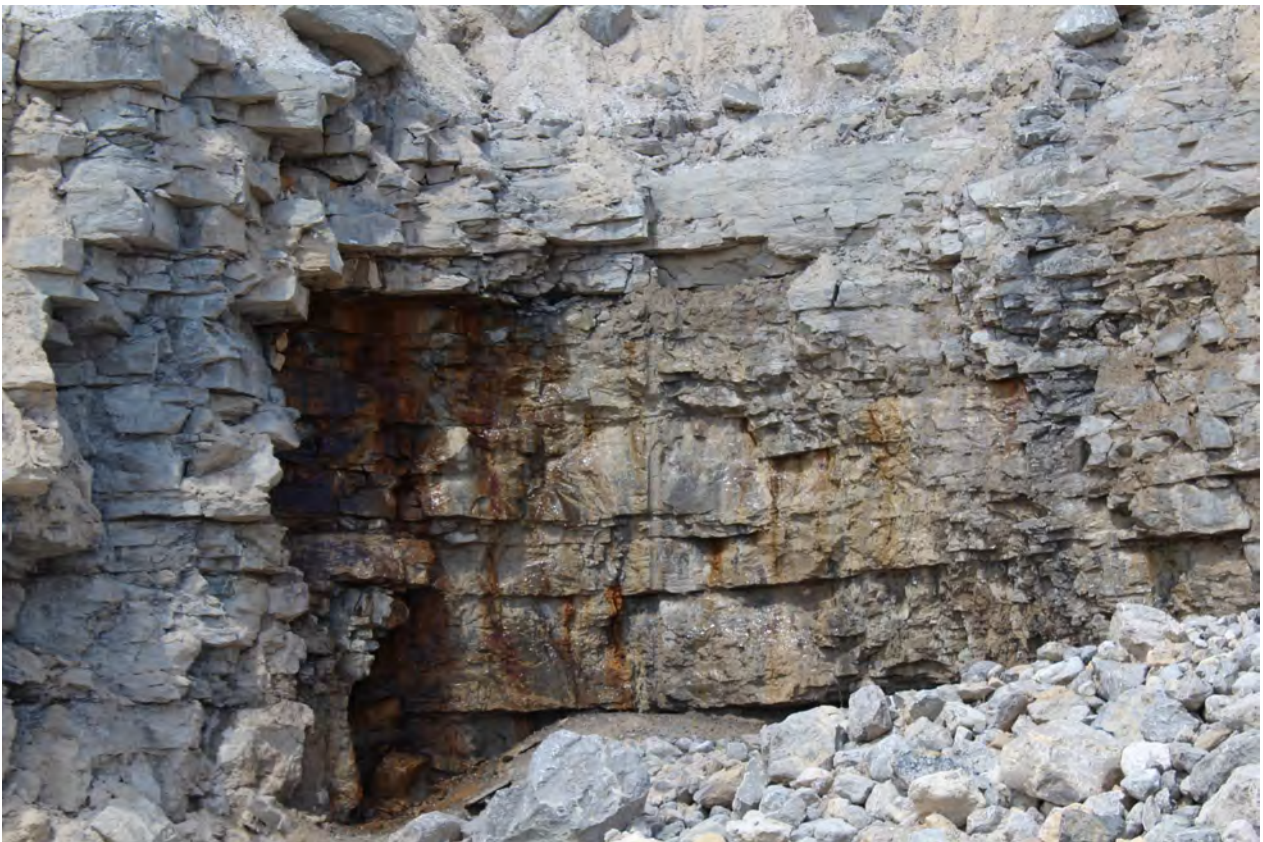
3057, 8/15/2022, by Sam Gowan: Ground water seepage from a few feet below the base of the overburden in the north face of the highwall at the County Line Stone Akron Quarry.

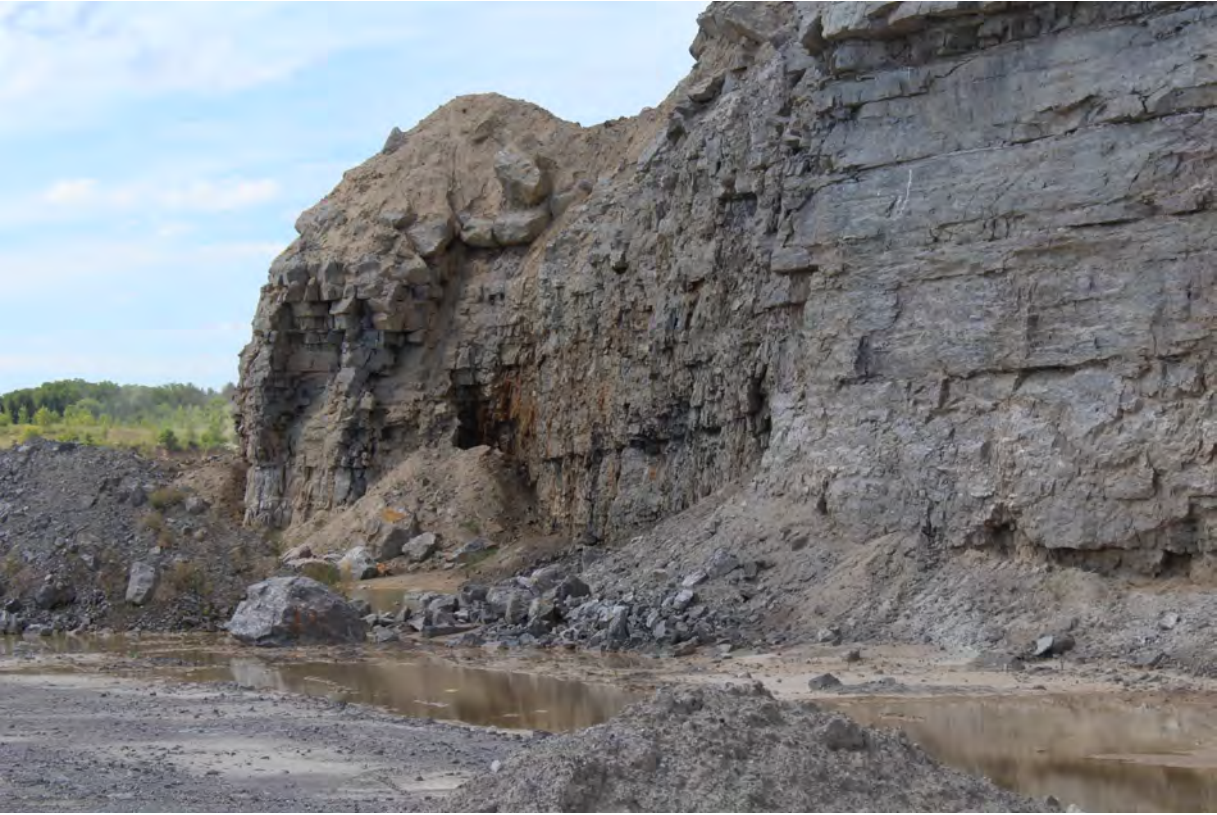
3058, 8/15/2022, by Sam Gowan: Ground water seepage and pooled ground water discharge along the north face of the County Line Stone Akron Quarry.

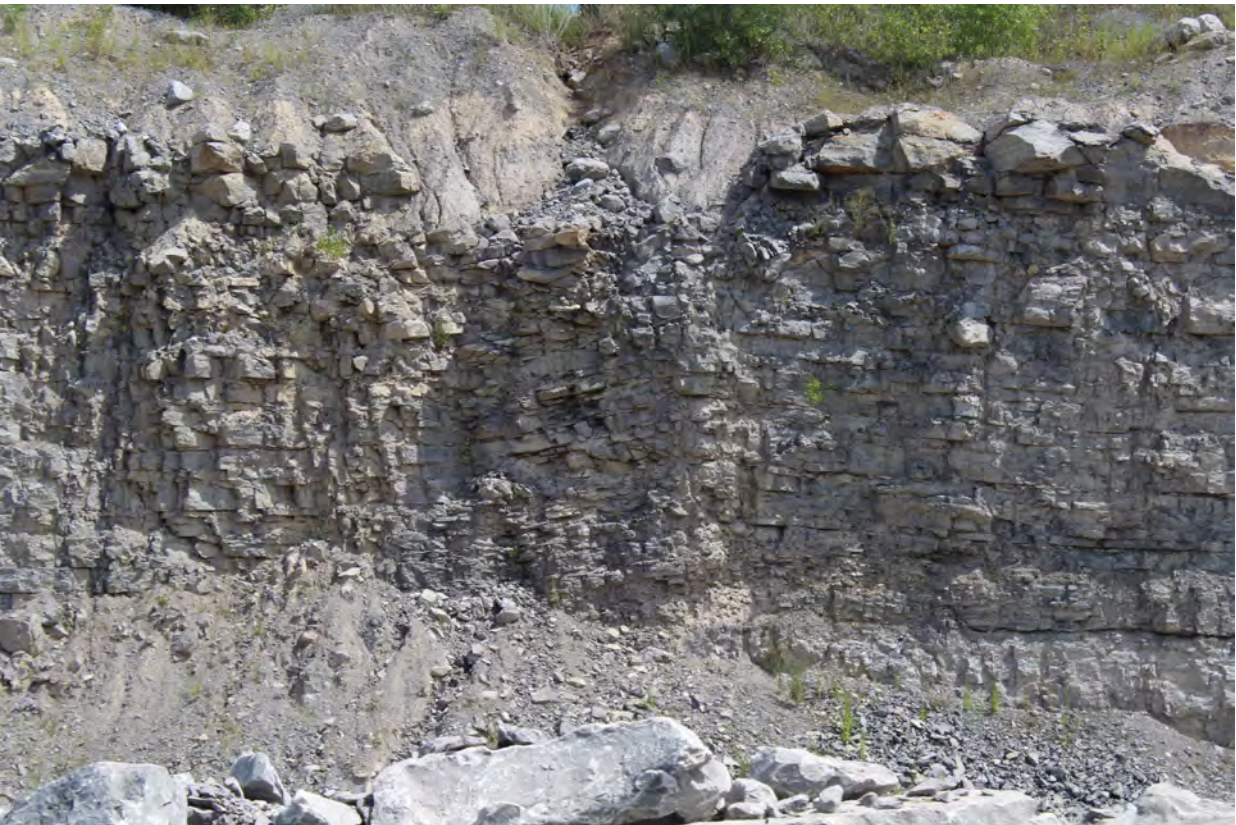
3059, 8/15/2022, by Sam Gowan: View to the east of the east end of the rock pop-up that extends N75°W across the entire north end of the County Line Stone Akron Quarry.

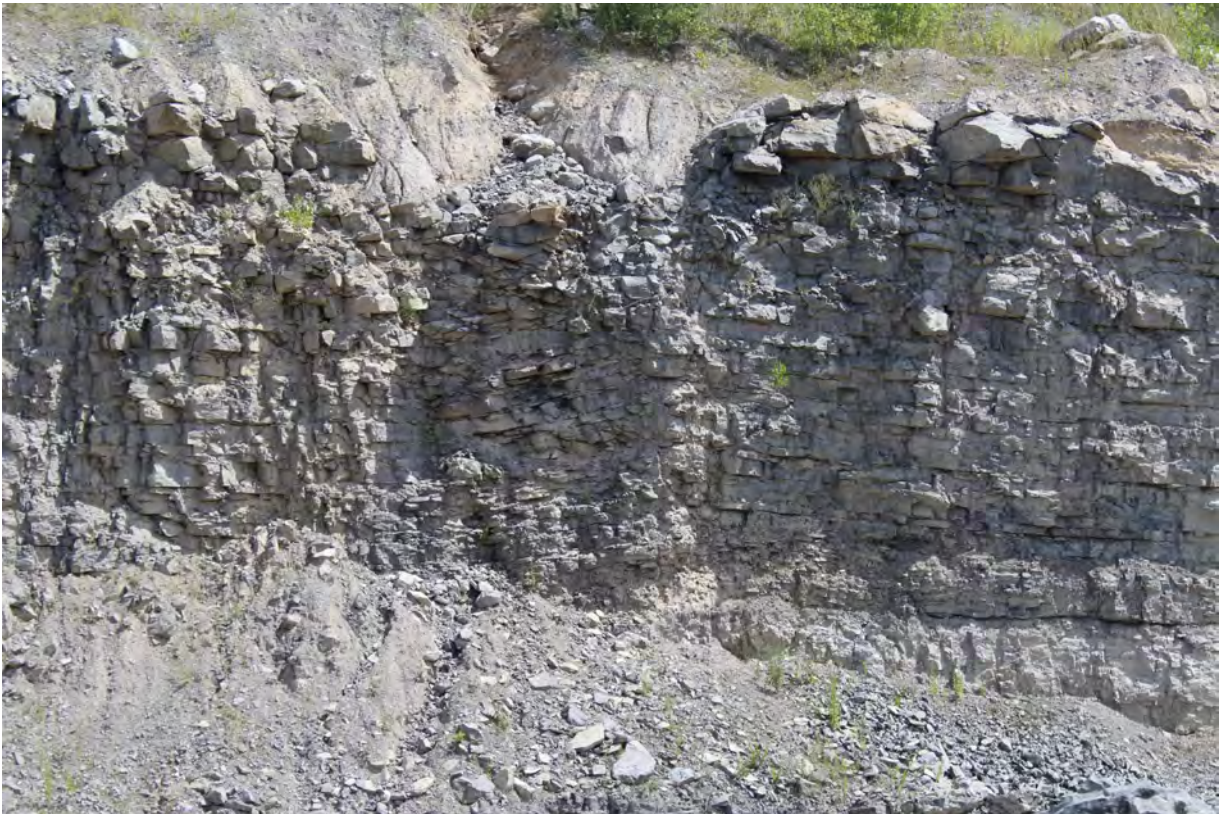
3060, 8/15/2022, by Sam Gowan: View to the east of the east end of the quarry-wide rock pop-up in the County Line Stone Akron Quarry.

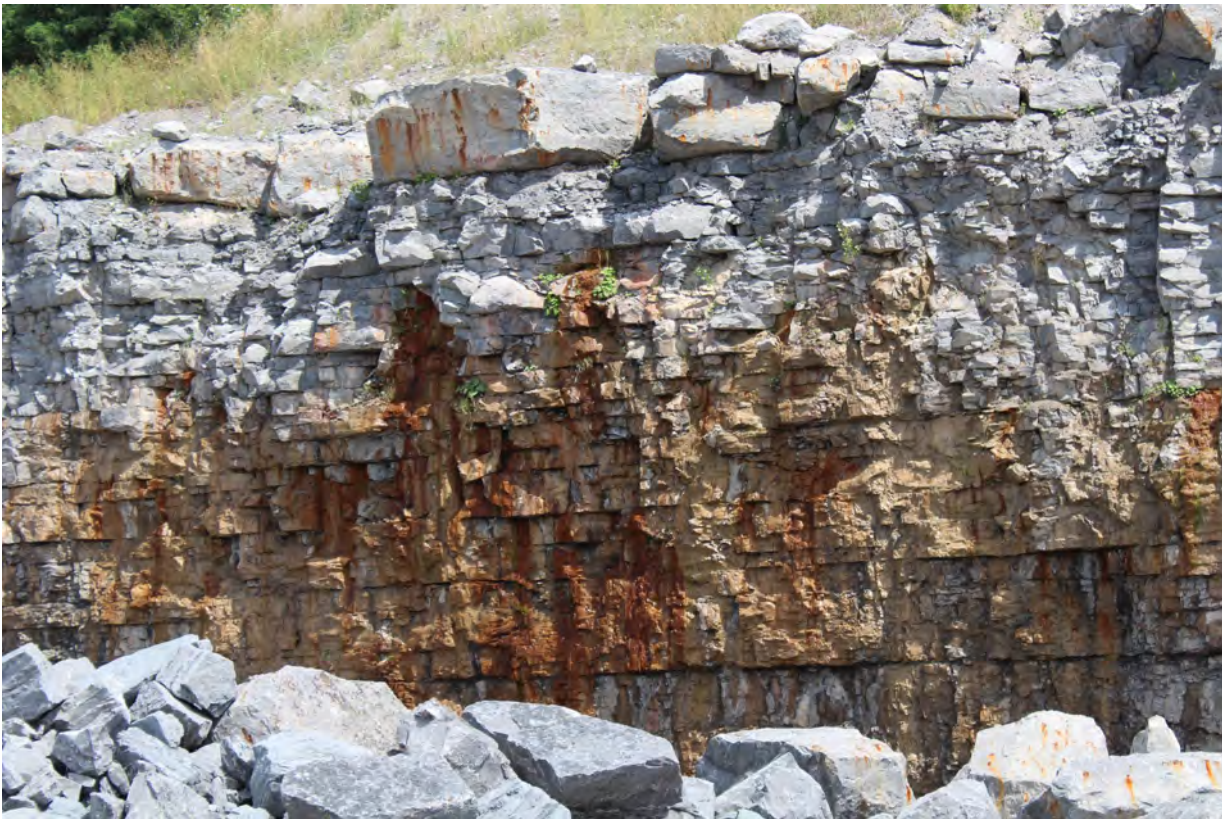
3061, 8/15/2022, by Sam Gowan: Iron staining from ground water seepage along the eastern highwall of the County Line Stone Akron Quarry.

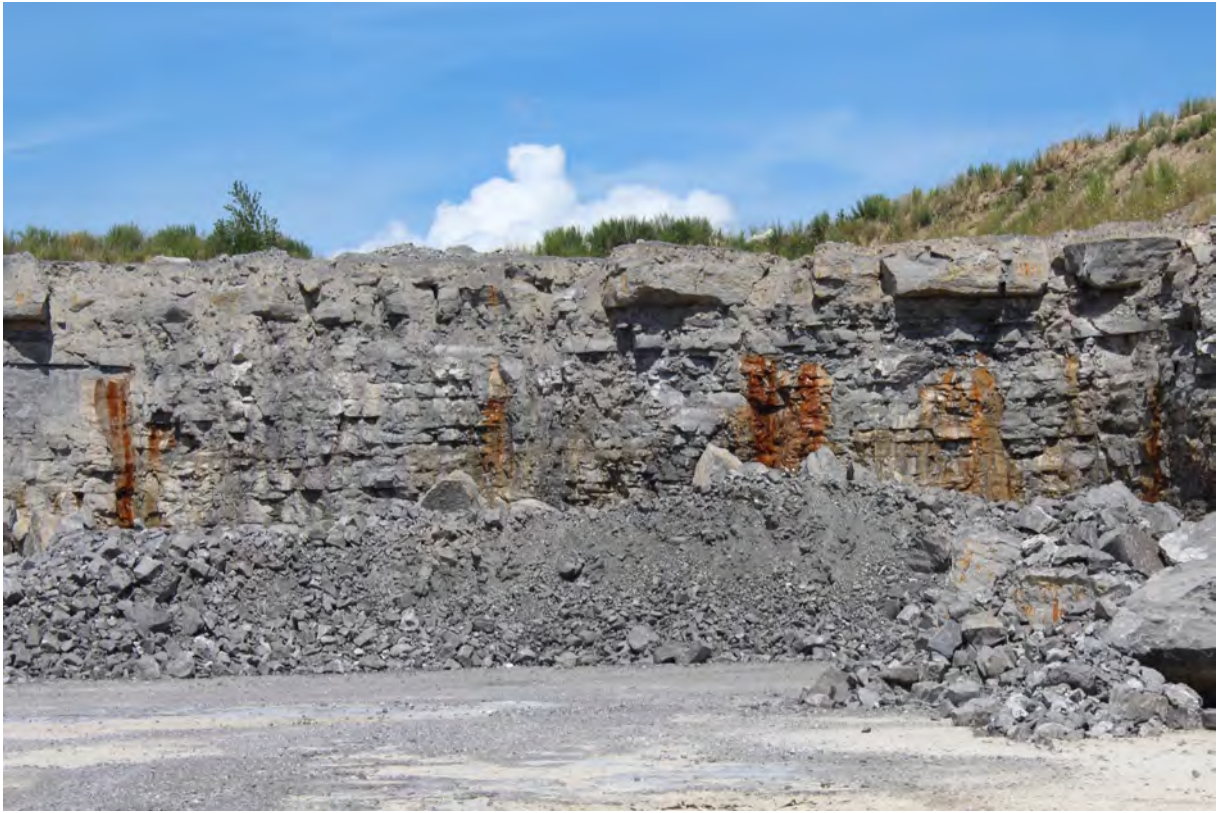
3062, 8/15/2022, by Sam Gowan: Ground water seepage on the north highwall, northeast corner of the County Line Stone Akron Quarry.

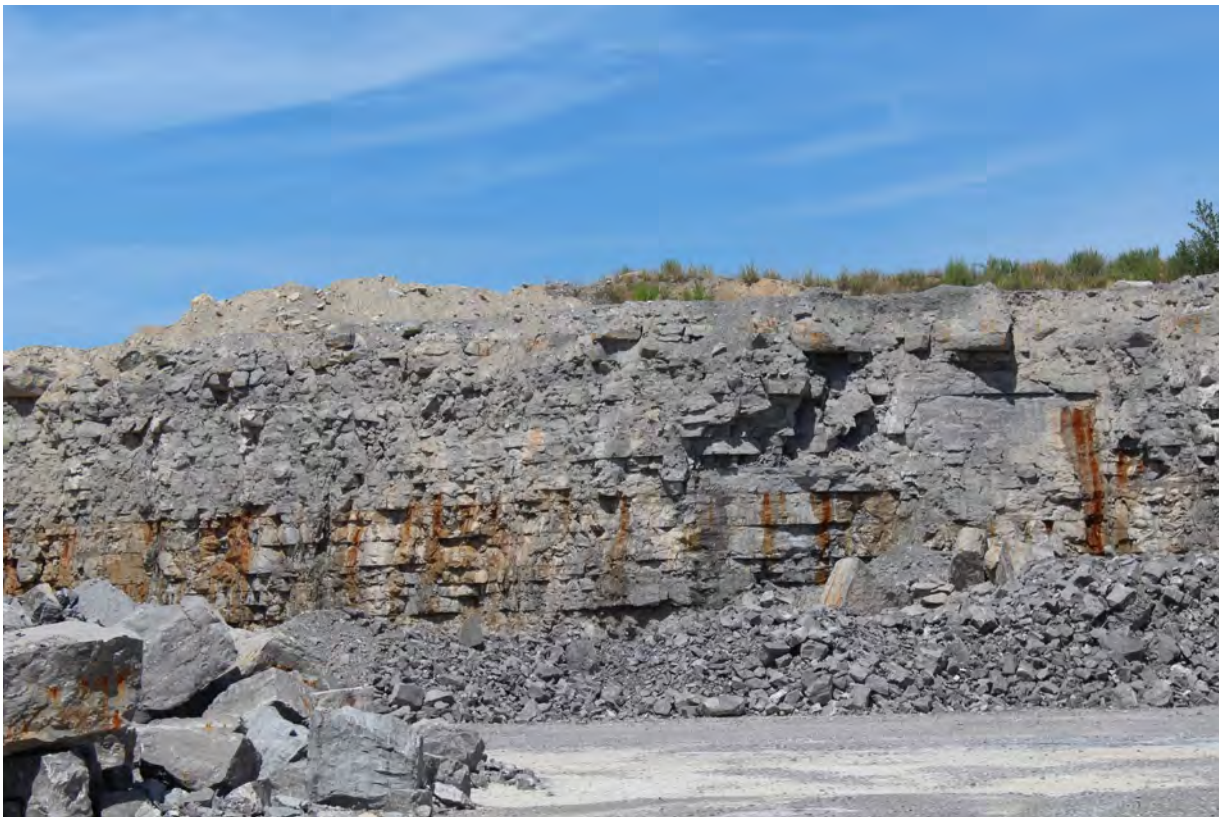
3063, 8/15/2022, by Sam Gowan: Iron staining and ground water seepage from the north highwall near the northeast corner of the County Line Stone Akron Quarry.
