**ASSESSMENT OF THE PHYSICAL CHARACTERISTICS
AND POSSIBLE CAUSE OF GROUND MOVEMENT AT
445 SCRIBNER ROAD, TOWN OF PEMBROKE, NEW YORK**

**County Line Stone Co., Inc.
Akron Quarry
4515 Crittenden Road
Akron, New York 14001**

September 2022

Samuel Ward Gowan, PhD, PG, CPG
Alpha Geological Services, DPC
679 Plank Road
Clifton Park, New York 12065

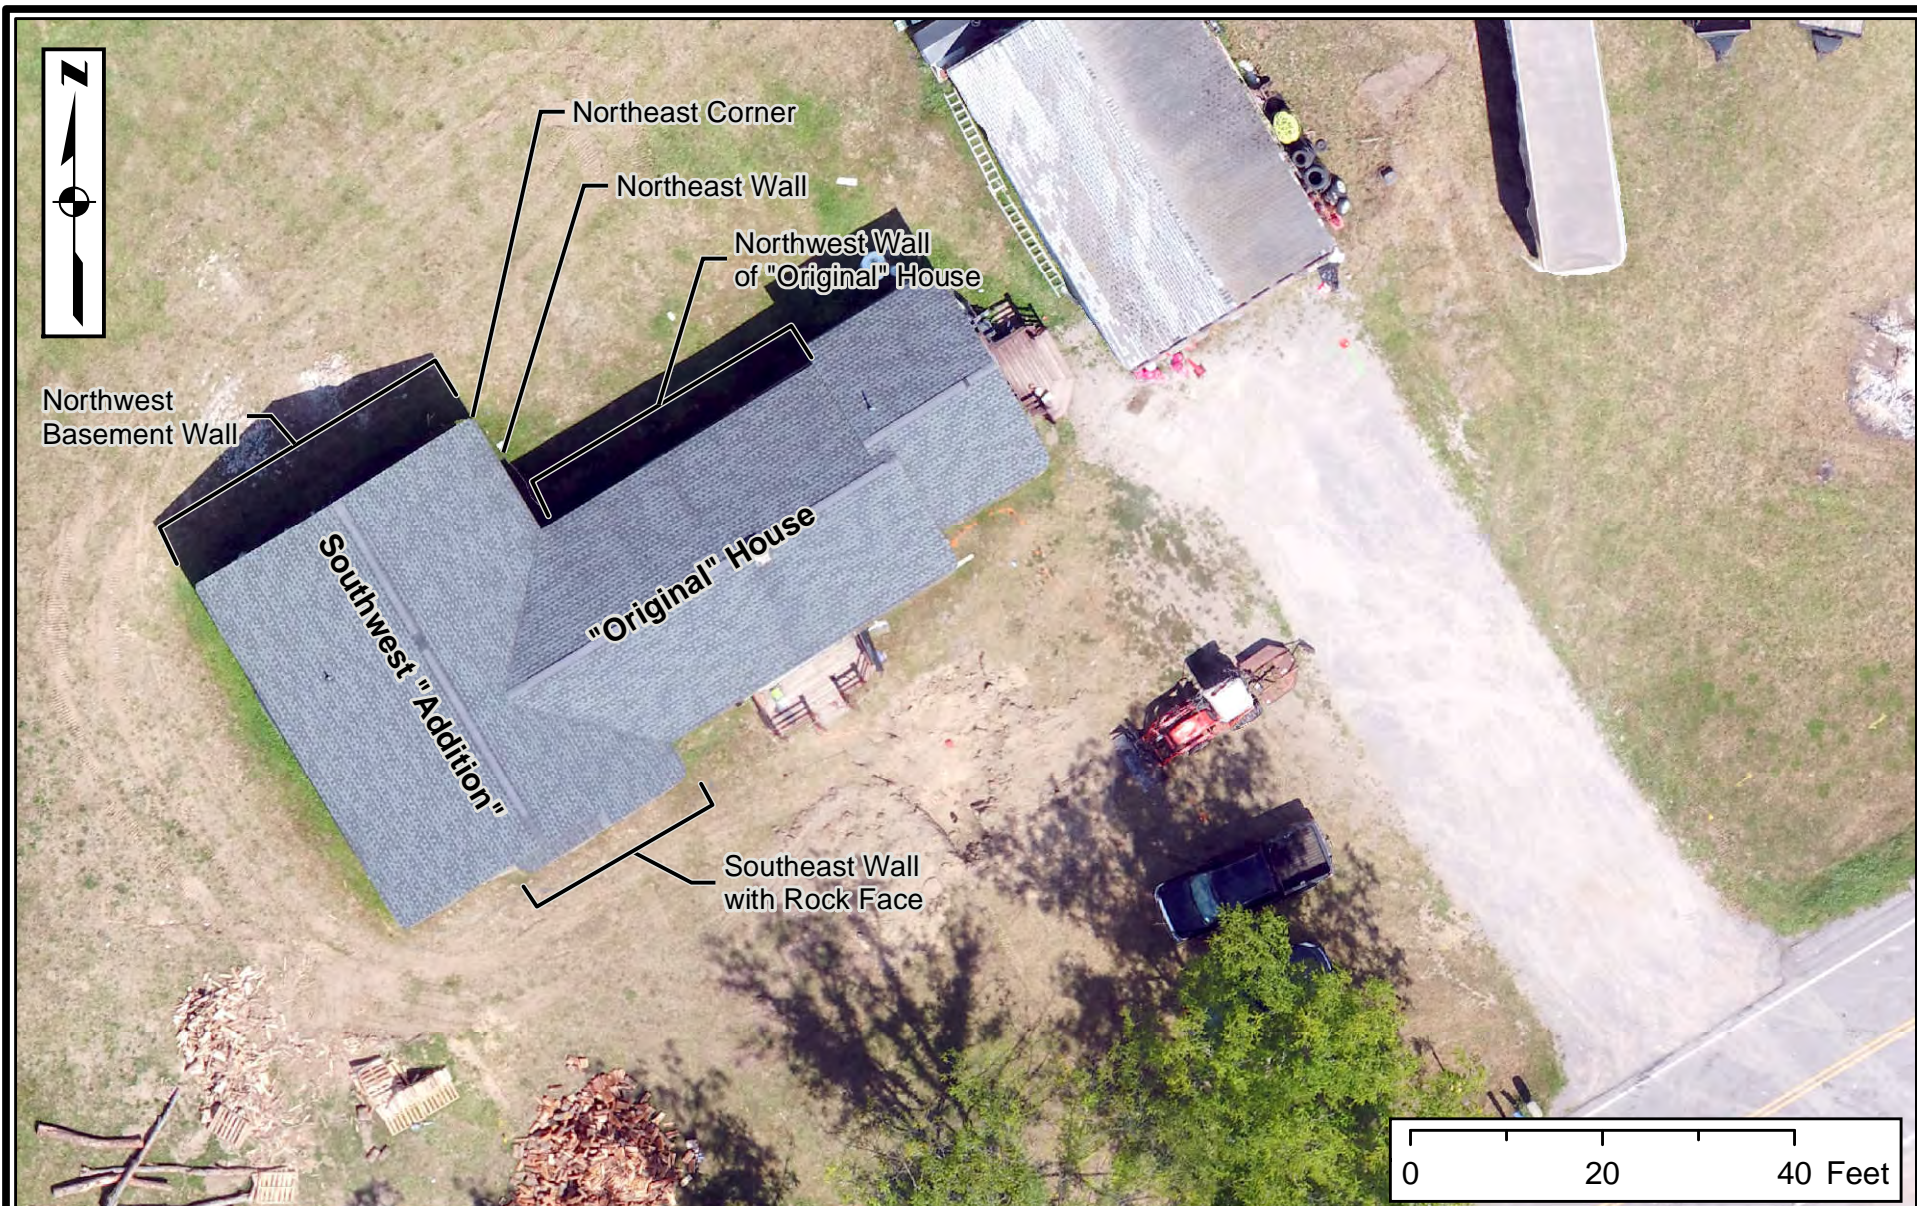
FIGURE 4
 House at Lot
 445 Scribner Road

Damage to the foundation of the home was documented by Dr. Gowan. Images 3028 and 3026 (Appendix A) show that the northwest basement wall was buckled in starting at the fracture that was located approximately 16 inches in from the northeast end of the wall. Image 3026 shows an extension fracture where the buckling appears. Image 3029 (Appendix A) shows an extension

fracture at the northeast corner of the northwest wall of the “Southwest Addition” to the house (Figure 4). The inward buckling of the northeast wall of the “Southwest Addition” is apparent but is less visible than along the northwest wall. A steel support beam is visible on Image 3033 where it has punched through the buckled cinder block wall approximately 10 to 12 feet from the northeast end of the northwest wall.

Image 3037 (Appendix A) shows an extension fracture in the northwest wall. This crack is at the southwest corner of the northwest wall of the “SW Addition” (Figure 4).

Image 3030 (Appendix A) shows the northeast corner of the northwest wall where the extension cracks are visible on both the northwest and northeast walls (Figure 4). Image 3032 shows the same northeast corner of the northwest wall (foreground) with an extension crack visible in the background on the northwest wall of the “Original” part of the house at Lot 445. Image 3031 provides a closeup view of the fracture. It is apparent on Image 3031 that the blocks on the right (southwest) have moved up a fraction of an inch relative to the left side (northeast).

Image 3038 (Appendix A) is a view looking to the northeast along the portion of southeast wall that extends out from the rest of the southeast wall of the “SW Addition” (Figure 4). This picture shows a complex of extension fractures related to the movement of the blocks on the left side toward the northeast relative to the blocks on the right side. Image 3039 provides a wider view of the same location at the front (southeast side) of the house. Images 3040 and 3041 (Appendix A) show tension cracks in the northeast end of the portion of the house represented on Images 3038 and 3039.

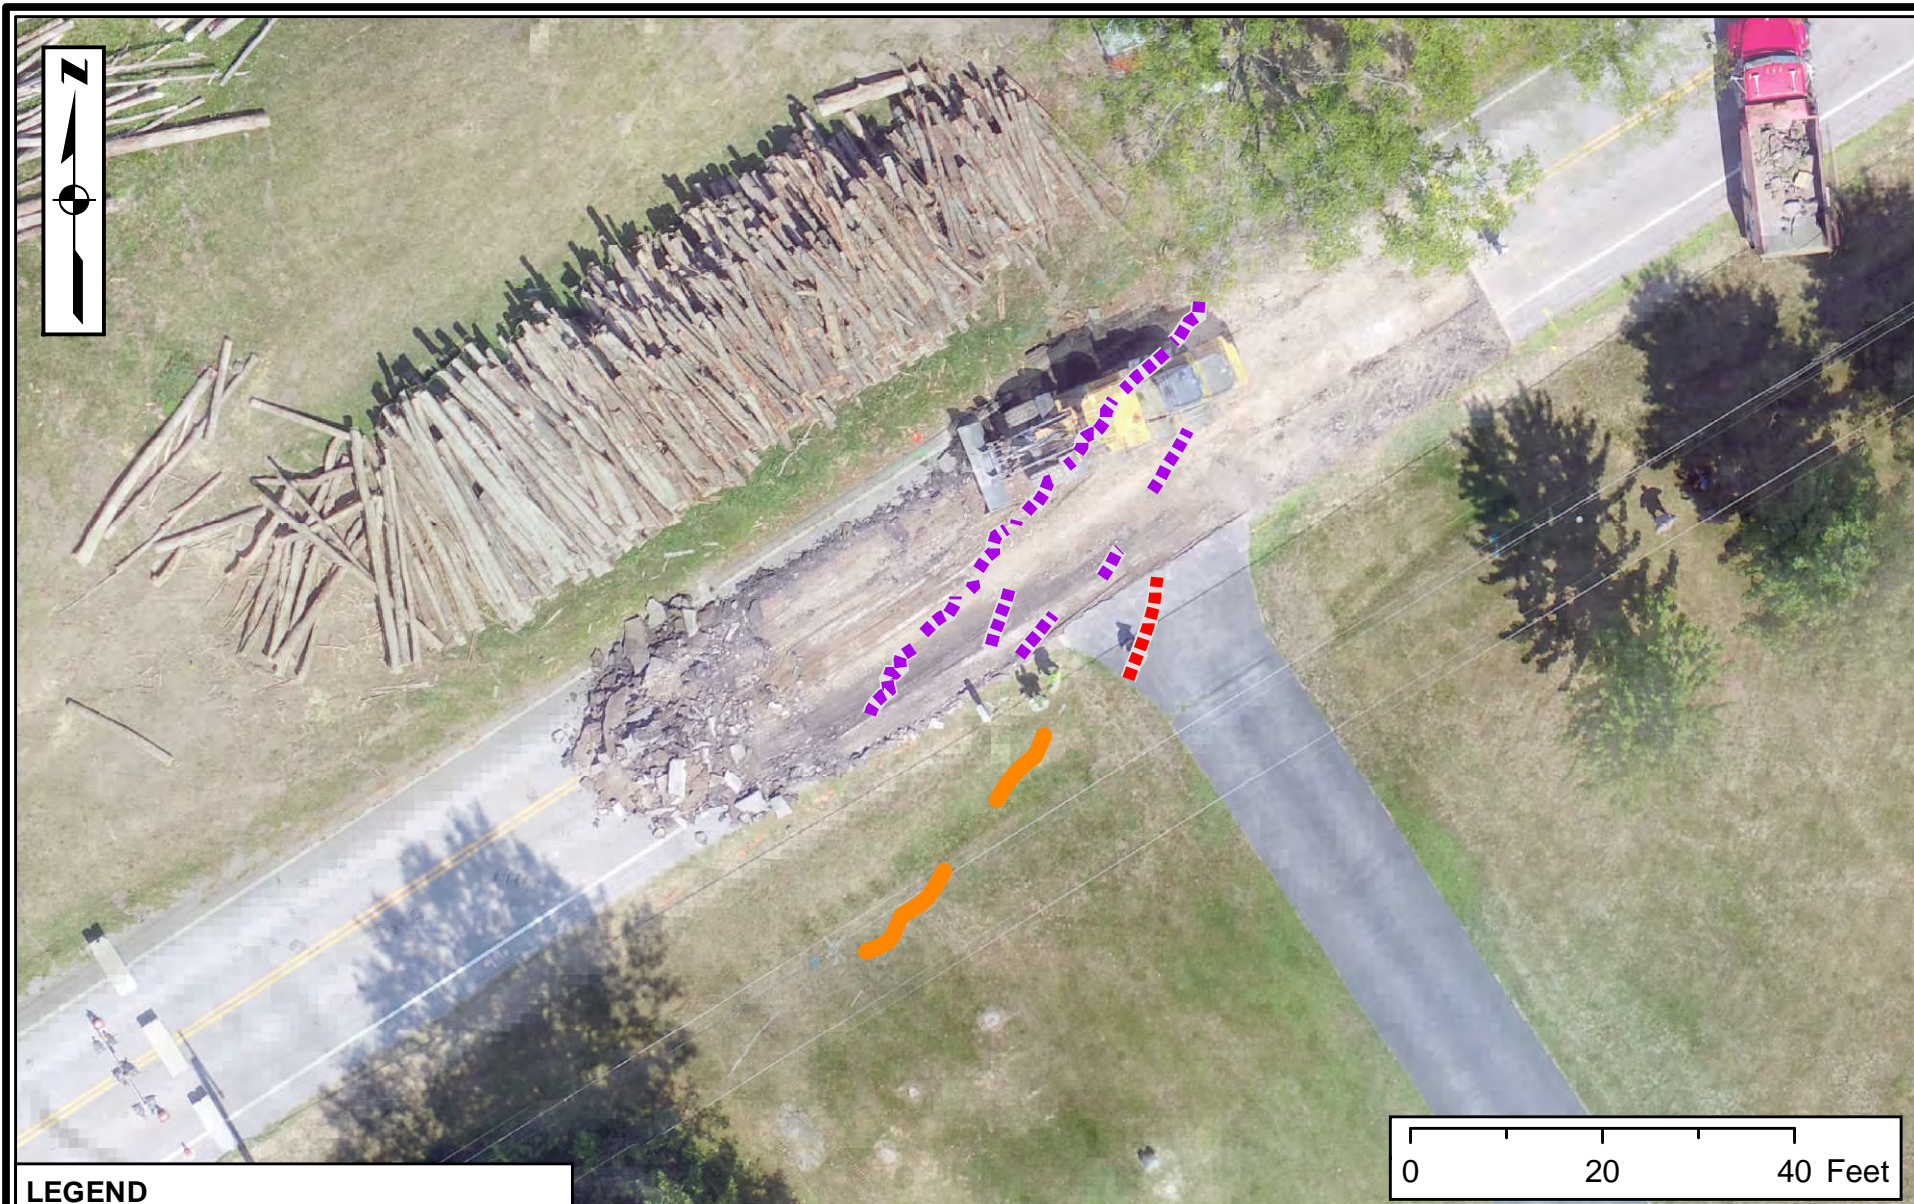
FIGURE 14
Field Observations
August 15, 2022

A cluster of fractures were visible extending diagonally across the road and into the yard at Lot 440. In general, the fractures encountered at Lot 445, in the road, and at Lot 440 were oriented approximately S29°W and covered a distance of approximately 345 feet from the northeast end of the northeastern-most fracture to the southwest end of the southwestern-most fracture. The only other visible fracture not in the 345-foot-long area is a 4-foot-long fracture located at Lot 430 and approximately 230 feet to the south-southwest of the southwestern end of the 345-foot-long area that ends at Lot 440. The fracture at Lot 430 had an orientation of S3°W.

Tension Cracks Observed on August 15, 2022

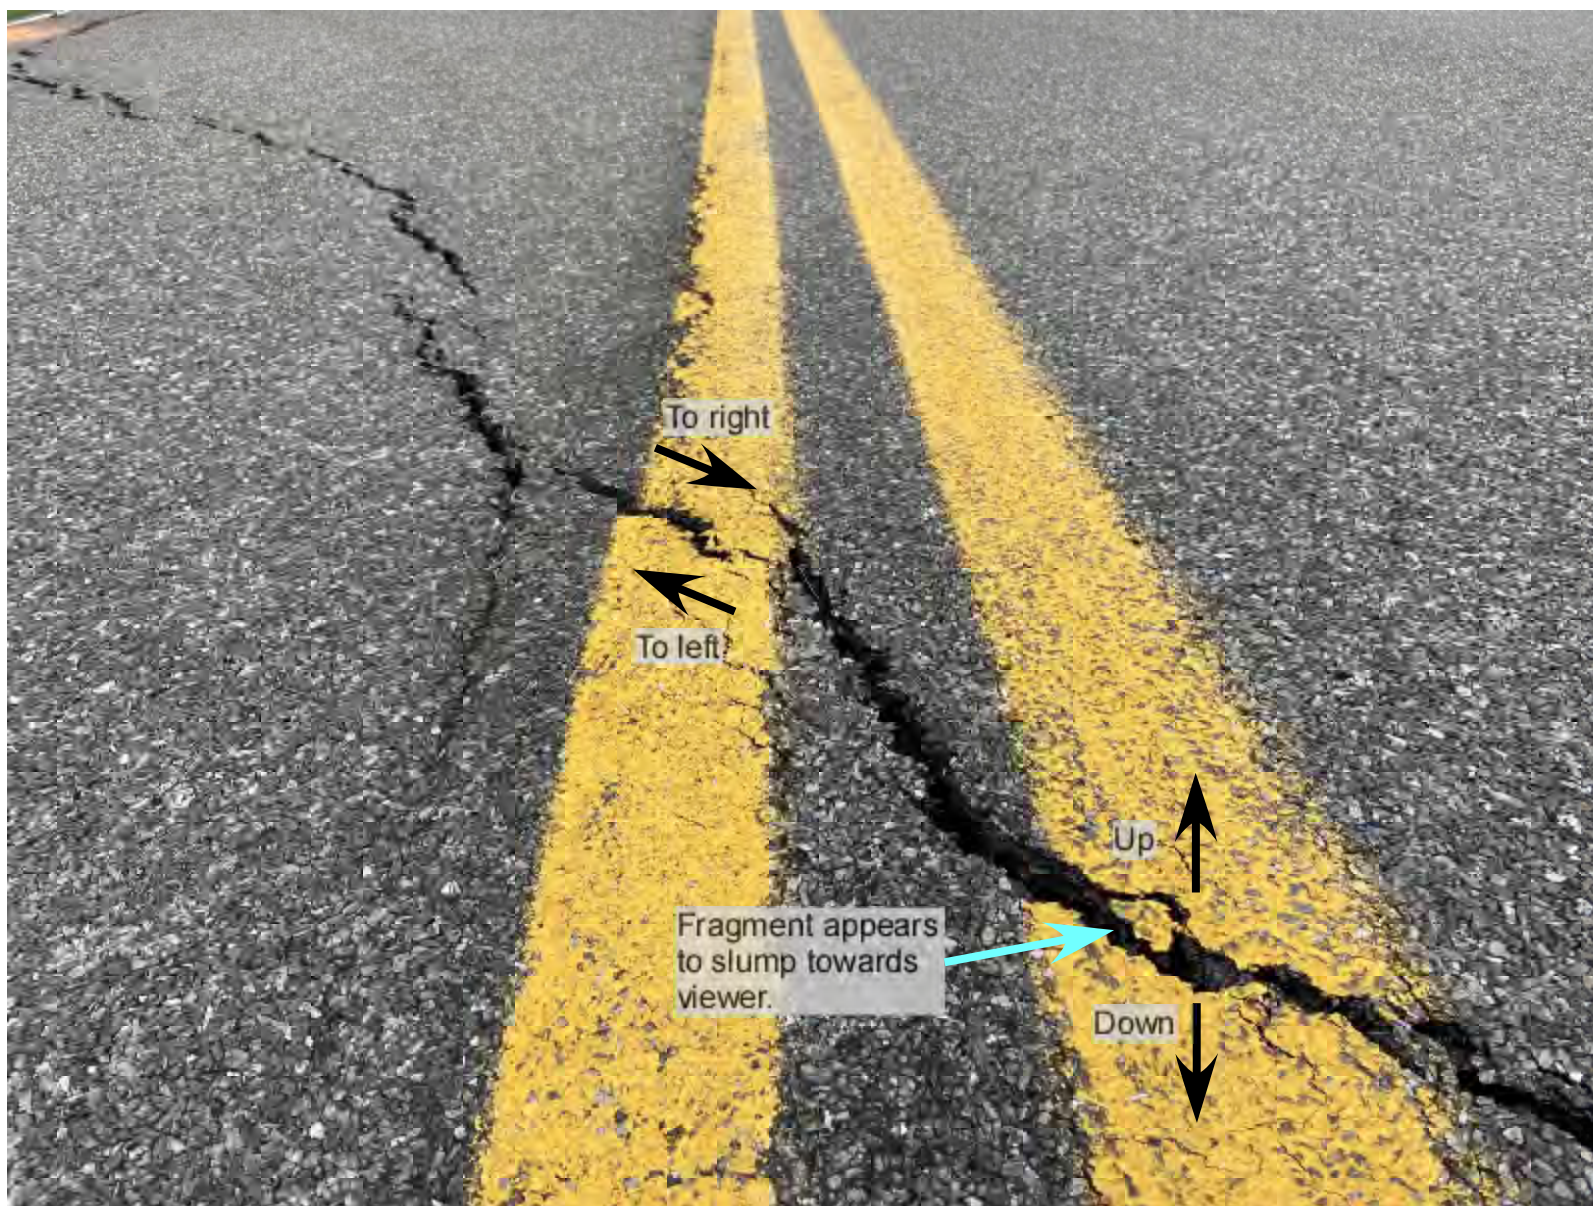
FIGURE 15
 Scribner Road Fracture
 Looking Northeast

Gardner's closeup picture of the center stripes in Scribner Road appears to show a down-drop to the left (northwest) relative to the right (southeast). This apparent displacement is illustrated on a reproduction of Gardner's picture as Figure 15. There also appears to be a right-lateral shift across the fracture; however, this apparent right-lateral shift may be an optical illusion resulting from the angle of the camera. The apparent right-lateral shift is also visible and annotated on the photograph taken of the road subbase (Figure 16). There is also less ambiguous evidence of a right-lateral shift in the foundation at the front of the house as illustrated on Figure 17. The location of this picture is

Photograph Location near Lots 440 and 445 Scribner Road, Pembroke, NY
 Photograph provided by Mr. Norm Gardner of Clark, P.G. of Patterson, and Lee
 Photo date: circa August 7-15, 2022

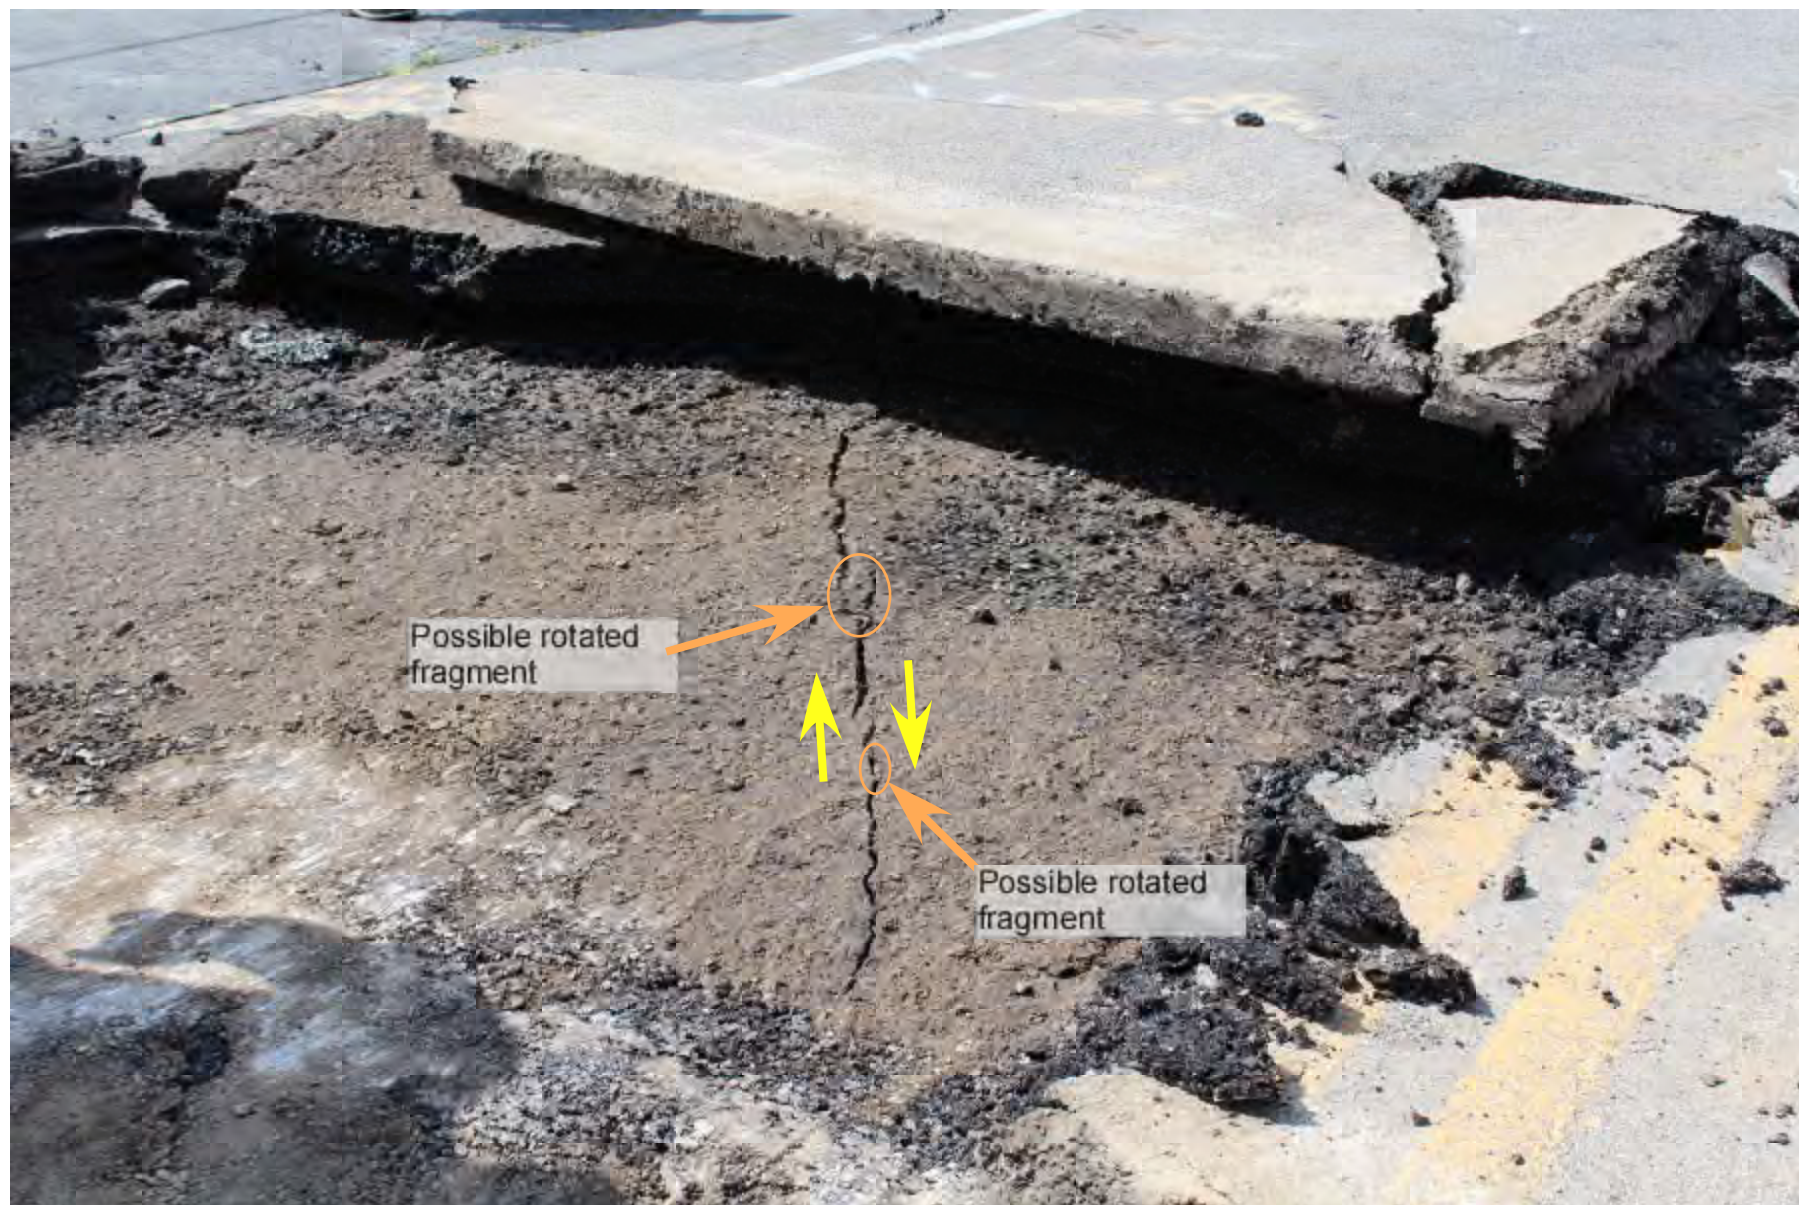
FIGURE 16
 Scribner Road Fracture
 in Road Base Below
 Pavement
 Scribner Road Project
 County Line Stone
 Town of Pembroke
 Genesee County, New York

The significance of the subsurface motion at the Scribner Road site is best illustrated by looking at the fracture pattern crossing the road despite the fact that the fractures were being destroyed as Alpha and AGS were conducting the investigation. The fractures cross the road in a swarm of roughly parallel fractures in a zone that is approximately 15 to 18 feet wide in the area shown on Figure 14. All of these fractures are extension features (see Images 3009, 3010, 3012, 3016, 3017, 3018 in Appendix A and Gardner's images of cracks in Scribner Road in Appendix B).

Photograph Location: Scribner Road adjacent to lots 440 and 445, with view to the south
 Photograph taken by Sam Gown, Alpha Geoscience
 Photo date: August 15, 2022

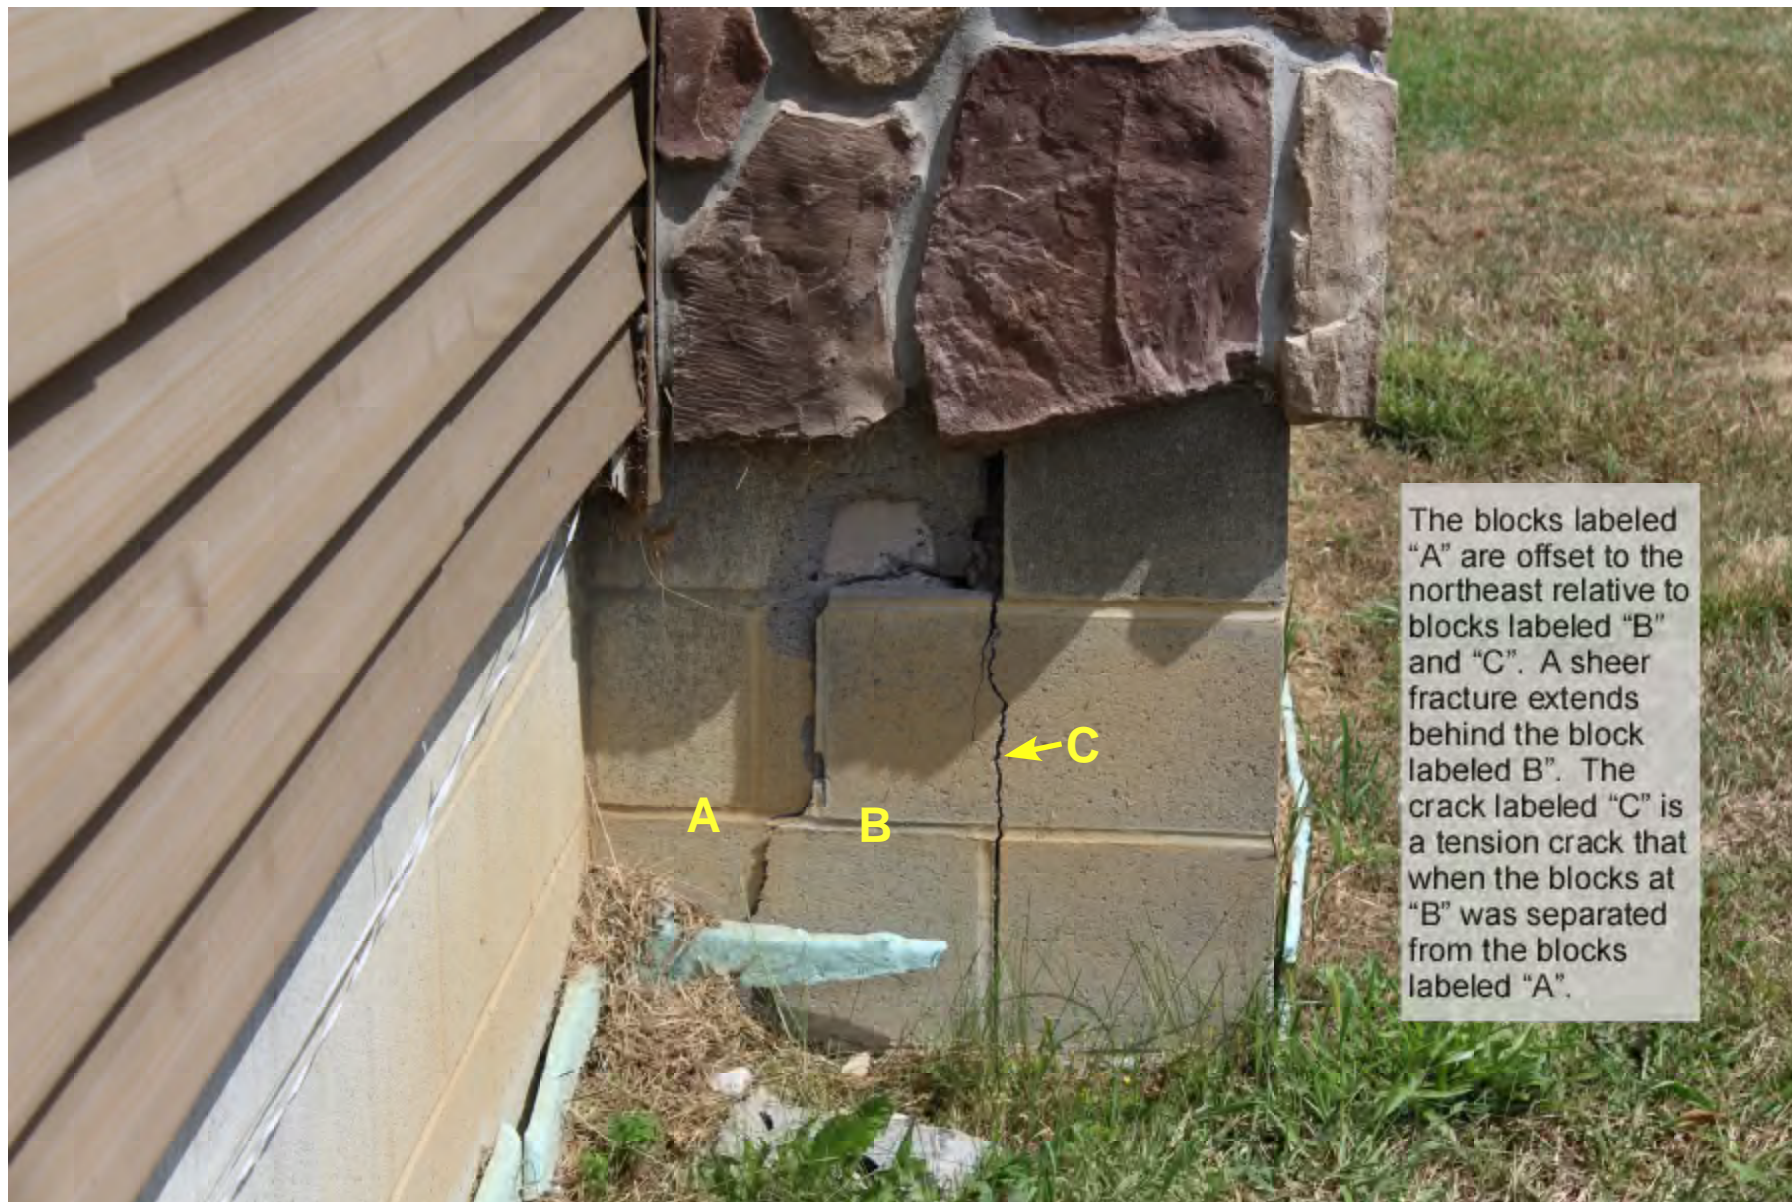
FIGURE 17
 Southeast Side of 445
 Scribner Road
 Scribner Road Project
 County Line Stone
 Town of Pembroke
 Genesee County, New York

The subtle suggestion that the tension cracks appear to have a small right-lateral movement along the structure has not been documented in other examples of pop-up structures; however, it is not unreasonable for a small amount of right-lateral shear to occur along the strike of the structure. This subtle right-lateral movement is consistent with the shear offset visible in the front of the house at Lot 445.

The blocks labeled "A" are offset to the northeast relative to blocks labeled "B" and "C". A sheer fracture extends behind the block labeled "B". The crack labeled "C" is a tension crack that when the blocks at "B" was separated from the blocks labeled "A".

Photograph Location: Southeast side of the northwest addition at Lot 445 Scribner Road, with view to the northeast
 Photograph taken by Sam Gown, Alpha Geoscience
 Photo date: August 15, 2022

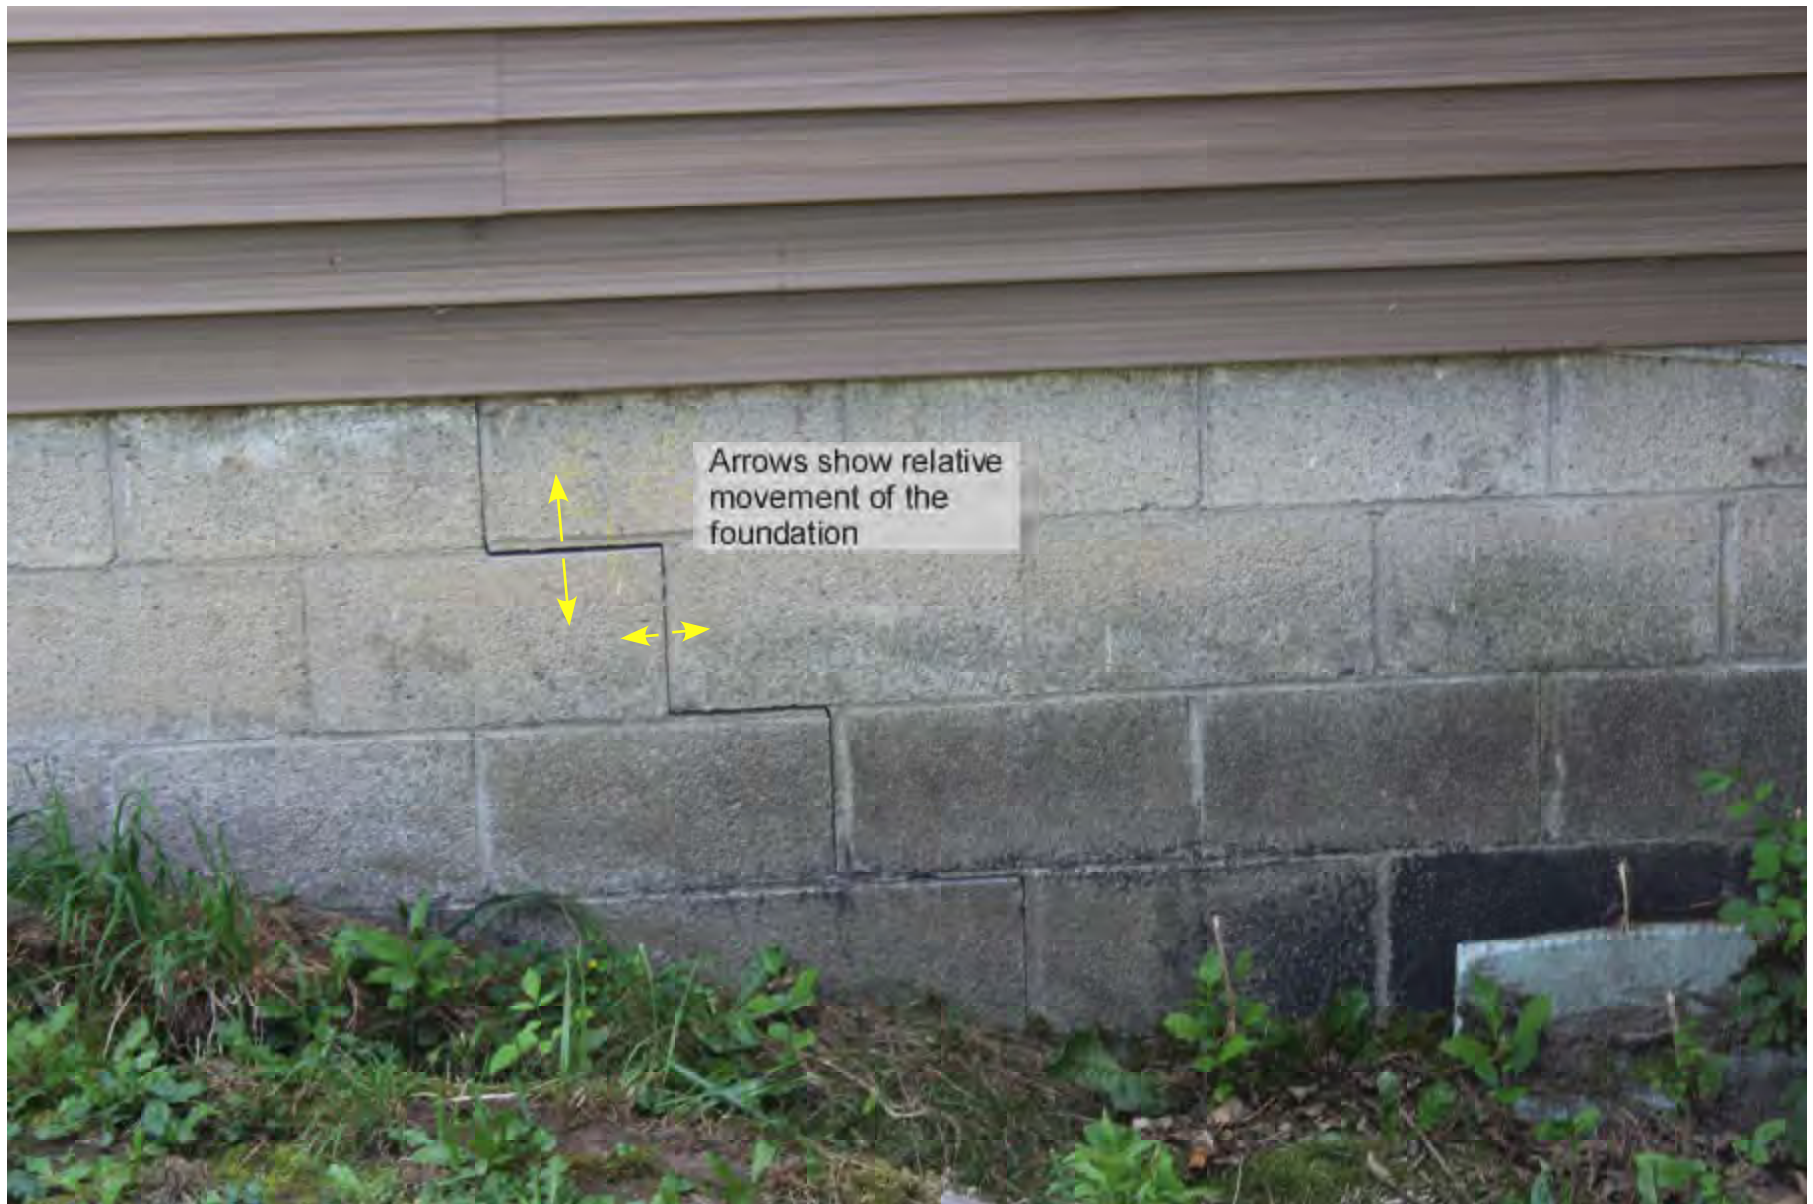
FIGURE 19
 Fracture and Relative
 Movement of Basement
 Wall at 445 Scribner Road

provided on Figure 18. A photograph of the northwest foundation wall of the “Original” part of the house shows that portions of the house to the right (southwest) have separated and are higher relative to the northeast parts of the “Original” house on the left side (Figure 19).

Photograph Location: View to the southeast of the northwest basement wall of the "original" house.
 Photograph taken by Sam Gown, Alpha Geoscience
 Photo date: August 15, 2022

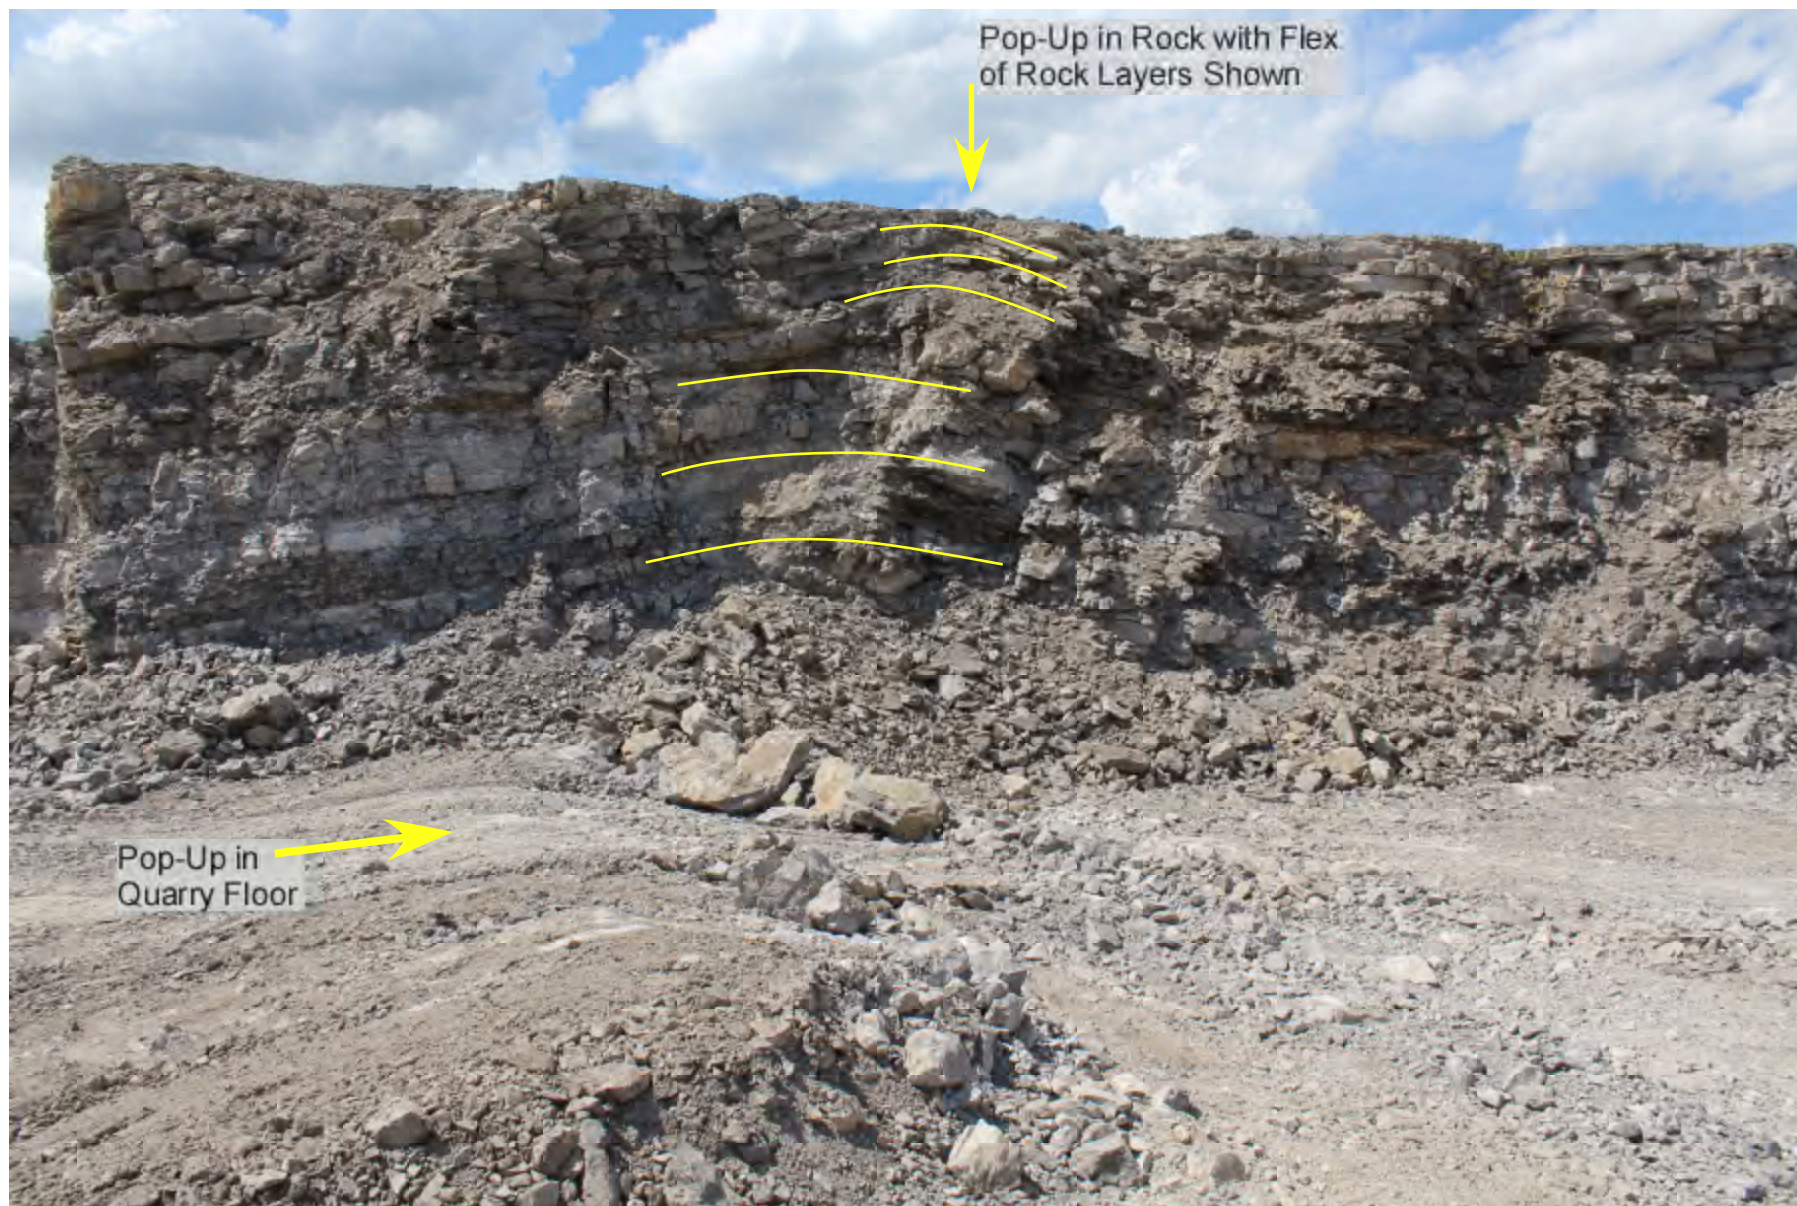
FIGURE 22
Pop-Up in Quarry
Face and Floor

Photograph Location: Western face of the Akron Quarry
Photograph taken by Sam Gown, Alpha Geoscience
Photo date: August 15, 2022

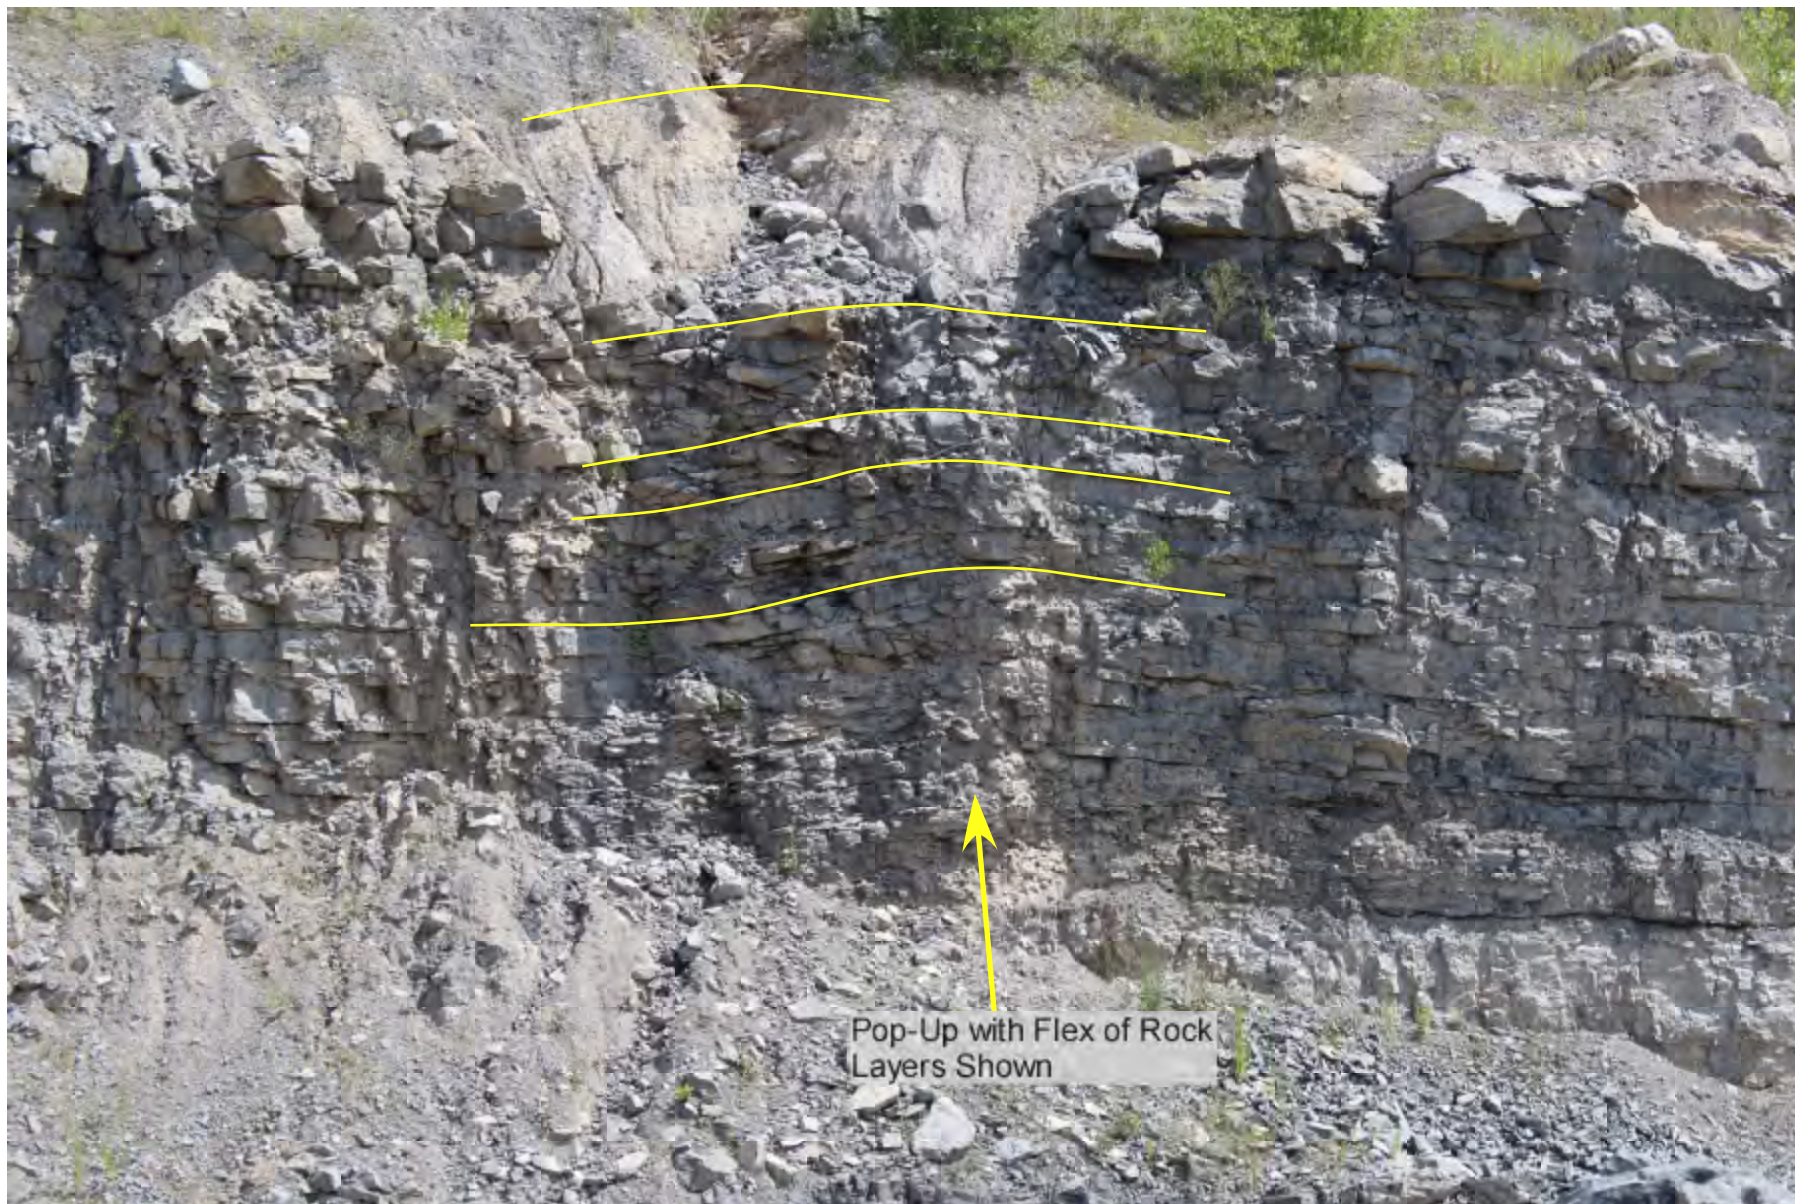
FIGURE 23
Pop-Up in Rock Face
and Overburden

Photograph Location: Eastern face of the Akron Quarry
Photograph taken by Sam Gown, Alpha Geoscience
Photo date: August 15, 2022
