APPENDIX A

**Photographs taken by Samuel Gowan on 8/15/2022 of the Scribner Road Area
and the Akron Quarry**

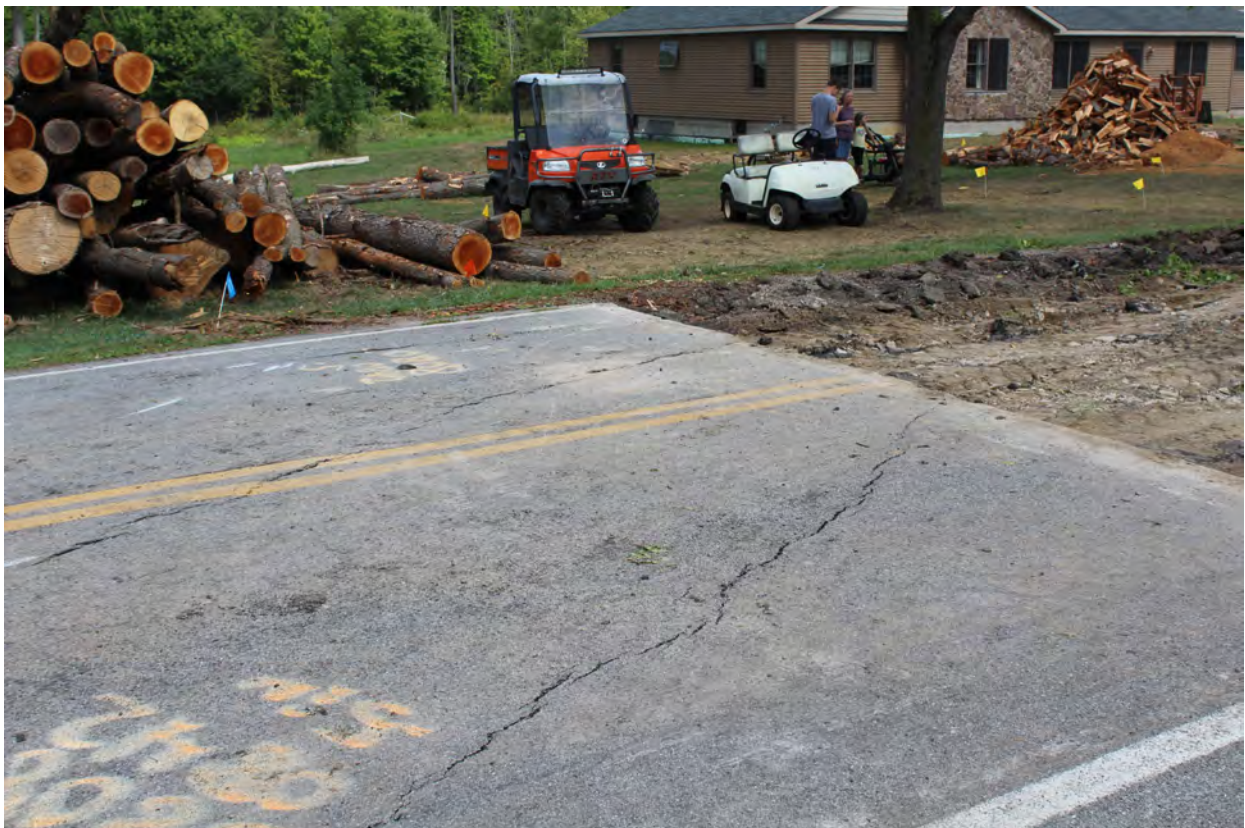
3012, 8/15/2022, by Sam Gowan: View to north across Scribner Road to Lot 445.

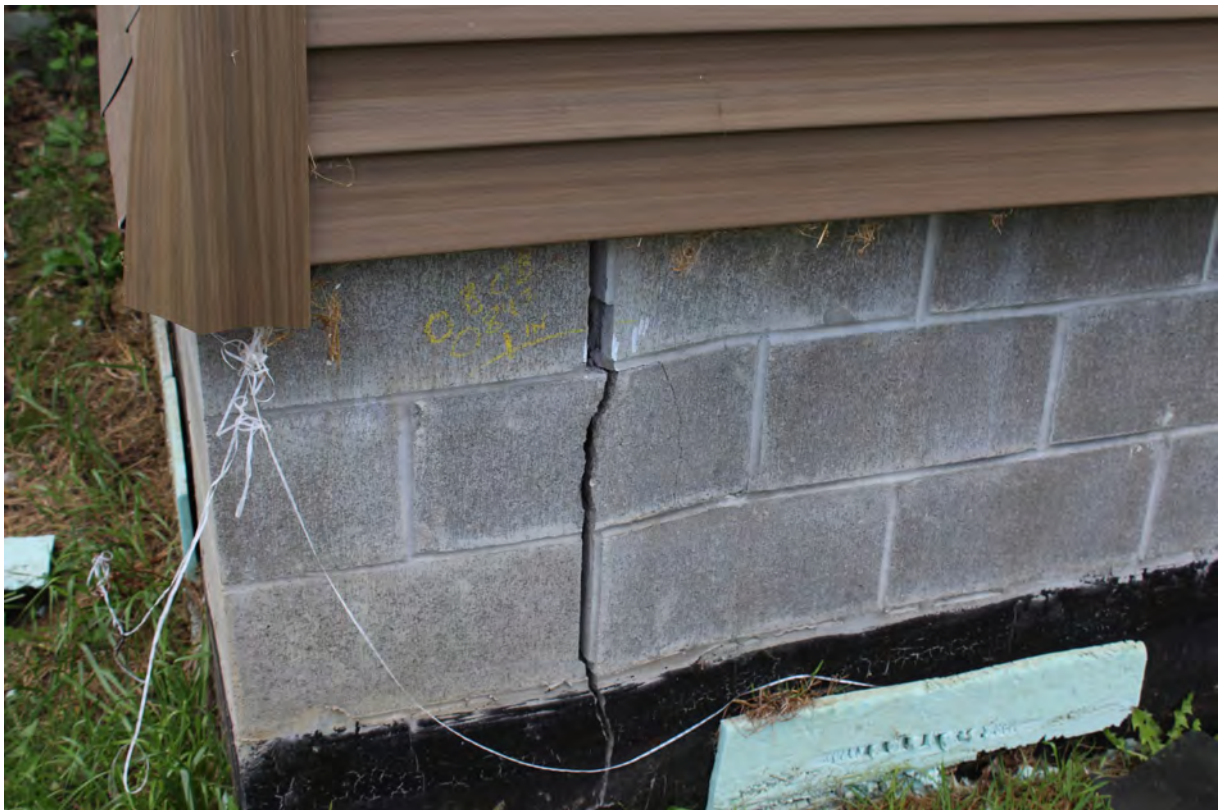
3026, 8/15/2022, by Sam Gowan: View of the northeast corner of the northwest wall of the addition on the southwest end of the house at 445 Scribner Road.

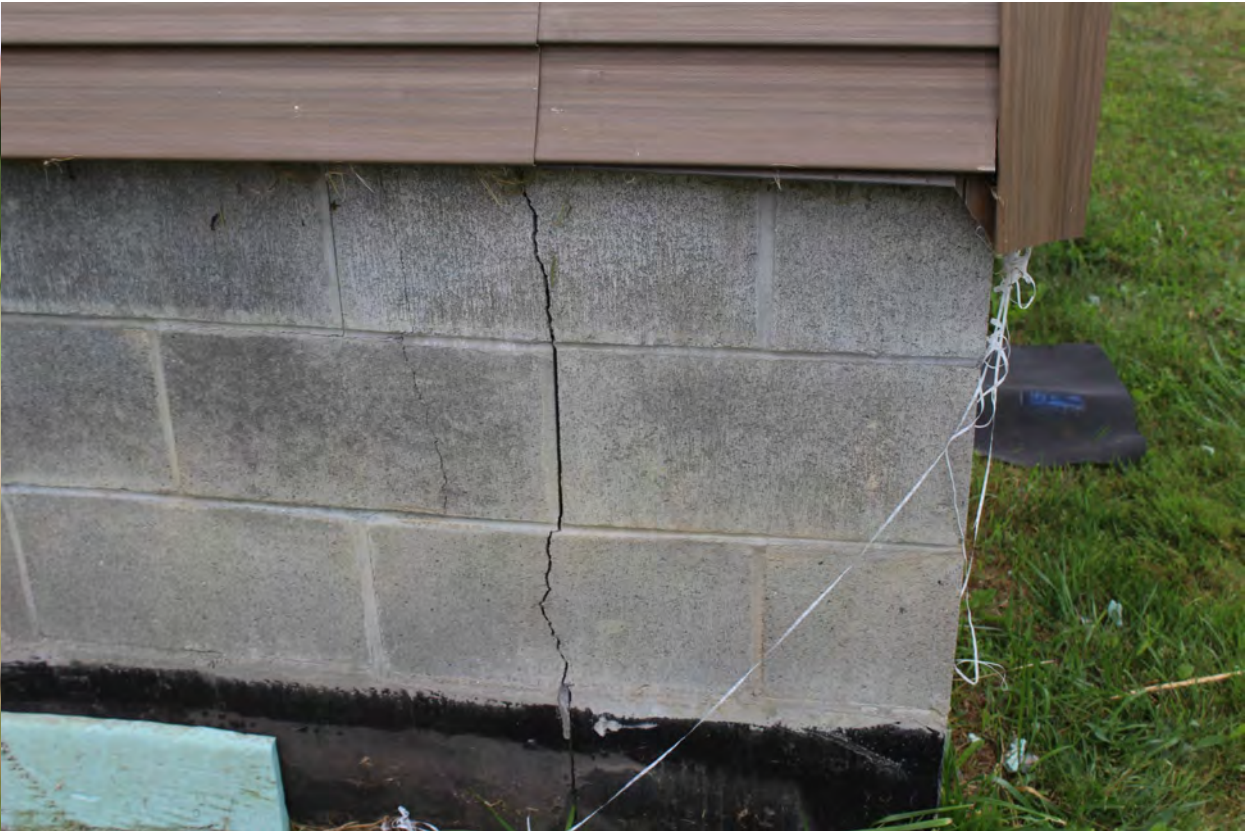
3029, 8/15/2022, by Sam Gowan: View to the south at the northeast corner of the northwest wall of the 445 Scribner Road addition.

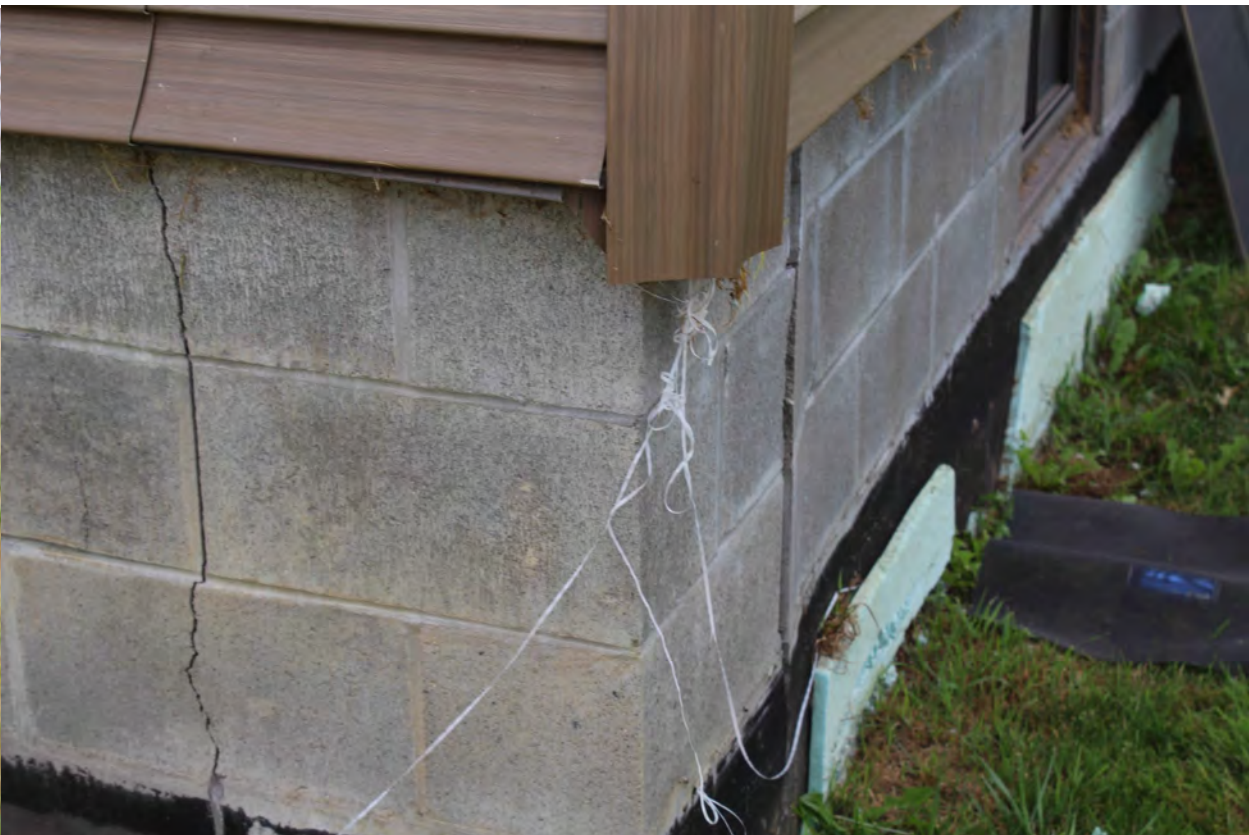
3030, 8/15/2022, by Sam Gowan: View to the south at the northeast corner of the addition at 445 Scribner Road.

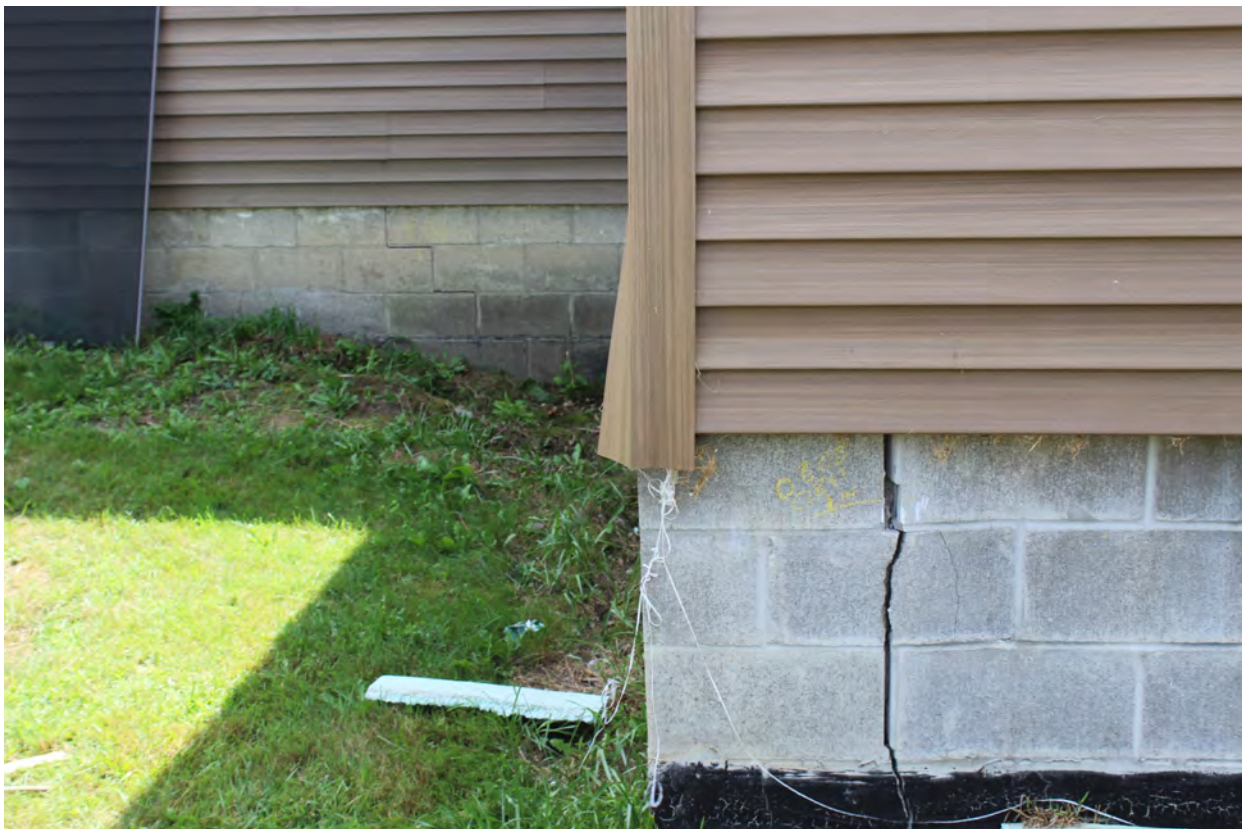
3032, 8/15/2022, by Sam Gowan: View to the east of the northeast corner of the addition, at 445 Scribner Road, with the northwest basement wall of the original part of the house in the background on the left.

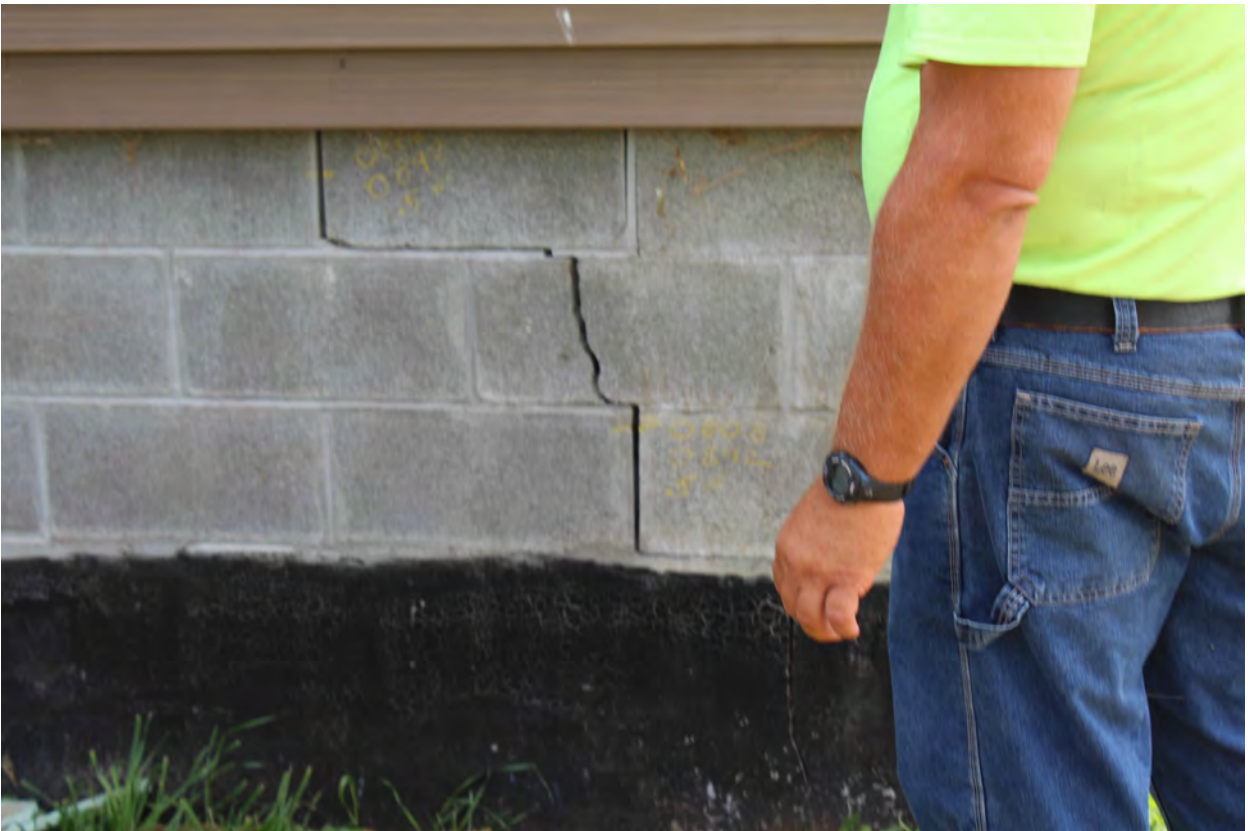
3037, 8/15/2022, by Sam Gowan: View to the east of the southwest corner of the northwest wall of the addition at 445 Scribner Road.

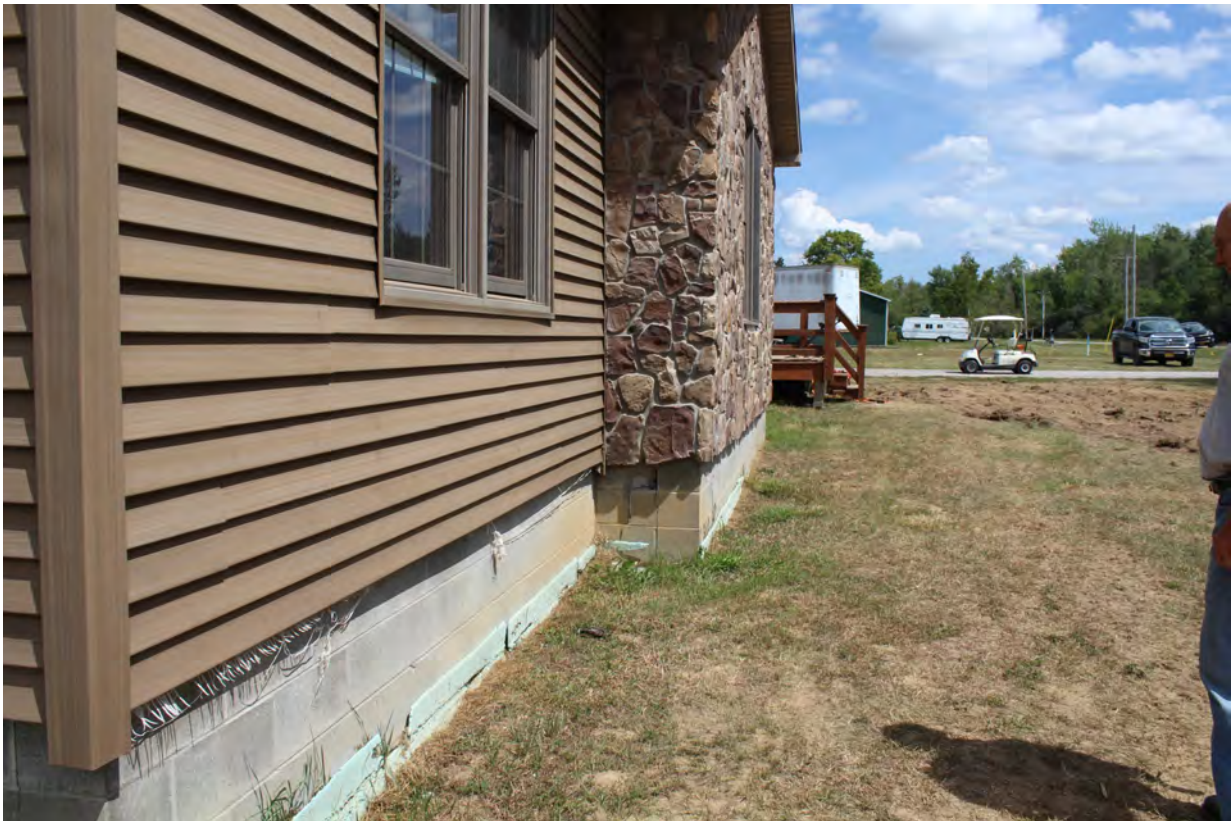
3039, 8/15/2022, by Sam Gowan: View of the southeast side of 445 Scribner Road, looking to the northeast.

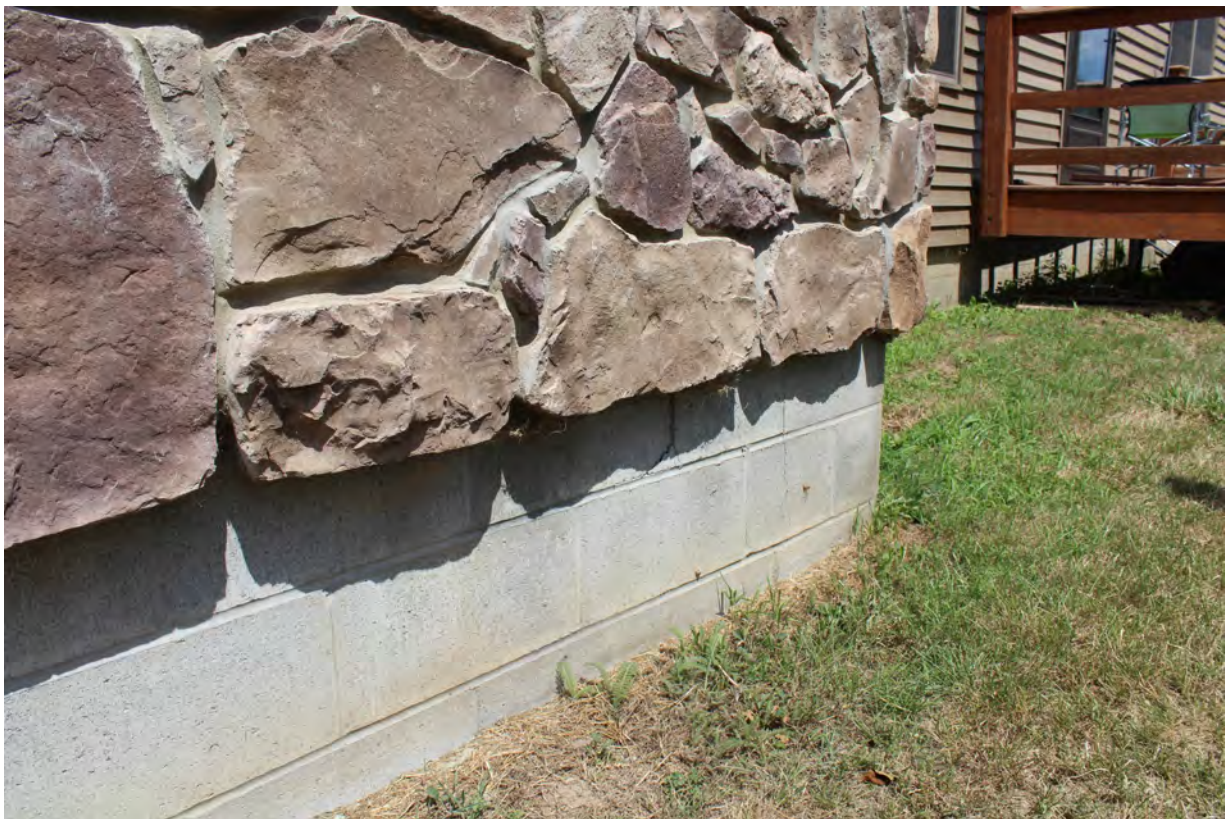
3040, 8/15/2022, by Sam Gowan: View to the northeast along the southeast side of the addition at 445 Scribner Road, with the original part of the house in the background.

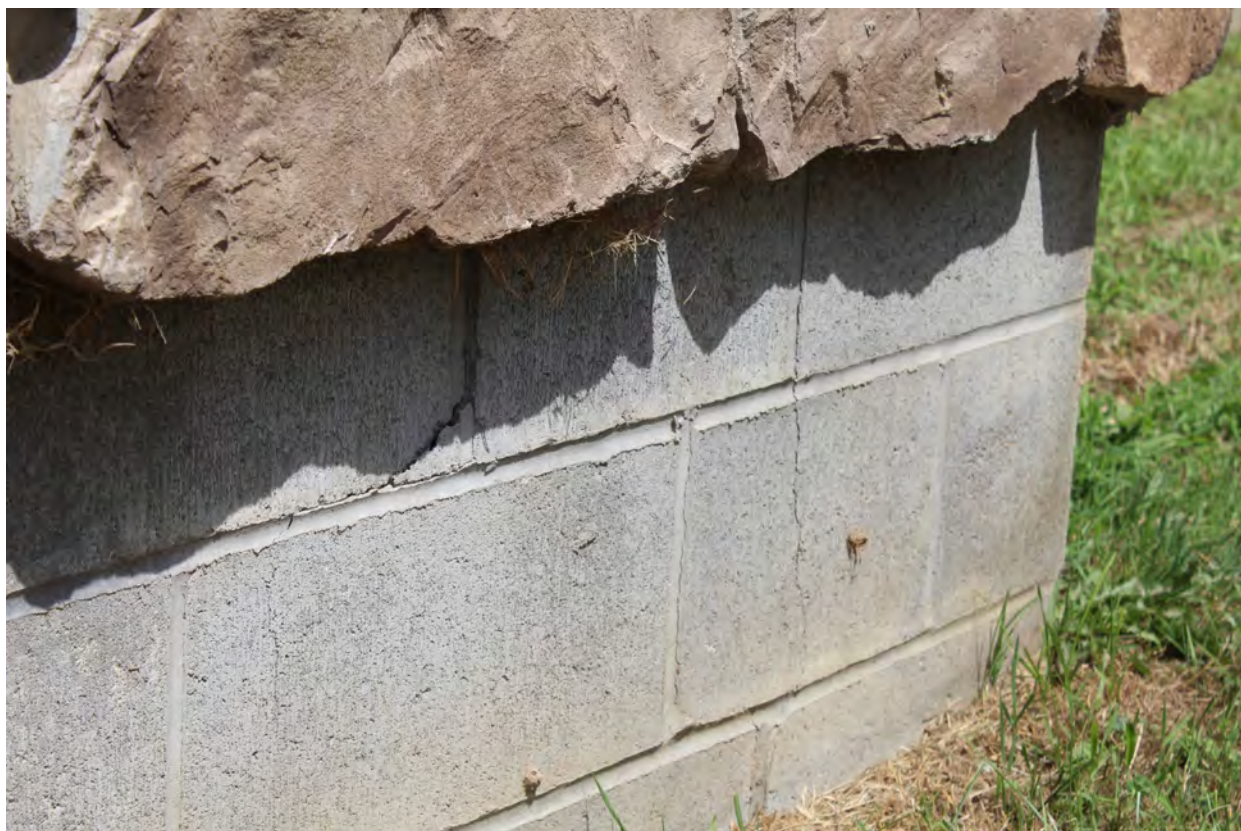
3041, 8/15/2022, by Sam Gowan: View to the northeast along the southeast side of the addition at 445 Scribner Road.

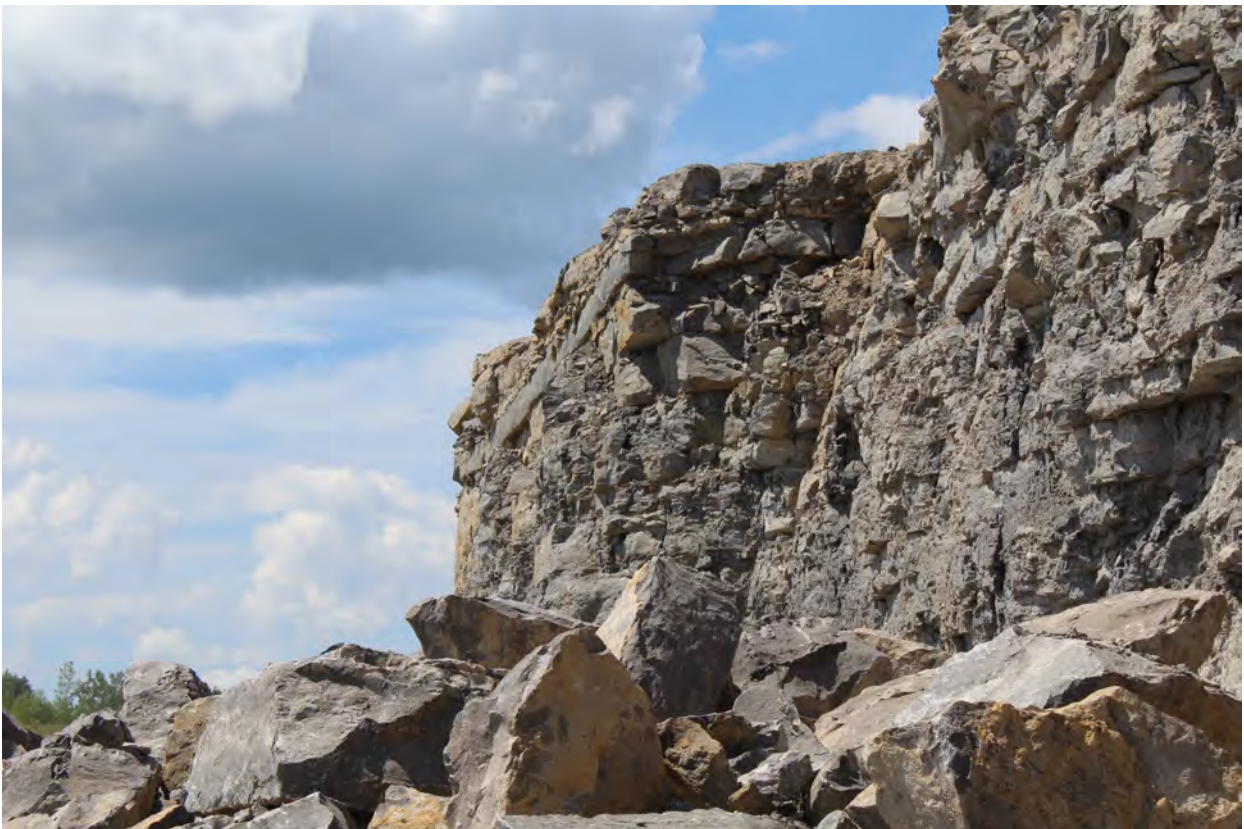
3051, 8/15/2022, by Sam Gowan: View to the west of an east-west oriented primary joint in the north quarry face at the County Line Stone Akron Quarry.

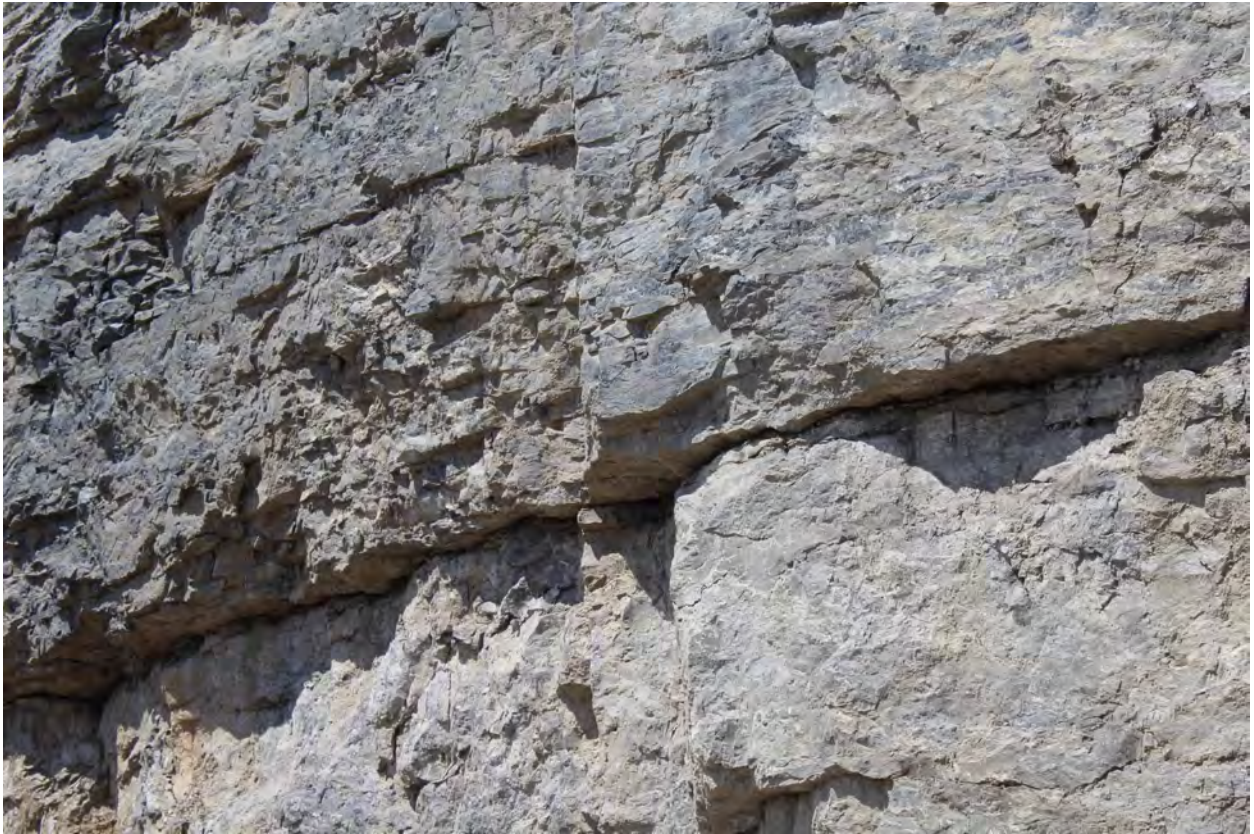
3052, 8/15/2022, by Sam Gowan: View of a secondary joint in the north rock face at the County Line Stone Akron Quarry. The joint is oriented N47°W.

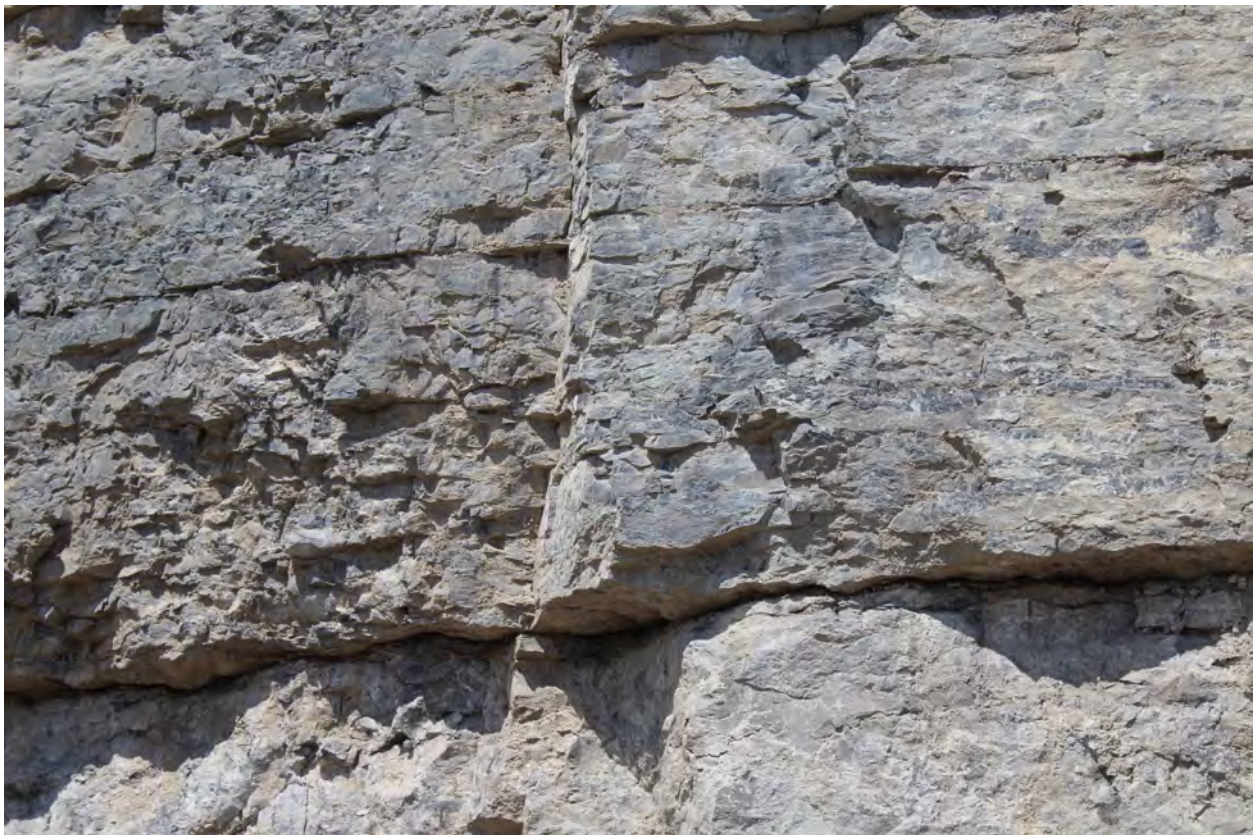
3053, 8/15/2022, by Sam Gowan: View of a secondary joint (N47°W) in the north highwall at the County Line Stone Akron Quarry.

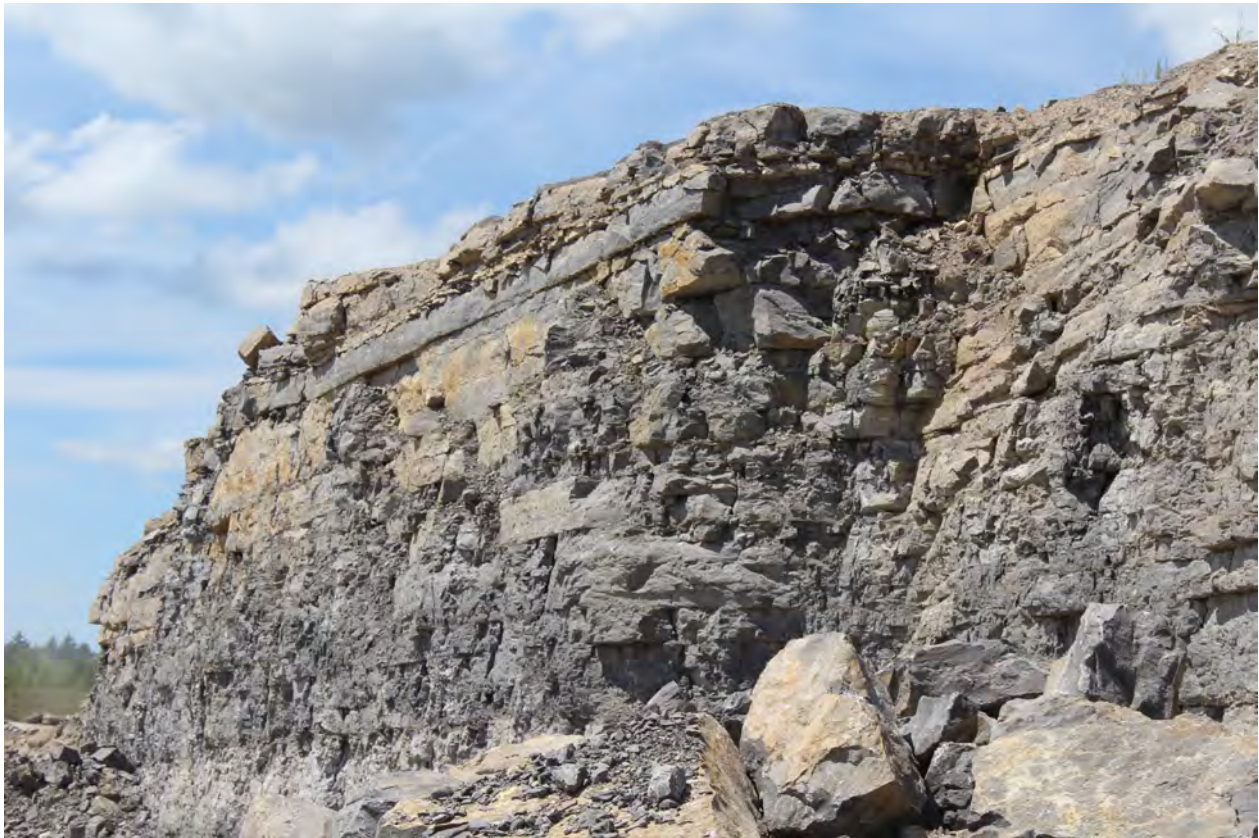
3054, 8/15/2022, by Sam Gowan: View of the primary joint in the north highwall at County Line Stone Akron Quarry.
