**ASSESSMENT OF THE PHYSICAL CHARACTERISTICS
AND POSSIBLE CAUSE OF GROUND MOVEMENT AT
445 SCRIBNER ROAD, TOWN OF PEMBROKE, NEW YORK**

**County Line Stone Co., Inc.
Akron Quarry
4515 Crittenden Road
Akron, New York 14001**

September 2022

Samuel Ward Gowan, PhD, PG, CPG
Alpha Geological Services, DPC
679 Plank Road
Clifton Park, New York 12065

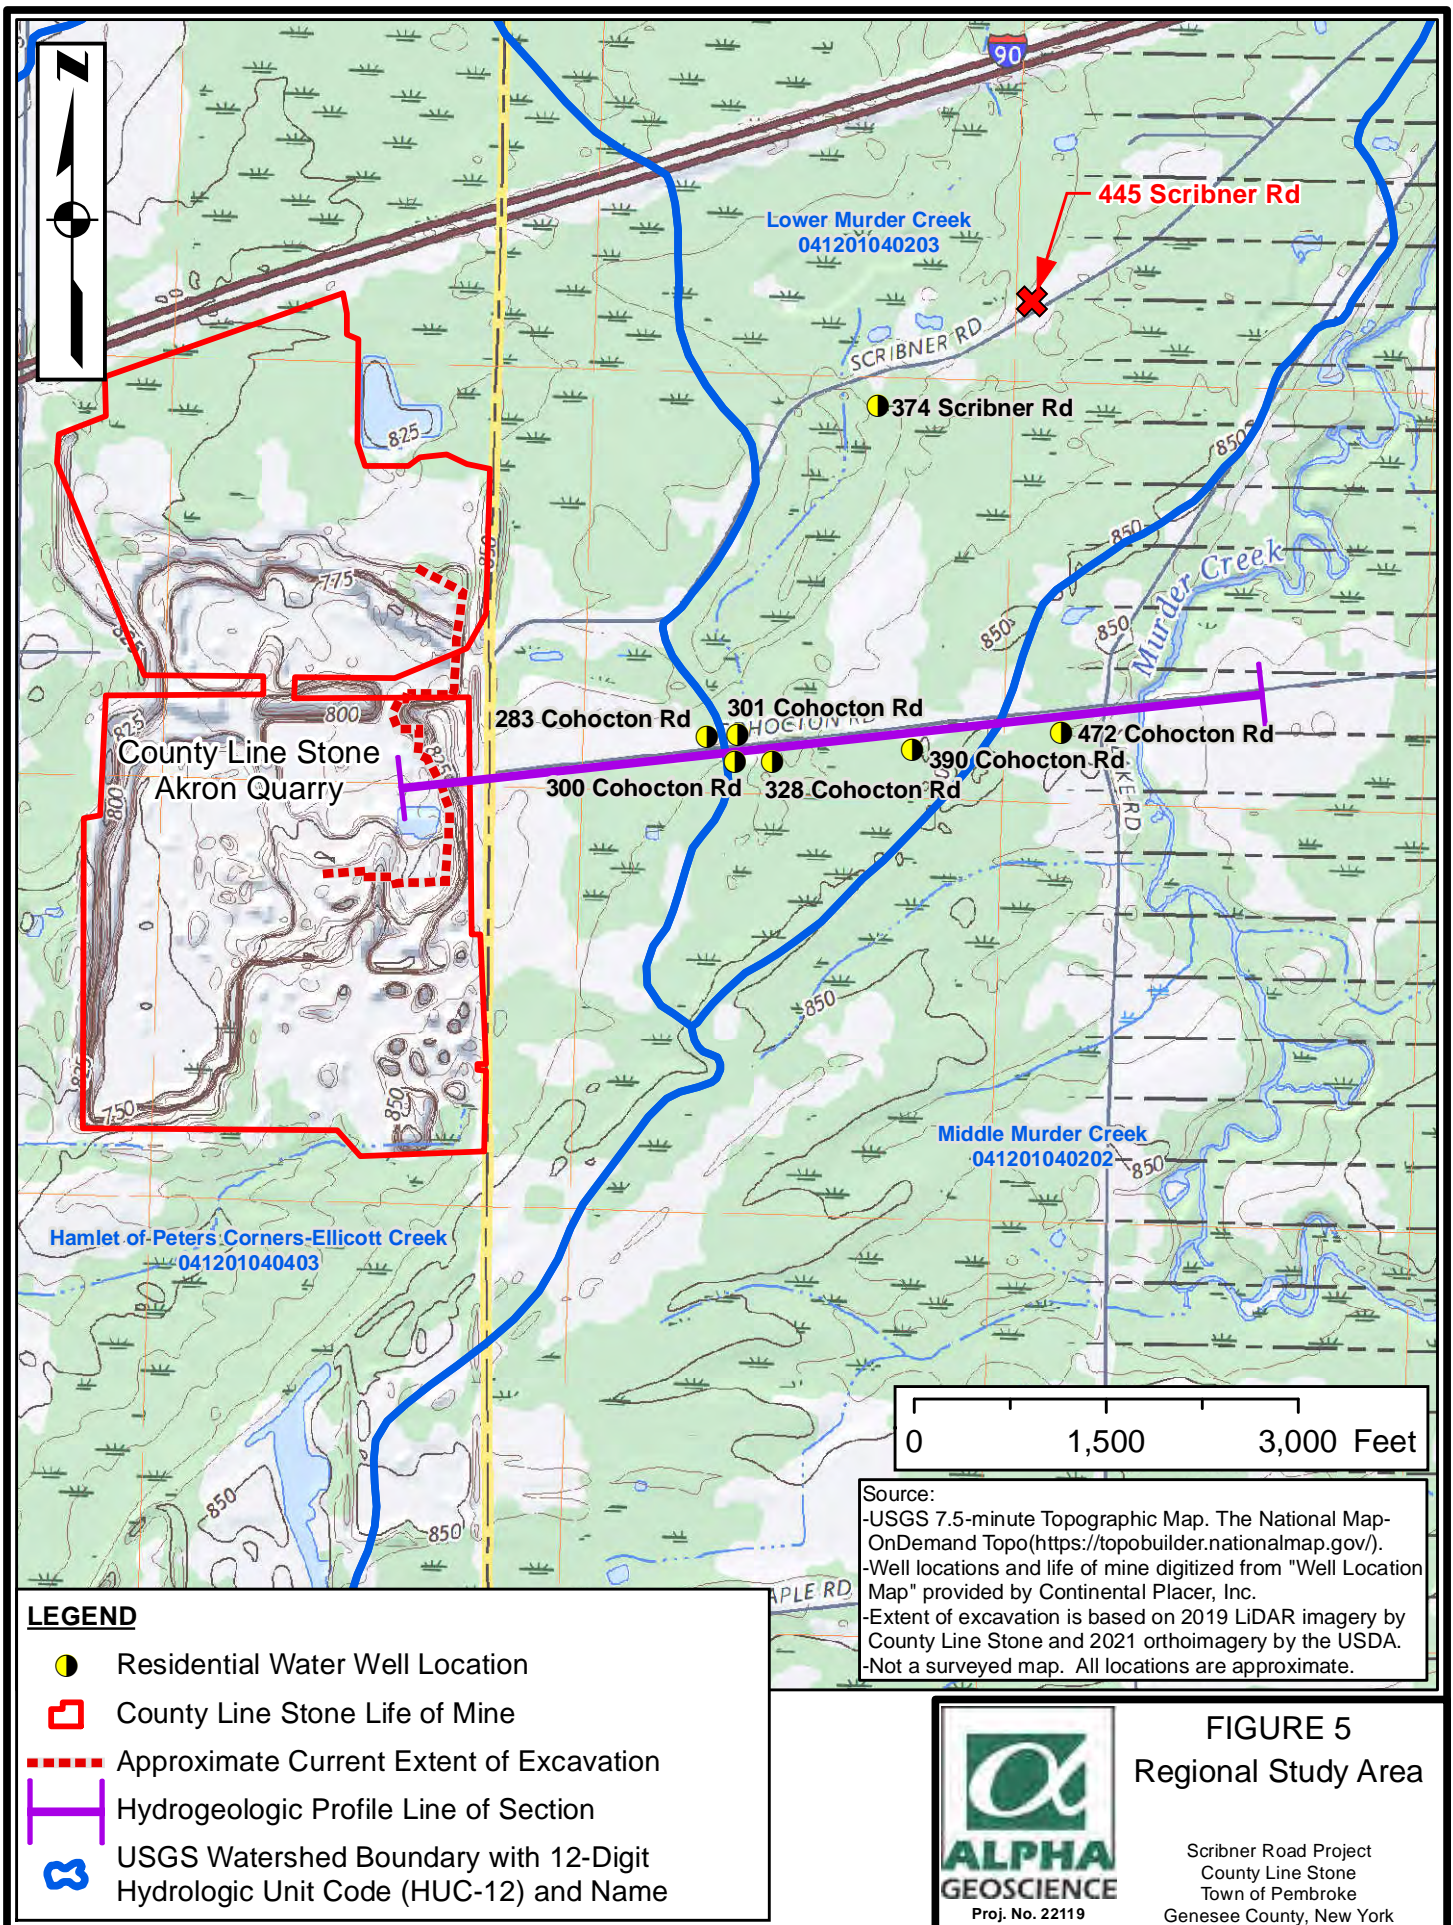
FIGURE 4
 House at Lot
 445 Scribner Road

fracture at the northeast corner of the northwest wall of the “Southwest Addition” to the house (Figure 4). The inward buckling of the northeast wall of the “Southwest Addition” is apparent but is less visible than along the northwest wall. A steel support beam is visible on Image 3033 where it has punched through the buckled cinder block wall approximately 10 to 12 feet from the northeast end of the northwest wall.

Image 3037 (Appendix A) shows an extension fracture in the northwest wall. This crack is at the southwest corner of the northwest wall of the “SW Addition” (Figure 4).

Image 3030 (Appendix A) shows the northeast corner of the northwest wall where the extension cracks are visible on both the northwest and northeast walls (Figure 4). Image 3032 shows the same northeast corner of the northwest wall (foreground) with an extension crack visible in the background on the northwest wall of the “Original” part of the house at Lot 445. Image 3031 provides a closeup view of the fracture. It is apparent on Image 3031 that the blocks on the right (southwest) have moved up a fraction of an inch relative to the left side (northeast).

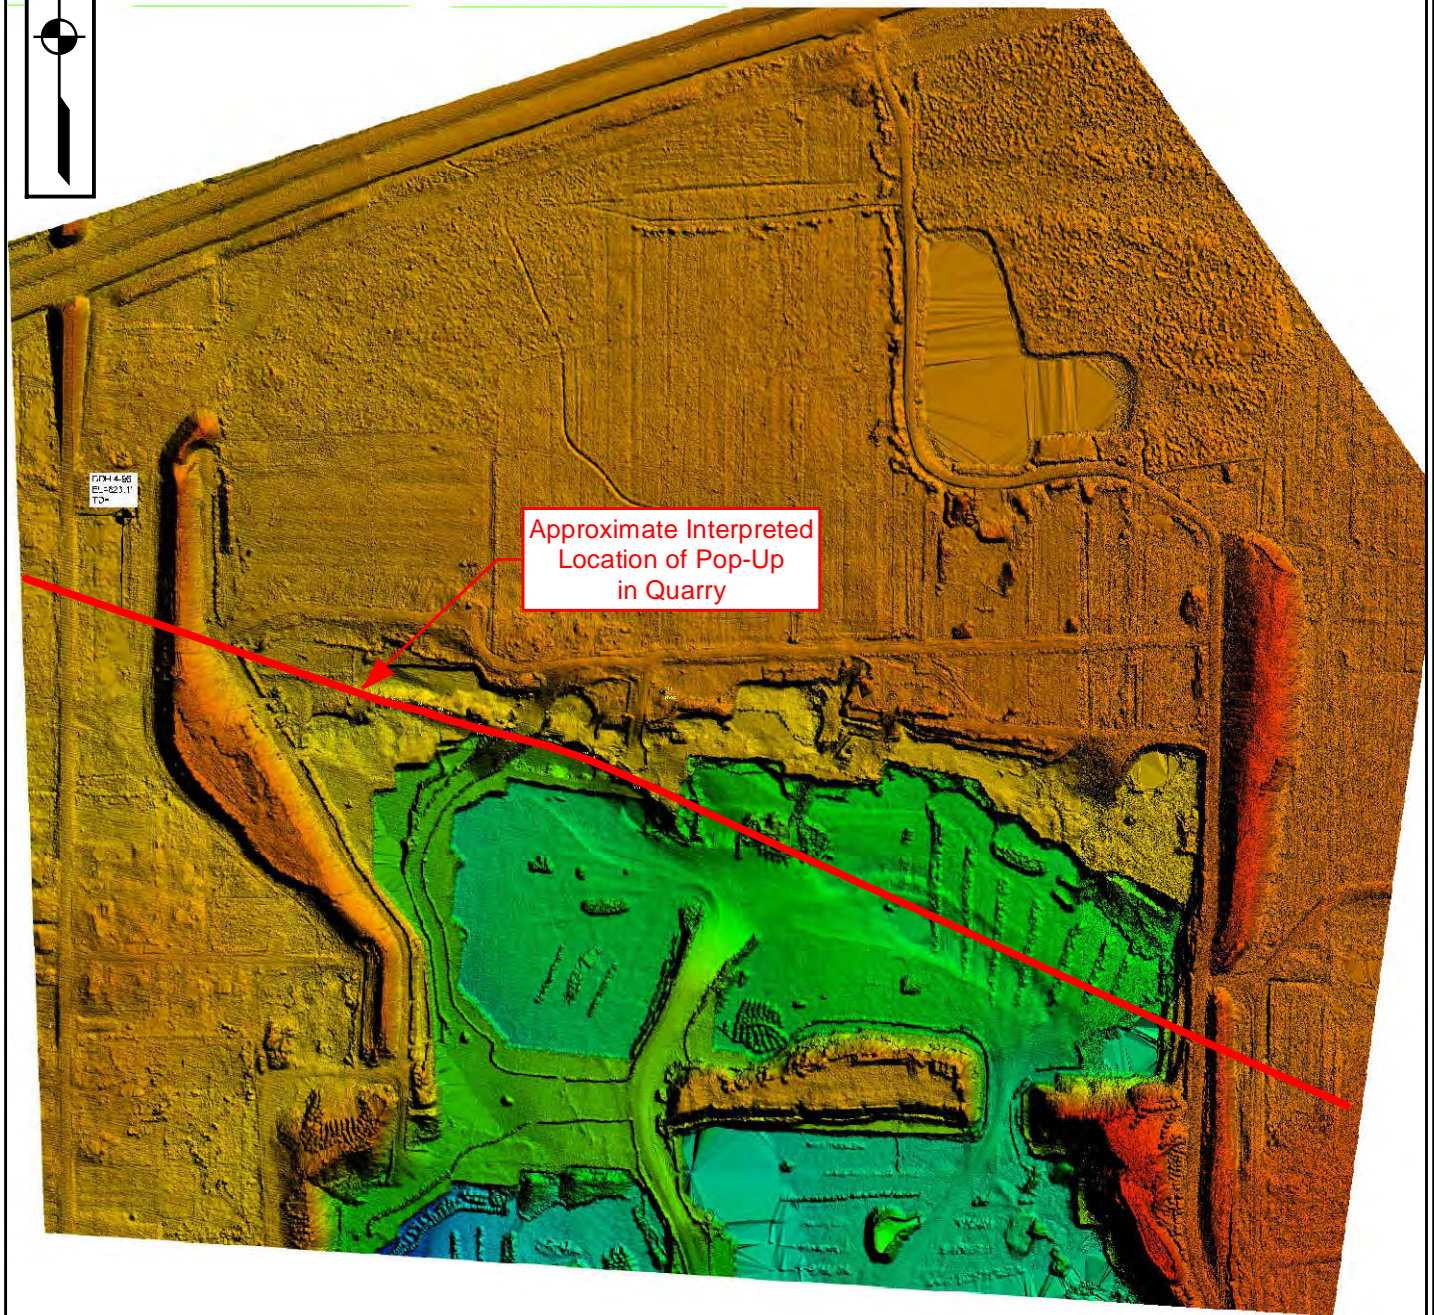
Approximate Interpreted
Location of Pop-Up
in Quarry

These same types of pre-existing and recent features exist in the region near the Scribner Road area. For example, a pop-up was discovered in the floor of the Akron Quarry and was detected extending up through the rocks and overburden when the area was core drilled in 1996 and subsequently when mined more than ten years ago. Figure 22 shows the feature in the quarry floor (foreground) and in the quarry face on the west side of the quarry. Figure 23 shows the same feature on the east rock face. The slight upwarping of the glacial overburden is illustrated on the figures. This pop-up is documented in images 3048, 3049, 3050, 3059, and 3060 in Appendix A. The trace of this pop-up, which is oriented northwest to southeast across the quarry floor is shown on Figure 24.
